STUDENT REPORT

Conservation of Wall Paintings at Suuremõisa Manor

Hiiumaa, Estonia

Nordplus Intensive Course, 24 – 29 August 2015

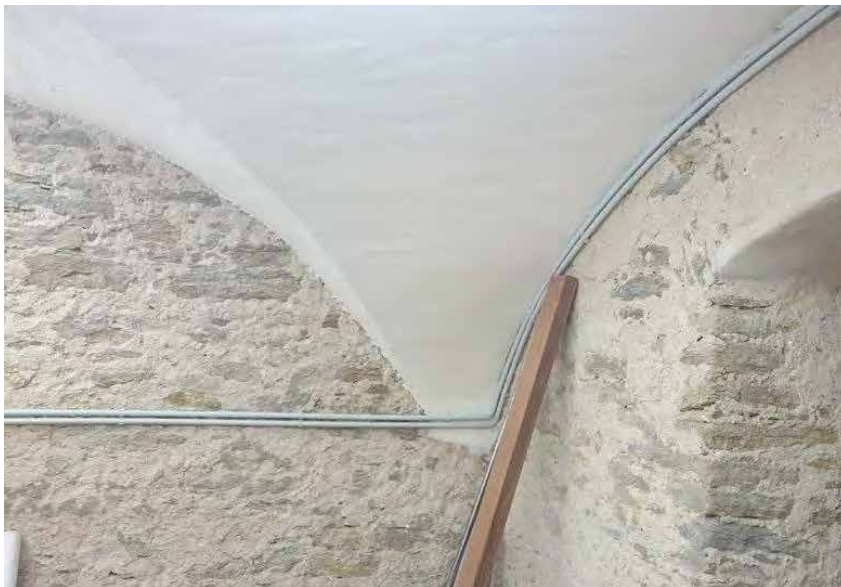
The basement was built in vaults of limestone. The higher ranked paid servants were living in the basement which was also used as a working space and storage area.

Basement. Photo: Robin Lindqvist.

The basement was renovated in 2015 when the new ventilation system and electrical wiring were also installed. The ceilings and walls were painted white. Some of the floors got new tiles.

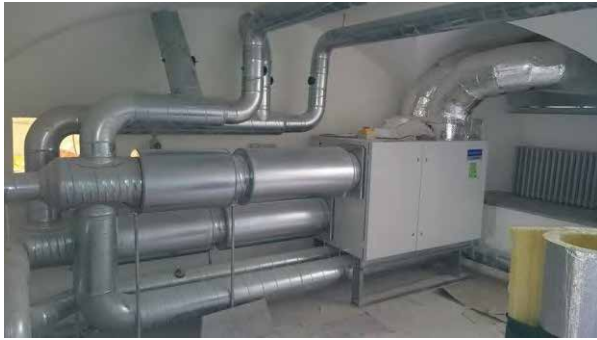
Ventilation machine. Photo: Robin Lindqvist.

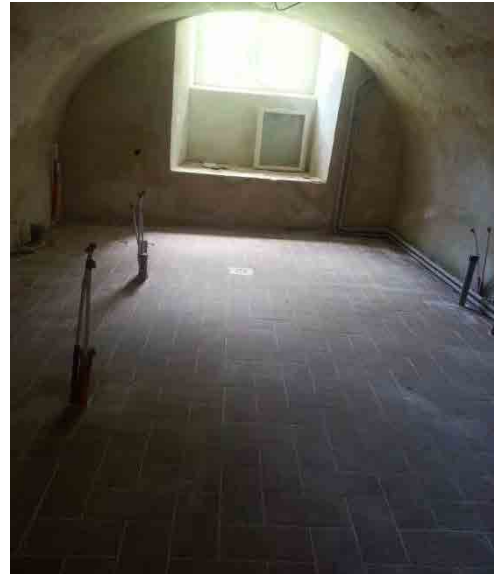
New flooring in the basement. Photo: Andreas Selenius.

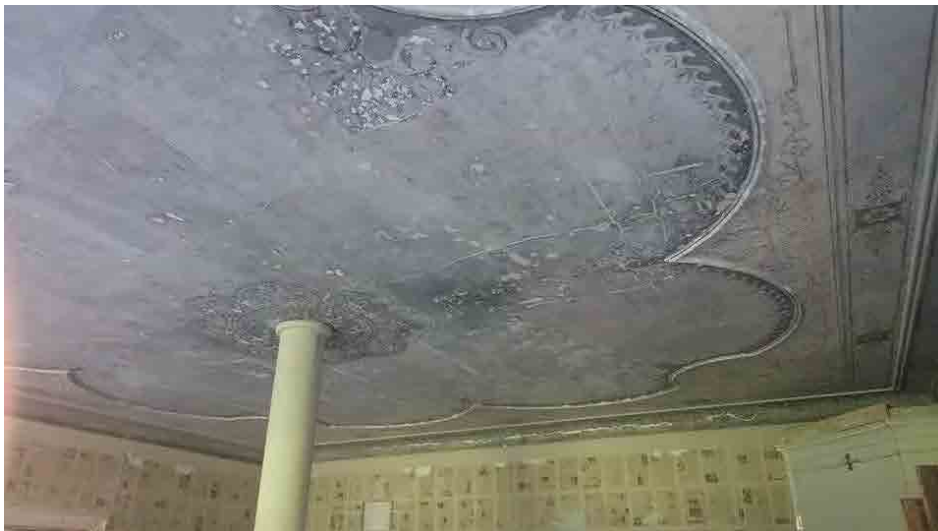
On the first floor the ceiling is reinforced with a pillar to avoid it from collapsing due to large loads on the 2nd floor.

The pillar. Photo: Robin Lindqvist.

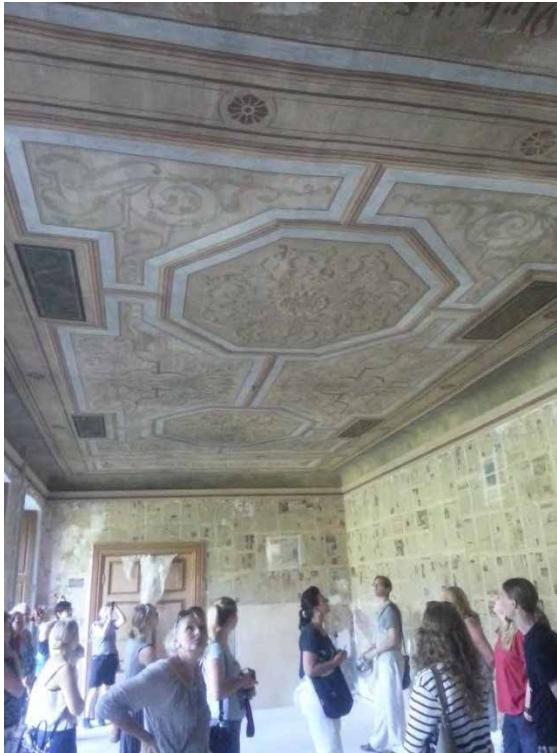
The original ceiling paintings in some of the rooms have been recreated. In some of the rooms the floors were replaced and the panels and walls painted over. Due to heavy water damage one of the ceilings had to be reinforced with a metal plate which is hanging from the roof truss.

Recreated painting. Photo: Andreas Selenius.

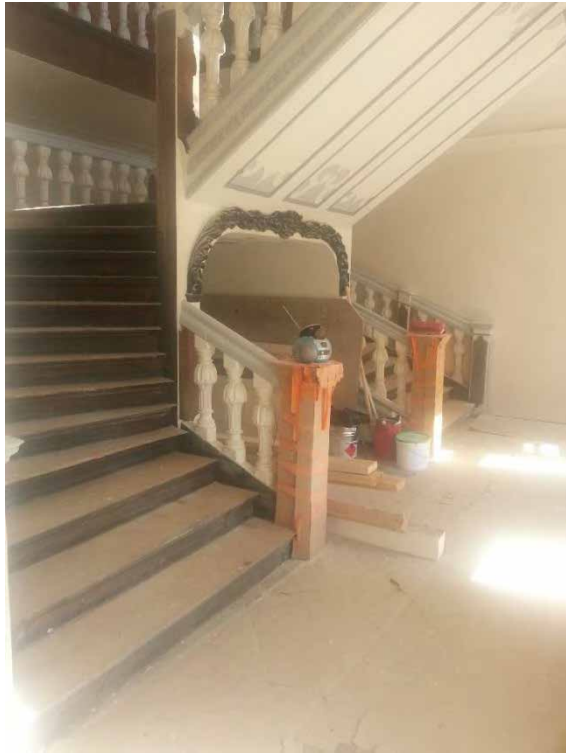
The carved oak staircase leading up to the 2nd floor right from the entrance. Photo: Andreas Selenius

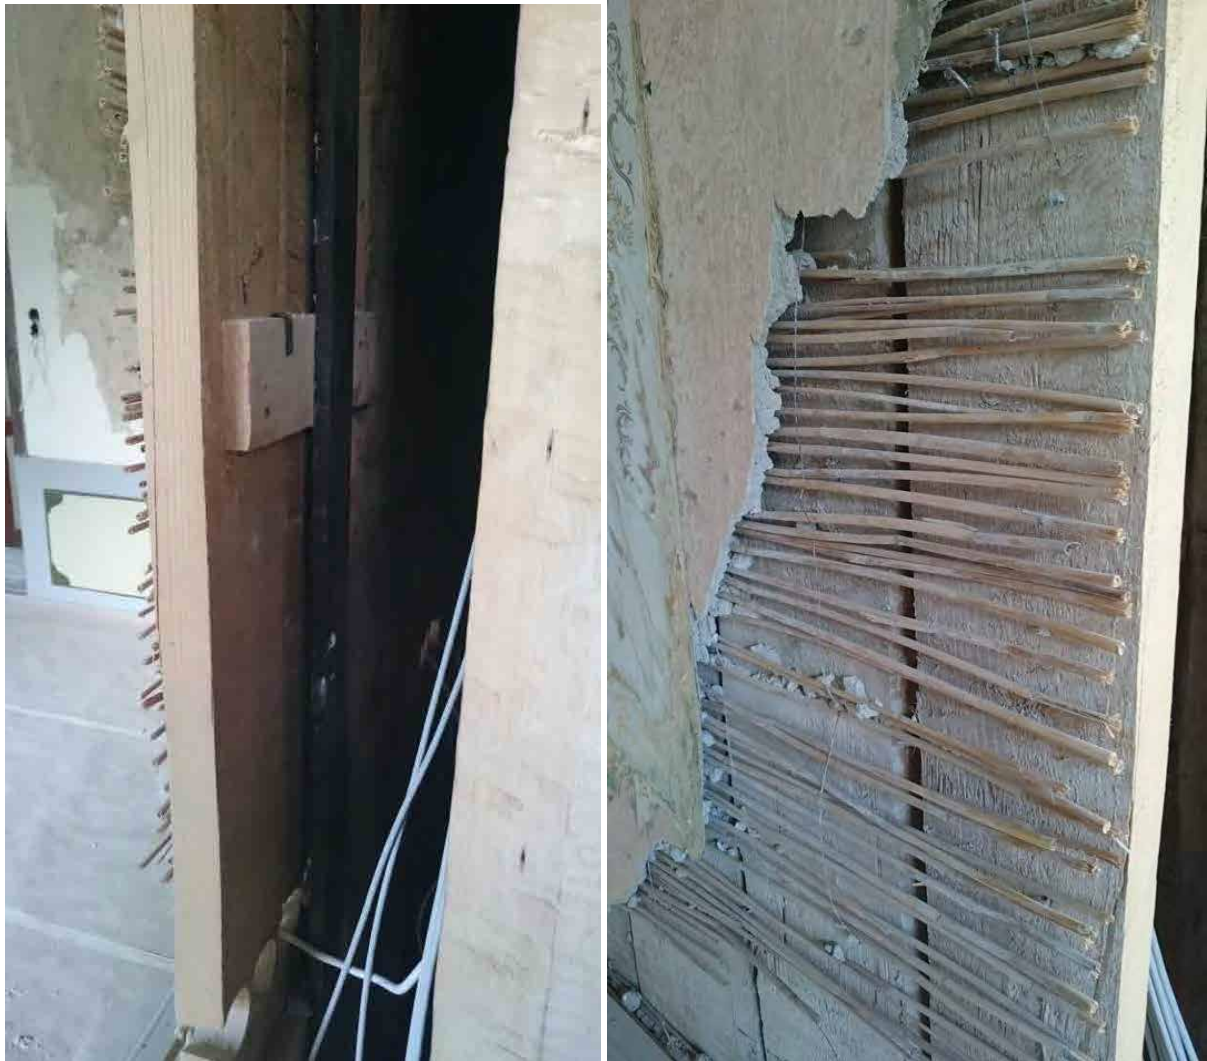
On the second floor there is a wall which is made of wood and is constructed later. The rest of the walls are made of stone. The metal beams leading from the roof truss to the metal plate reinforcing the floor on can be found inside the wooden wall.

The wooden wall. Photos: Robin Lindqvist.

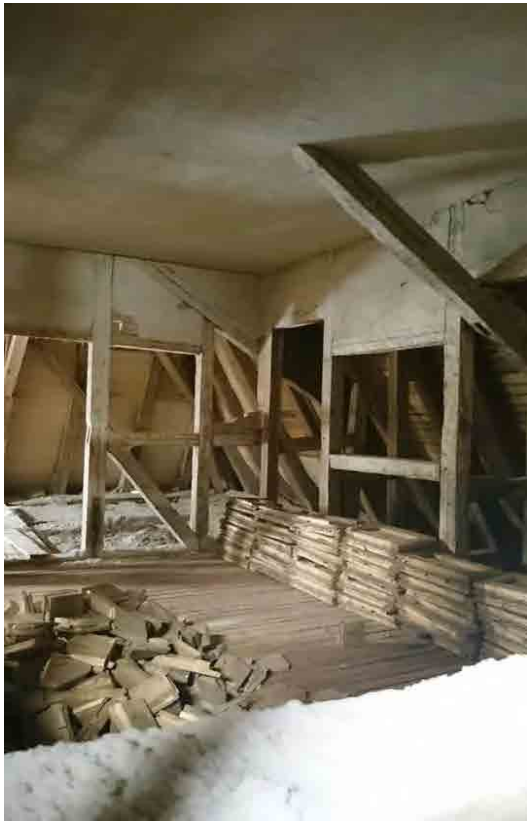
The attic was used as the living area for servants. The small rooms are made of wood and bricks. The filling material in the roof is renewed. The roof truss is made of massive wood. The huge chimneys worked also as ventilation and are connected to most rooms in the manor. Some of the ceiling constructions had to be renewed and reconstructed due to damages caused by fire and old age. There were 4-6 windows but they were removed due to leakage. The three roof-windows are original and are locally made in Hiiumaa.

Servants living area. Photo: Robin Lindqvist

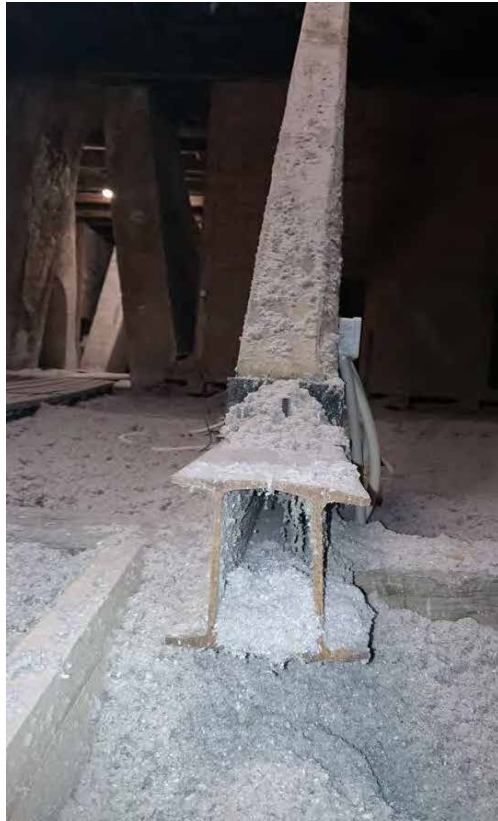
Metal beam, Russian-time engineering. Photo: Robin Lindqvist

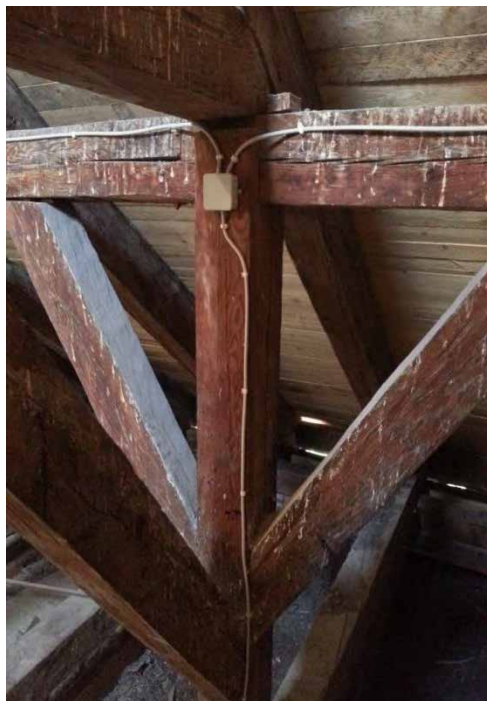
The roof truss of massive wood. Photo: Andreas Selenius

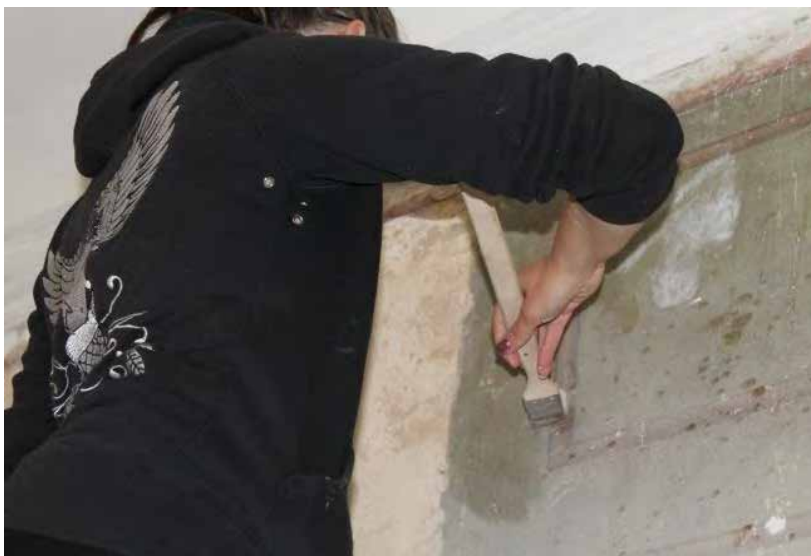
Dusting the wall surface. Photo: Anna Holmberg

The first task was to clean the walls with brushes to get all the loose dust away. The painting was also measured and drawn in the beginning of the day.

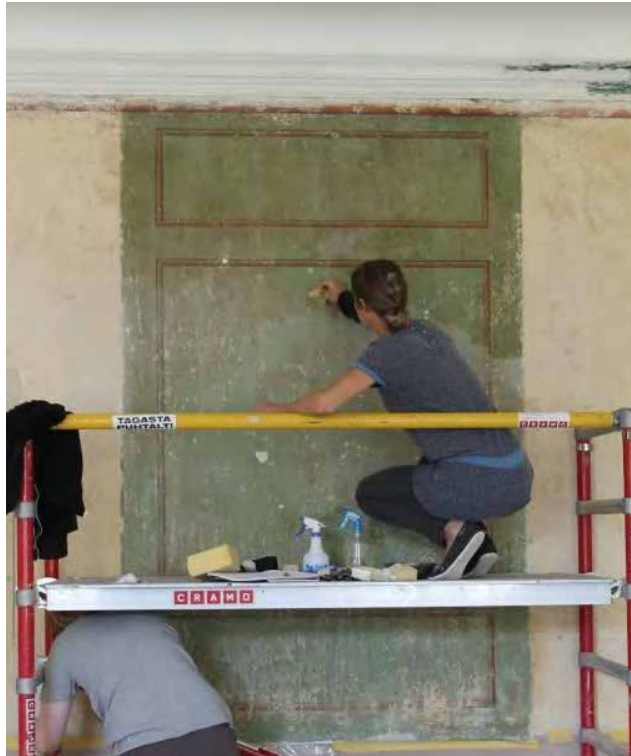
Kautchuck sponge cleaning. Photo: Anna Holmberg

After the dusting the next step was sponge cleaning. The particular sponge used is made of natural rubber. The rubber sponge used is broadly spread in the conservation field due to its neutral pH and ability to effectively pull the dirt from the surface cleaned. The later ability is promoted by the high porosity of the sponge.

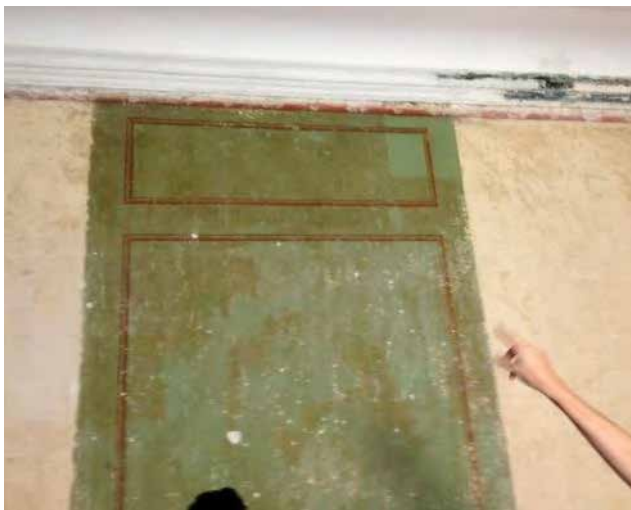
Wallpaper glue residues test cleaning.
Photo: Anna Holmberg

The next task was to remove the glue using wet mechanical method. The glue was firstly moistened using water and after cautiously removed using scalpel blade.

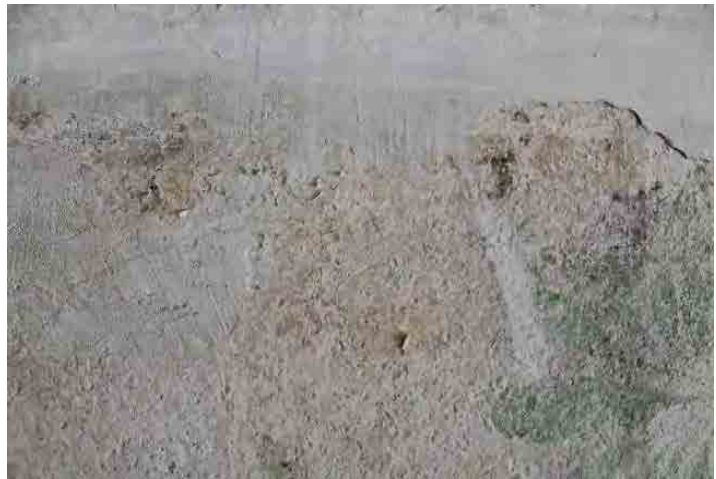
In Room N2 the cleaning took place on wall 1, wall 2 and wall 3. In the upper section of the wall 1 certain layers were discovered.

1. Base
2. Plaster /Lime wash
3. Brownish red paint layer
4. Plaster /lime wash
5. Light green colour
6. Plaster/ lime wash
7. Brown paint layer
8. Plaster / Lime wash
9. Red paint layer
10. Plaster/ Lime wash
11. Wallpaper fragments

Wall 1 fragment. Photo: Anna Holmberg

As one of the oldest and best preserved colour layers the green paint layer was decided to be overly revealed. The lost parts of the green paint layer on the wall 1 were decided to be reconstructed in order to obtain the visual integrity of the room. The walls 2 and 3 were decided to be left unreconstructed due to the conservation work relied on the principle of possibly minimal interpretation and intervention.

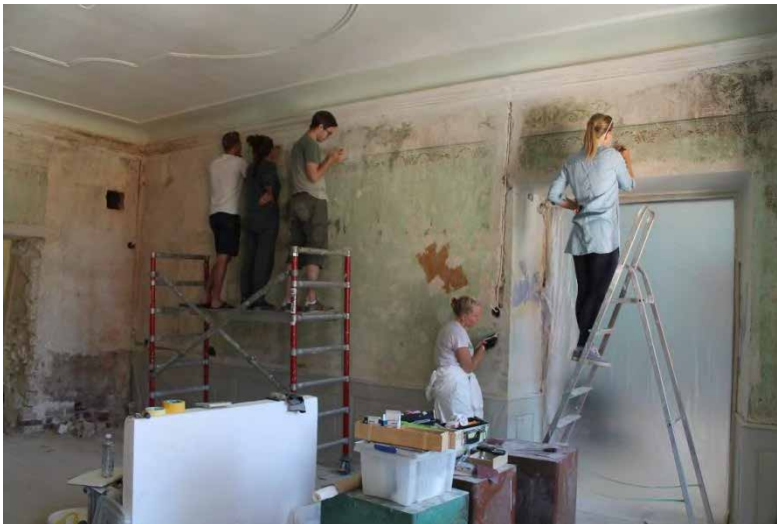
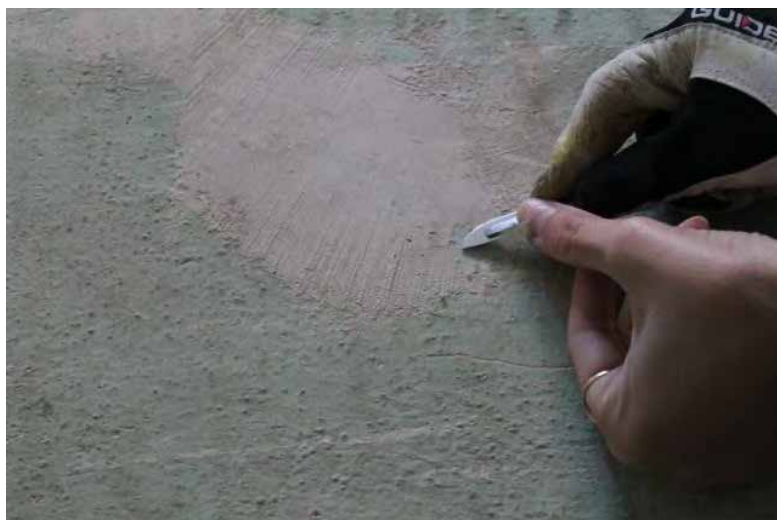
Photos depicting the process of revealing the green paint layer.

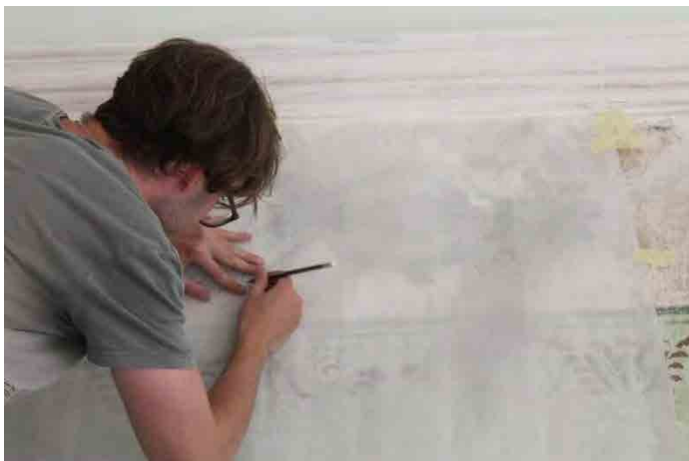
In the green room there were ornaments on the top of the walls that were going to be reconstructed and in some places renewed. To perform the reconstruction the reproduction of the green ornament was needed. The first task was to duplicate the ornament on transparent piece of paper using plain graphite pencil.

Reproduction of the ornament outlines through transparent paper. Photo: Anna Holmberg

The next task was to make a stencil preparation. The preparation phase consisted of sizing of the thick piece of paper with linseed oil. After the sizing performed on the paper, it was left to dry for a day. The linseed oil sizing was made to prevent the stencil from deformation during the process of paint application.

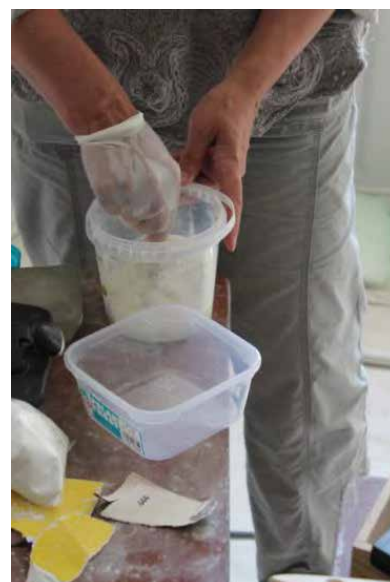
Preparation of the casein medium.
Photo: Anna Holmberg

The next step of reconstruction preparation was to make a casein medium which will be used as a paint binder. The casein paint medium consisted of dry casein powder, water and borax. Casein is normally a protein extracted from cottage cheese. Borax is a material of mineral descent. Its use allows the casein medium to obtain neutral pH and use it with all kinds of pigments.¹

- 2 1/2 oz. (80g) Casein Powder
- 9 fl. oz. (ca 250ml) cold water
- 1 oz. (32g) Crystalline Borax
- 9 fl. oz. (ca 250ml) hot water

1. The dry casein powder is soaked in cold water for approximately one night
2. Borax powder dissolved in warm water
3. Borax solution is added to casein solution and stirred
4. The mixture is left to cool down

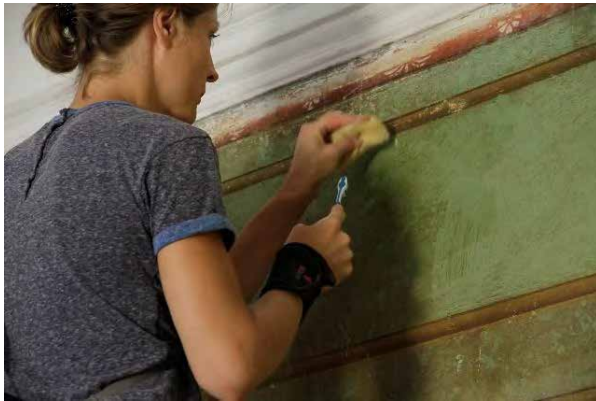
For the green surface we used clean water and toothbrushes to get off the wallpaper glue residues.

Karin cleaning the W-wall painting
Photo: Josefine Israelsson

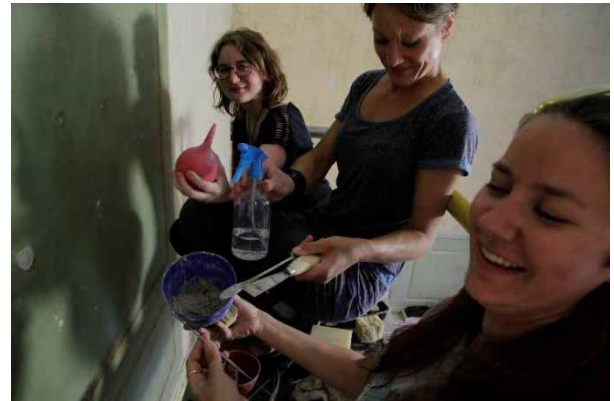
Picture of all the tools to clean and plaster the holes
Photo: Liina Talts

When we were satisfied with the result of the cleaning, we started filling the holes. We used an air pump to get the loose particles away from the cavity so the plaster could stick better. The plaster consisted of $\frac{3}{4}$ sand and of $\frac{1}{4}$ lime, the filler was cattail fluff (kaveldun).

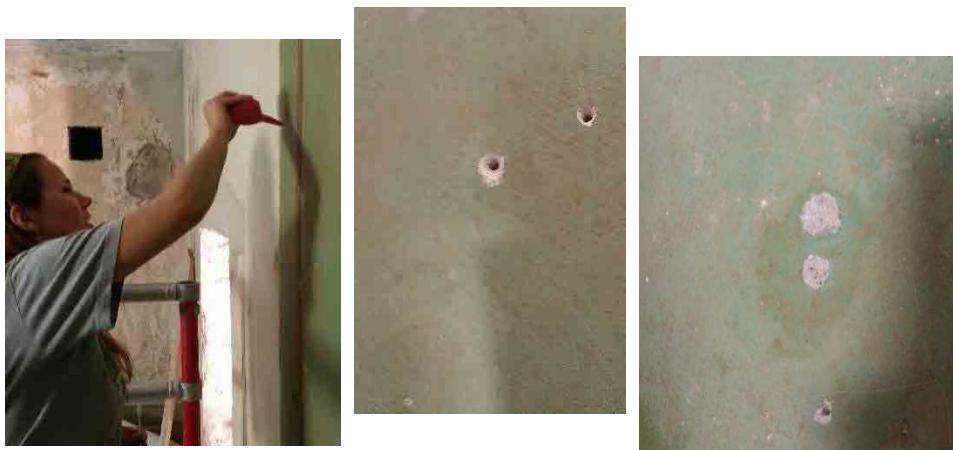
Air pumping the dirt away from the holes. Pictures of holes on the W-wall painting and holes filled up with plaster.
Photos: Josefine Israelsson

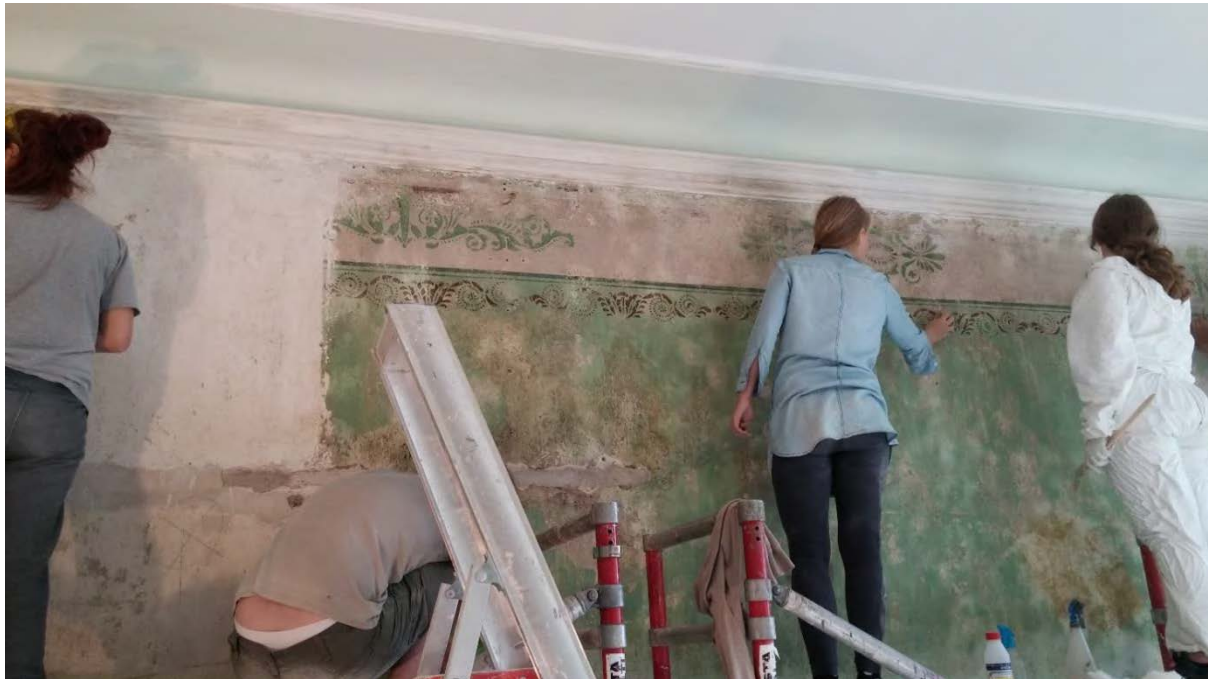
Cleaning the example wall. Photo: Josefine Israelsson

Also in room N2 we continued cleaning the wall painting (mint-green walls and two different stencil ornaments on the upper part of the wall). We worked on every wall but we focused on the S-wall since it was supposed to serve as an example in the end. The residues of plaster and putty were

removed mechanically with scalpels and for soot deposits we used water and sponges or sand paper. Ugly yellowish brushstrokes were removed with acetone. When we considered the wall to be clean enough, we consolidated the wall painting of the S-wall with transparent layer of casein using spray bottles.

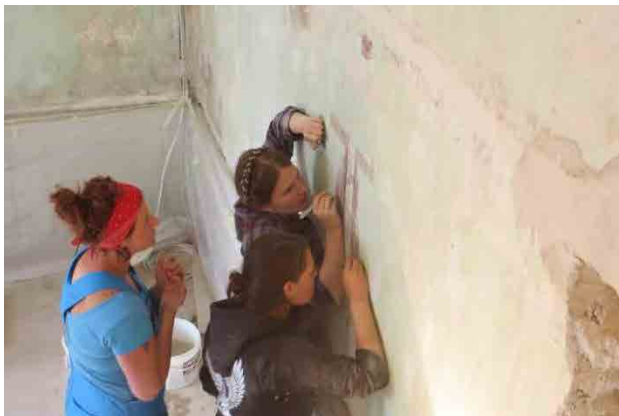
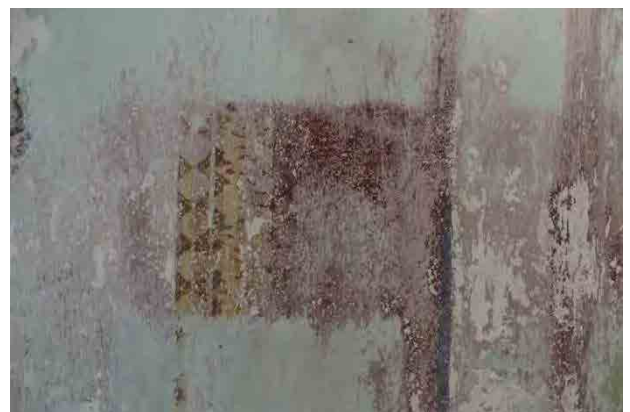
Concurrently with cleaning the visible paint layer we continued with exposing little sample areas of the wall painting under it. We discovered that in the first paint layer, there was probably some kind of vessel on tripod painted on the upper part of the wall and large panels with ornamented borders in the lower parts of the wall.

Exposing sample areas of the first wall painting. Photos: Taavi Tiidor

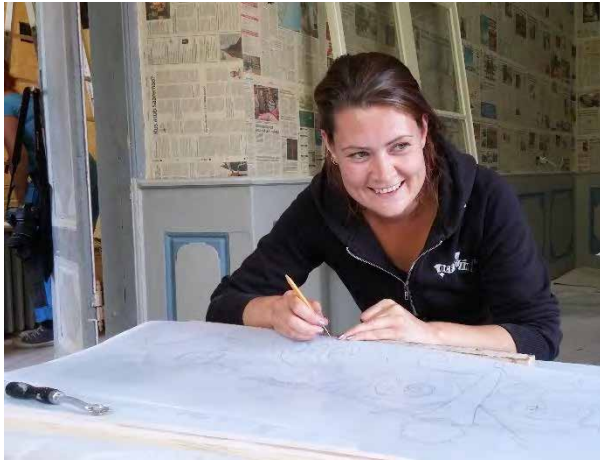
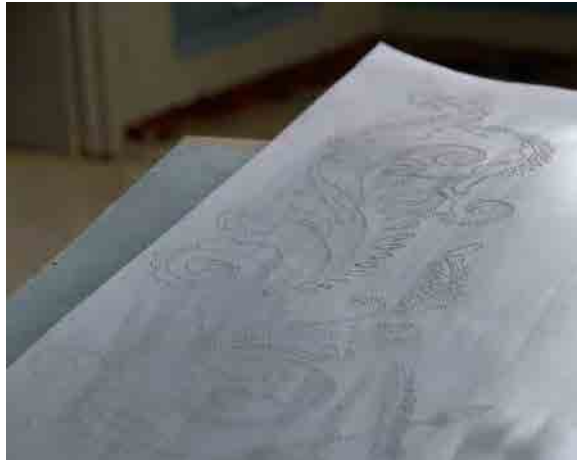
Magdalena using the needle to punctuate the outlines of the ornament and a close-up of the ornament.
Photos: Josefine Israelsson

We used two techniques to transfer the image on the wall to paper. The first technique was to punctuate with a needle the outlines of the ornament. The second one was to cut out the ornament and thus creating a stencil.

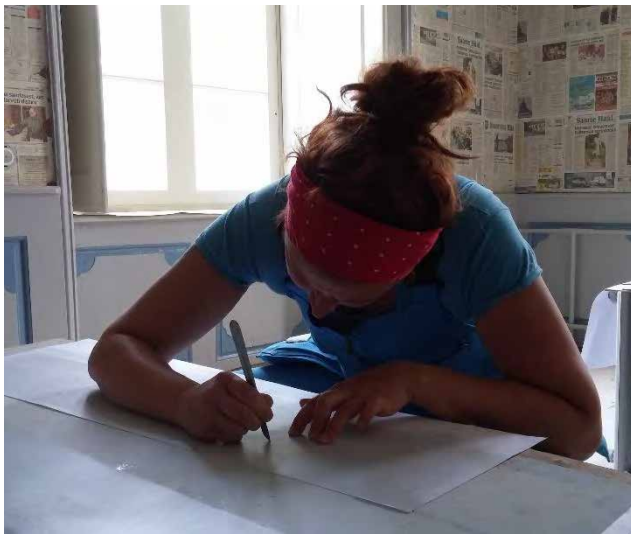
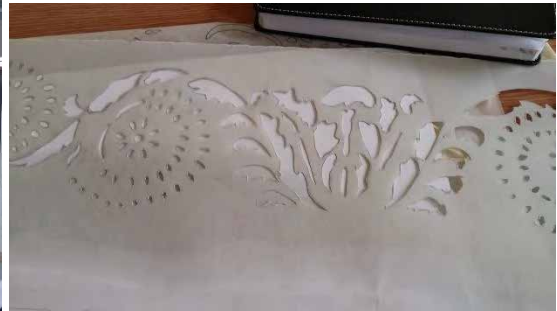
Rebecca cutting out the ornament and a close-up of the stencil. Photos: Josefine Israelsson

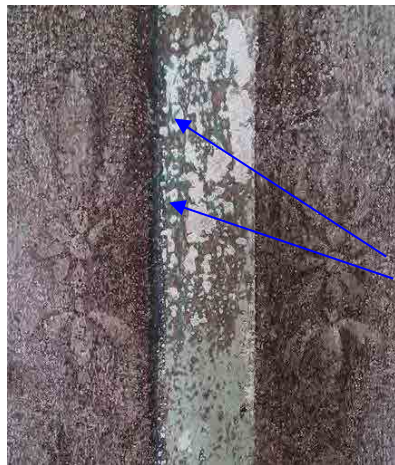
Close-up of the flower ornament on the brownish-red frame.

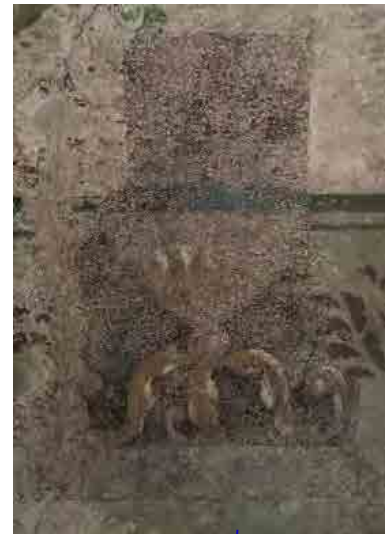
Sondage on the upper part of the wall. Supposedly some kind of a vessel on tripod.

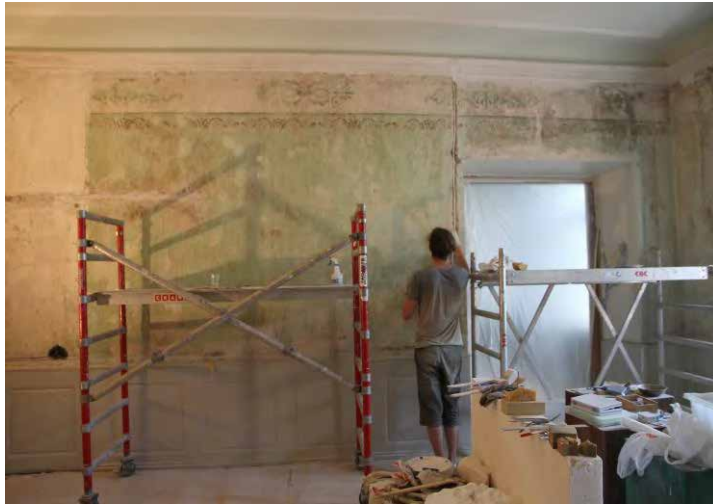
Work with filling holes with plaster continued.
Photo: Rebecca Vemdal

During the morning gathering it was decided that the work in room N2, the green room, should be concentrated on the south wall to give it a finished look. This decision was partly due to the reconstruction which will take place in the southeast corner of the room. Some students continued the work filling holes with the coarse plaster that was made the previous day.

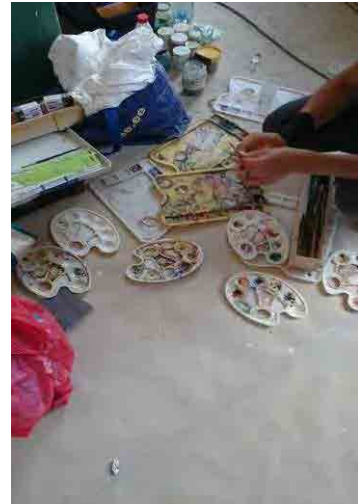
Mixing of pallets to get right hue of colour.
Photo: Rebecca Vemdal

Pallets were mixed to match the existing historical colour on the walls. The pigments used together with the kasein mixture included chrome oxide, yellow ocher, iron oxide black and chalk white, all of these together came as close as it could to the original colour. Aquarelle colours were also used

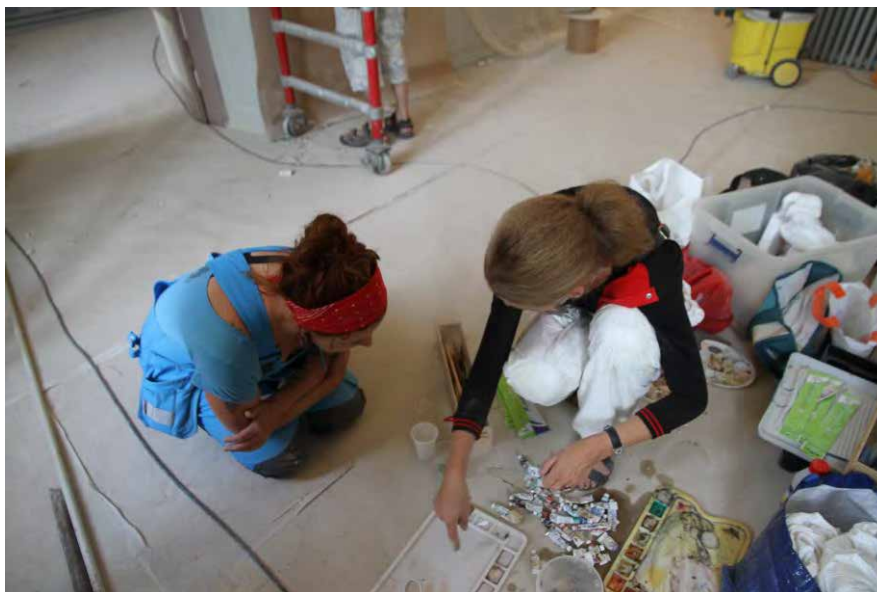
Student being shown how to mix the watercolour with the kasein.

during the process of painting, to give the finished result a more transparent hue, and not to interfere with the historic feel. Another reason for the use of watercolours is because the result will be more reversible than it would be with a pure casein based colour.

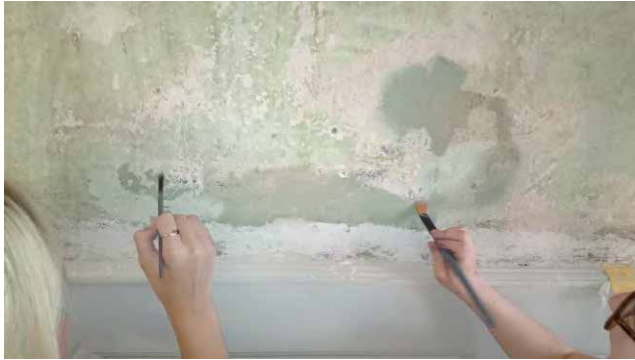
Retouching of stains and blemishes on the south wall.
Photo: Rebecca Vemdal

Retouching of the red/brown ornaments along the walls was made and work also started on the homogenous green by retouching stains and blemishes on the south wall.

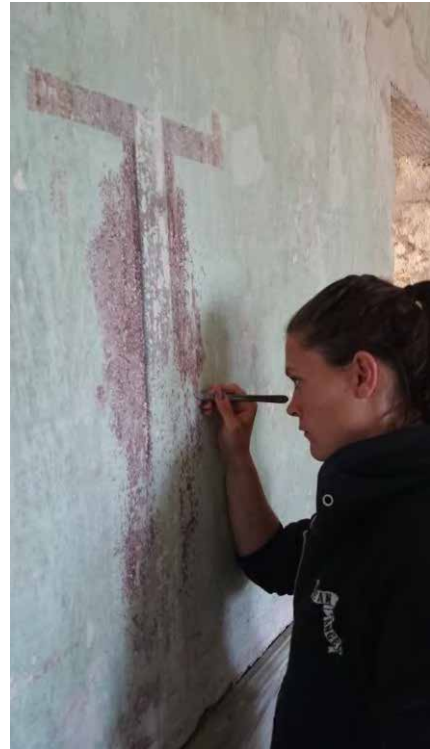
Right: Student scraping paint to reveal flower ornaments on the east wall.
Photo: Viktoria Arvidsson

The cleaning and revealing of the flower ornament continued on the east wall, traces of the same ornament were found on the north wall as well, also the pattern of the ornament became clear. A test stencil was made of that very same ornament.

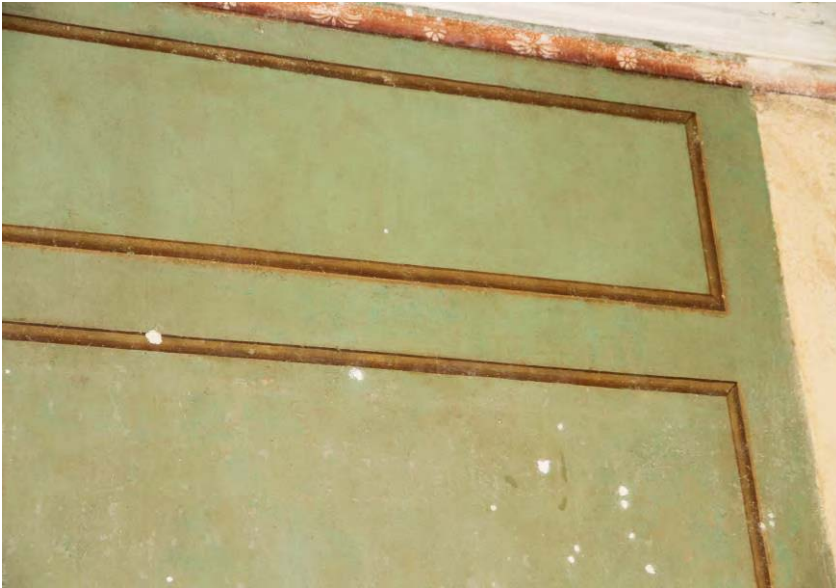
Dried plastered holes ready for retouching with paint.
Photo: Vikoria Arvidsson

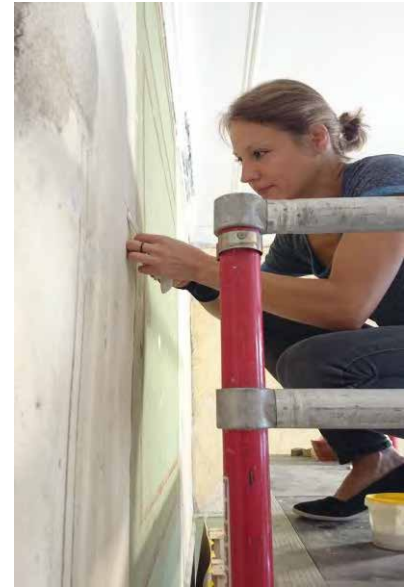
Filling of small holes in room N16
Photo: Rebecca Vemdal

Work continued with filling holes with fine plaster. Excess plaster was removed carefully with sponges and water. Tests were made to find the right palette to fit with the historical color of the wall. In this room casein based paint was also used, the same process of mixing the pigment base with aquarelle colours for reversibility was also applied.

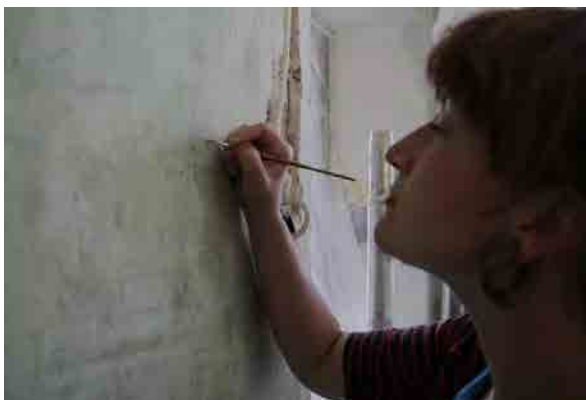
Rebecca filling in blank spots.
Photo: Viktor Källgren

On Friday the group concentrated on finishing work in the room N2 of the manor house. The main aim of the workshop was to conserve the south wall of this room since it hosted the best preserved stencil paintings. Therefore, most of the participants focused on filling in the uncoloured, and discoloured spots on the south wall. In order to give the south wall a more homogeneous appearance, casein colour mixed with several pigments or various watercolours were used.

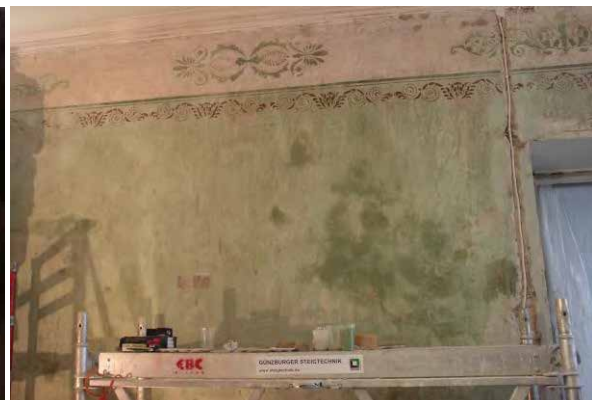
The green casein colour drying.
Photo: Diana Haapsal

It was a time-consuming process to mix a perfect-toned green casein colour to match the green finishing of the walls. First, a trial batch of green casein colour was made to try out on the western side of the south wall which was later to be replastered. The green colour was mixed using a variety of pigments: Chalk White, Chrome Green, Pine Needle Green, Turquoise, Deer Brown, Iron Oxide Black, Zinc White and Yellow Ocre.

The finished product was then applied with either a brush or a sponge to all the noticeably discoloured patches on the walls. In some discoloured areas it was needed to remove the dark paint layers or soot prior to the recolouring.

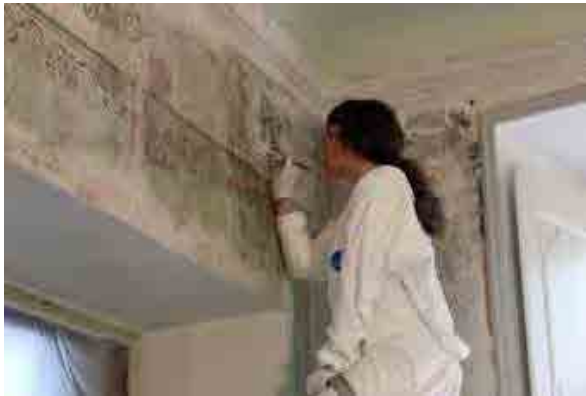
Claudia cleaning out the amphora with a scalpel.
Photo: Diana Haapsal

Some continued previous day's work by cleaning out the stencil paintings hidden underneath smudgy wallpaper paste or secondary paint layers.

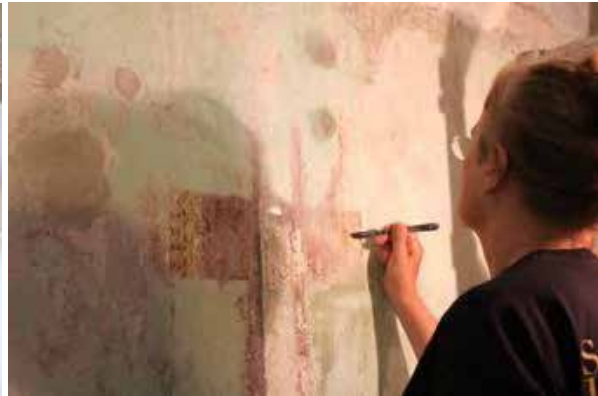
Kirsti cleaning out the earlier wall painting.
Photo: Diana Haapsal

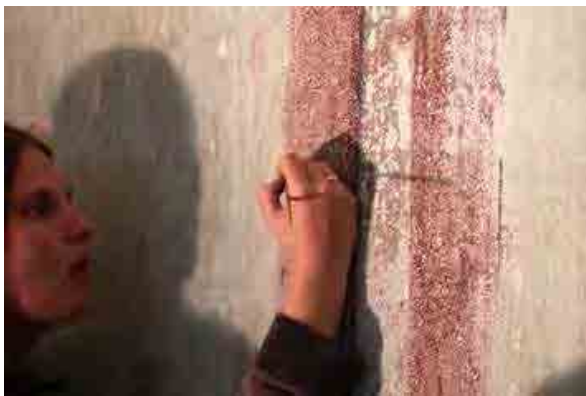
Magdalena doing neutral retouch with a brush.
Photo: Diana Haapsal

Due to the colours being badly preserved in certain areas, it was also necessary to fill in minor lacunae in the stencil paintings. This was done using the *aqua sporca* technique with much diluted watercolours. The aforementioned method, which is also called “flat on surface” technique, consists of covering the lacunae with neutral colours similar in hue to the painting, in order to create an aesthetic whole. In doing so the original painting becomes more visible whilst retaining its authentic essence.

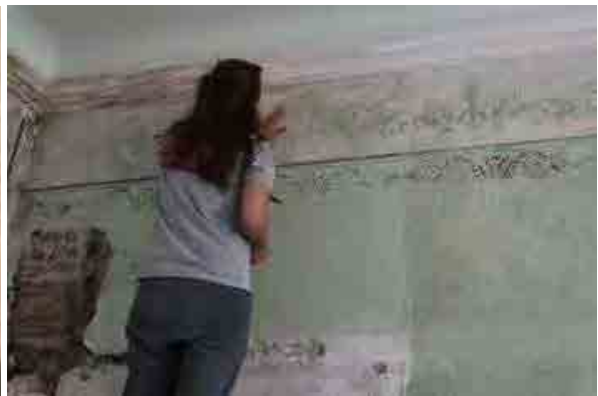
Egle making greyish spot even with white chalk.
Photo: Diana Haapsal

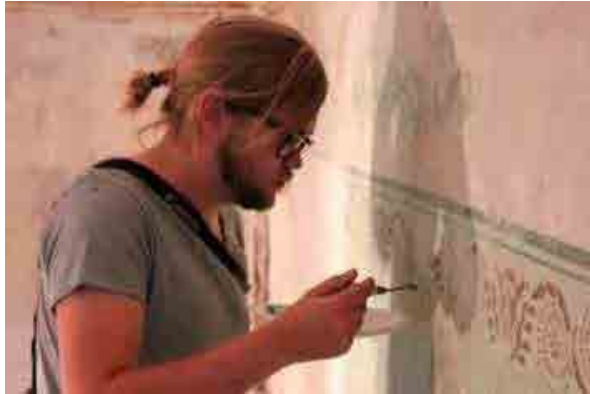
Viktor fixing holes with plaster.
Photo: Diana Haapsal

In order to complete the finishing of the south wall, some minor holes from nails and other damages had to be filled with fine plaster. The plaster which consisted of lime, sand, water and typha was applied with a spatula and a wet sponge to blend its surface with the surroundings. The plaster corrections were later toned with the green casein colour to match the colour of the conserved walls.

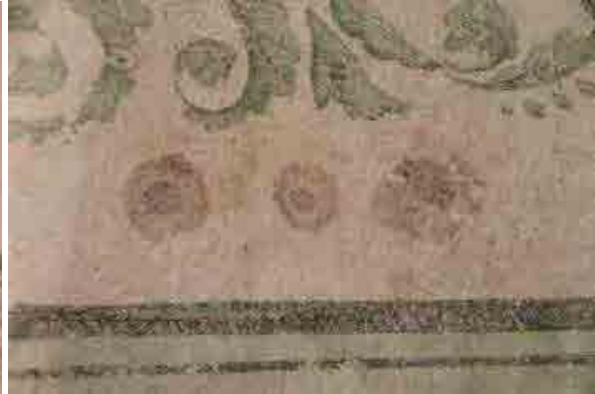
Recently placed plaster in 3 damaged spots on the south wall.
Photo: Viktor Källgren

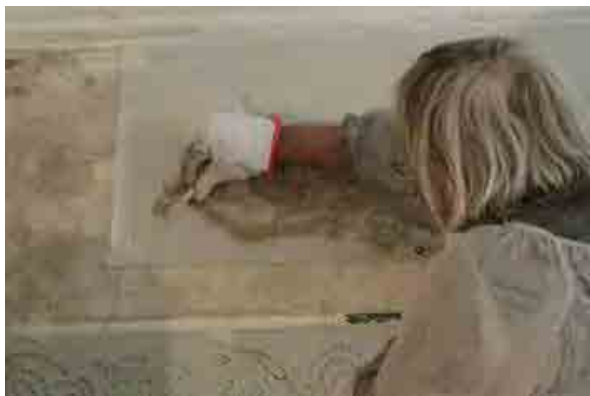
Heli is using a sachet with pigment to attach it to the wall using the pinned through stencil.
Photo: Viktor Källgren

In the re-plastered top left corner of the south wall Mihhail and Egle used previously made stencils to reconstruct the painting. Using stencils eased the continuation of the original ornaments on the left side of the wall. The first stencil was made by copying the herbal ornament on the top of the wall to some tracing paper. Then it was applied to a thicker paper by pricking through the lines of the ornament using a pin. This method enabled to copy the pattern on the wall by fixing the stencil to the desired location and sponging the ornament on the wall with a subtle loose pigment. As the guidelines of the ornament were therefore visible on the wall, it was easy to complete it by hand.

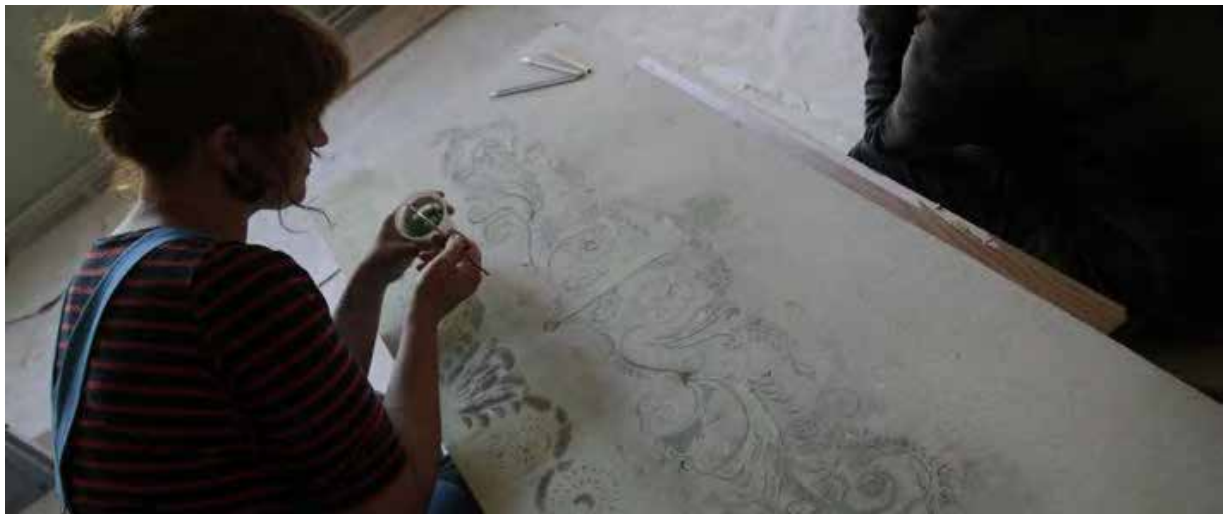
Rebecca is filling in the shadows of one of the ornaments made on masonite. Photo: Viktor Källgren

In order to give every participant a chance to practice creating stencil paintings, the three groups of students from Sweden, Finland and Estonia were each allotted a piece of masonite to make their own try-outs of the two different stencils.

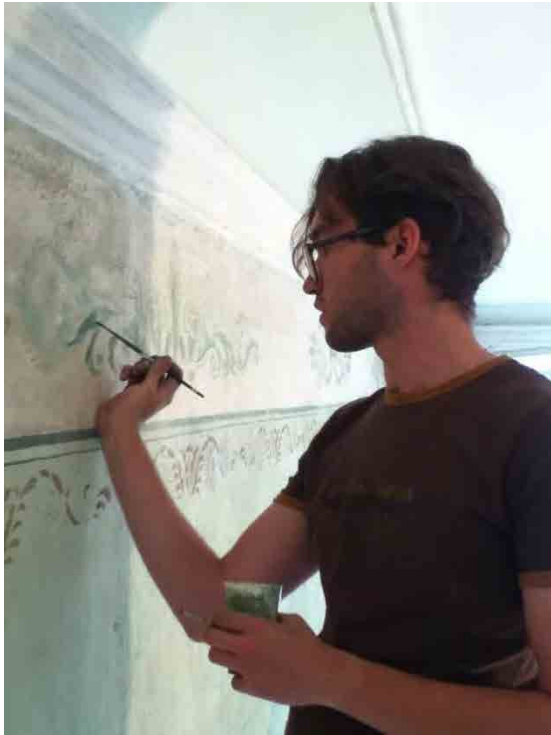
Mihhail adding shadow.
Photo: Egle Mikko

On Saturday 28th of august we started to finish works on the south wall in the main room of focus. By that time, works in the second room N16 had been finished to a satisfactory outcome. Mainly the S-walls reconstruction of a continuous part of the original ornament was being touched up by Mihhail to add shadow, light and also lighten the gray color of the background (background color was lightened with pastels). Most of the works, cleaning and retouching to the original ornaments were completed. Some finishing touches with watercolors to the S-walls original ornaments were given by Merike Kallas and Hilkka Hiiop. Also on the S-wall, the doors portal, Claudia was completing her cleaning of the victory chalice giving it a minimal retouch of color. The outcome of victory chalices cleaning came to be entirely different from the vision of what had been first retraced on paper. In the first retracing (made on Tuesday 24.08.15) there was a guess that, what came out later to be torches, were a crossed feather and sword at the foot of the chalice. This new discovery was at the same time corrected on the reproduction of the chalice (Friday 27.08.15).

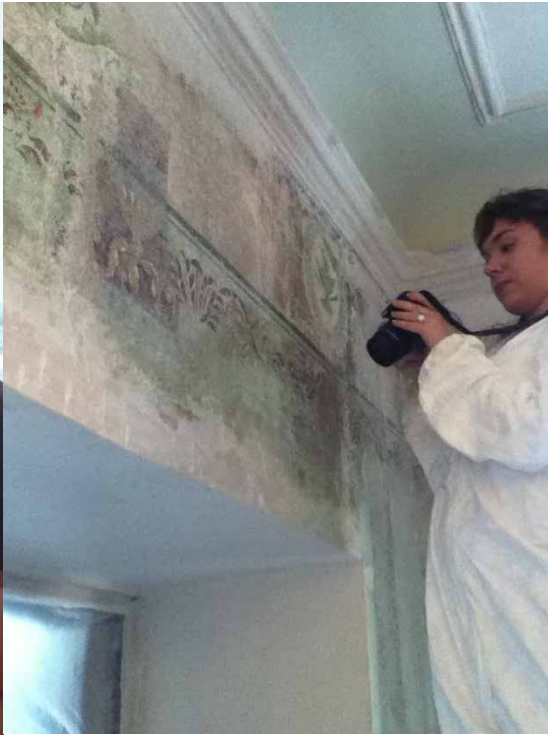
Claudia and her model the chalice.
Photo: Egle Mikko

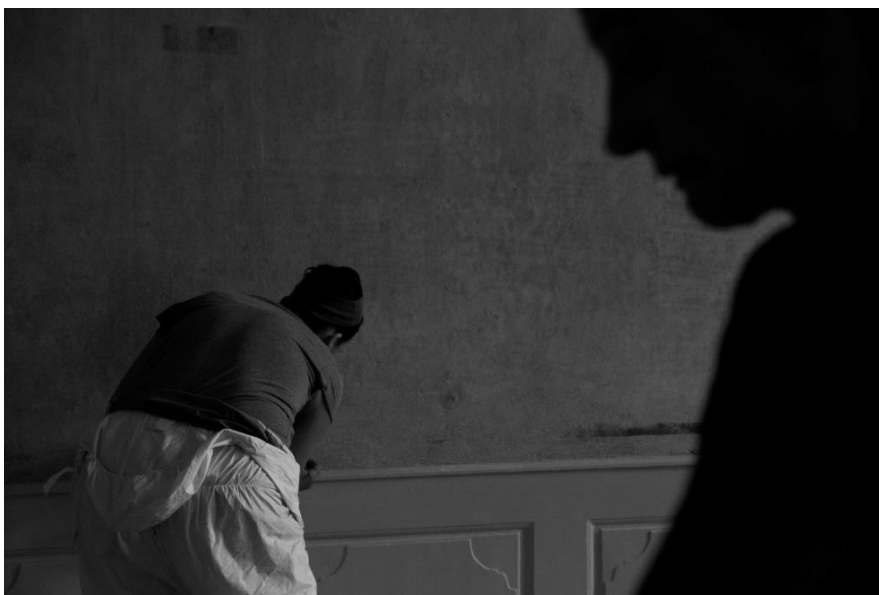
Merike doing some last touches. Photo: Viktor Källgren

The rest of the South wall was also done in aqua-sporca technique, last touches for the green wall were given, and the scaffoldings were removed from the room. Both N2 and N16 were given a thorough Scandinavian style speed cleaning, with Kirsti running the forces of students in this process.

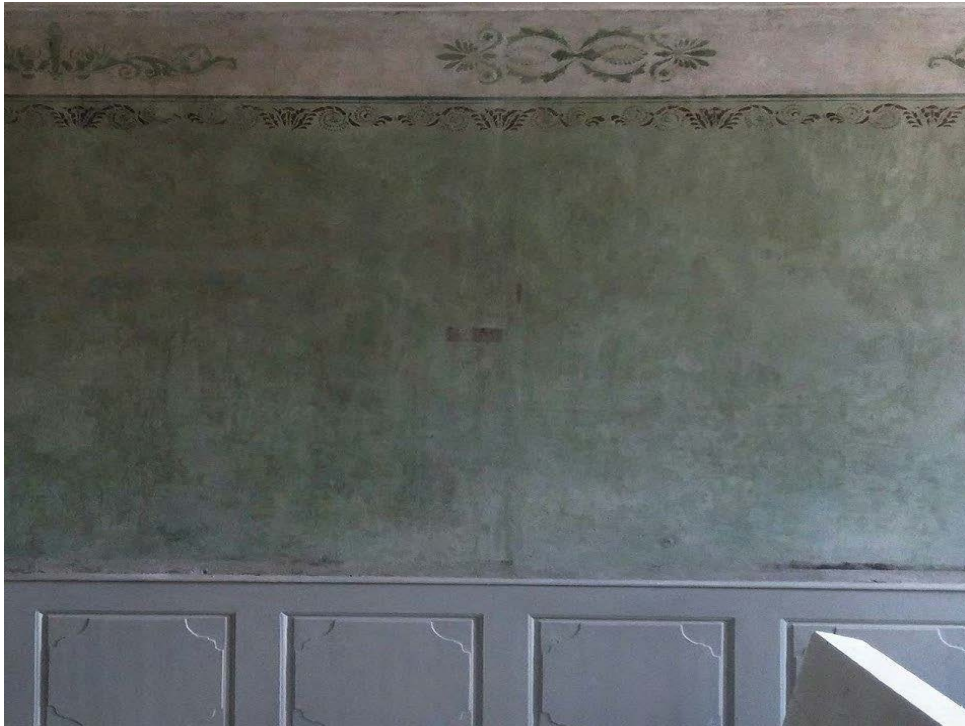
Finished look of the south wall. Photo: Merike Kallas
