STUDENT REPORT

Conservation of Wall Paintings at Suuremõisa Manor

Hiiumaa, Estonia

Nordplus Intensive Course, 24 – 29 August 2015

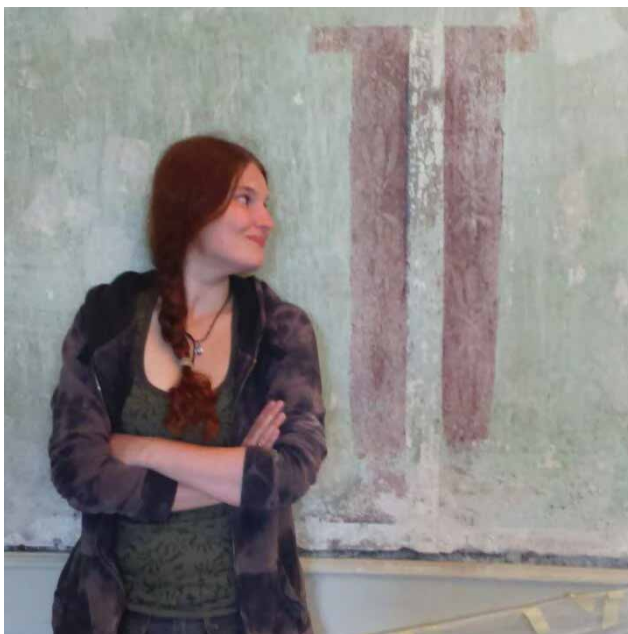
Satisfied Uppsala student Viktoria standing next to her findings
Photo: Egle Mikko

The works on the other walls were left unfinished due to the fact that there was no time to give them the proper attention needed. But a lot of information from the earlier paintings that were revealed on all of the three walls was properly framed, cleaned and retouched. Findings on these walls gave us a better idea of what lays beneath the green layer of paint and also a better idea what to do with the information next.
