Manual for Dismantling, Documenting and Rebuilding Historic Tiled Stoves

—Sustainable Heritage Report No. 3

A joint project between Gotland University, Estonian Academy of Arts and Novia University of Applied Sciences.

This report is a step by step description of the dismantling and rebuilding of two very tall tiled stoves in an historic school building in Ekenäs, Finland. It is meant to serve as a guide to anybody who is interested in building or rebuilding a classical stove.

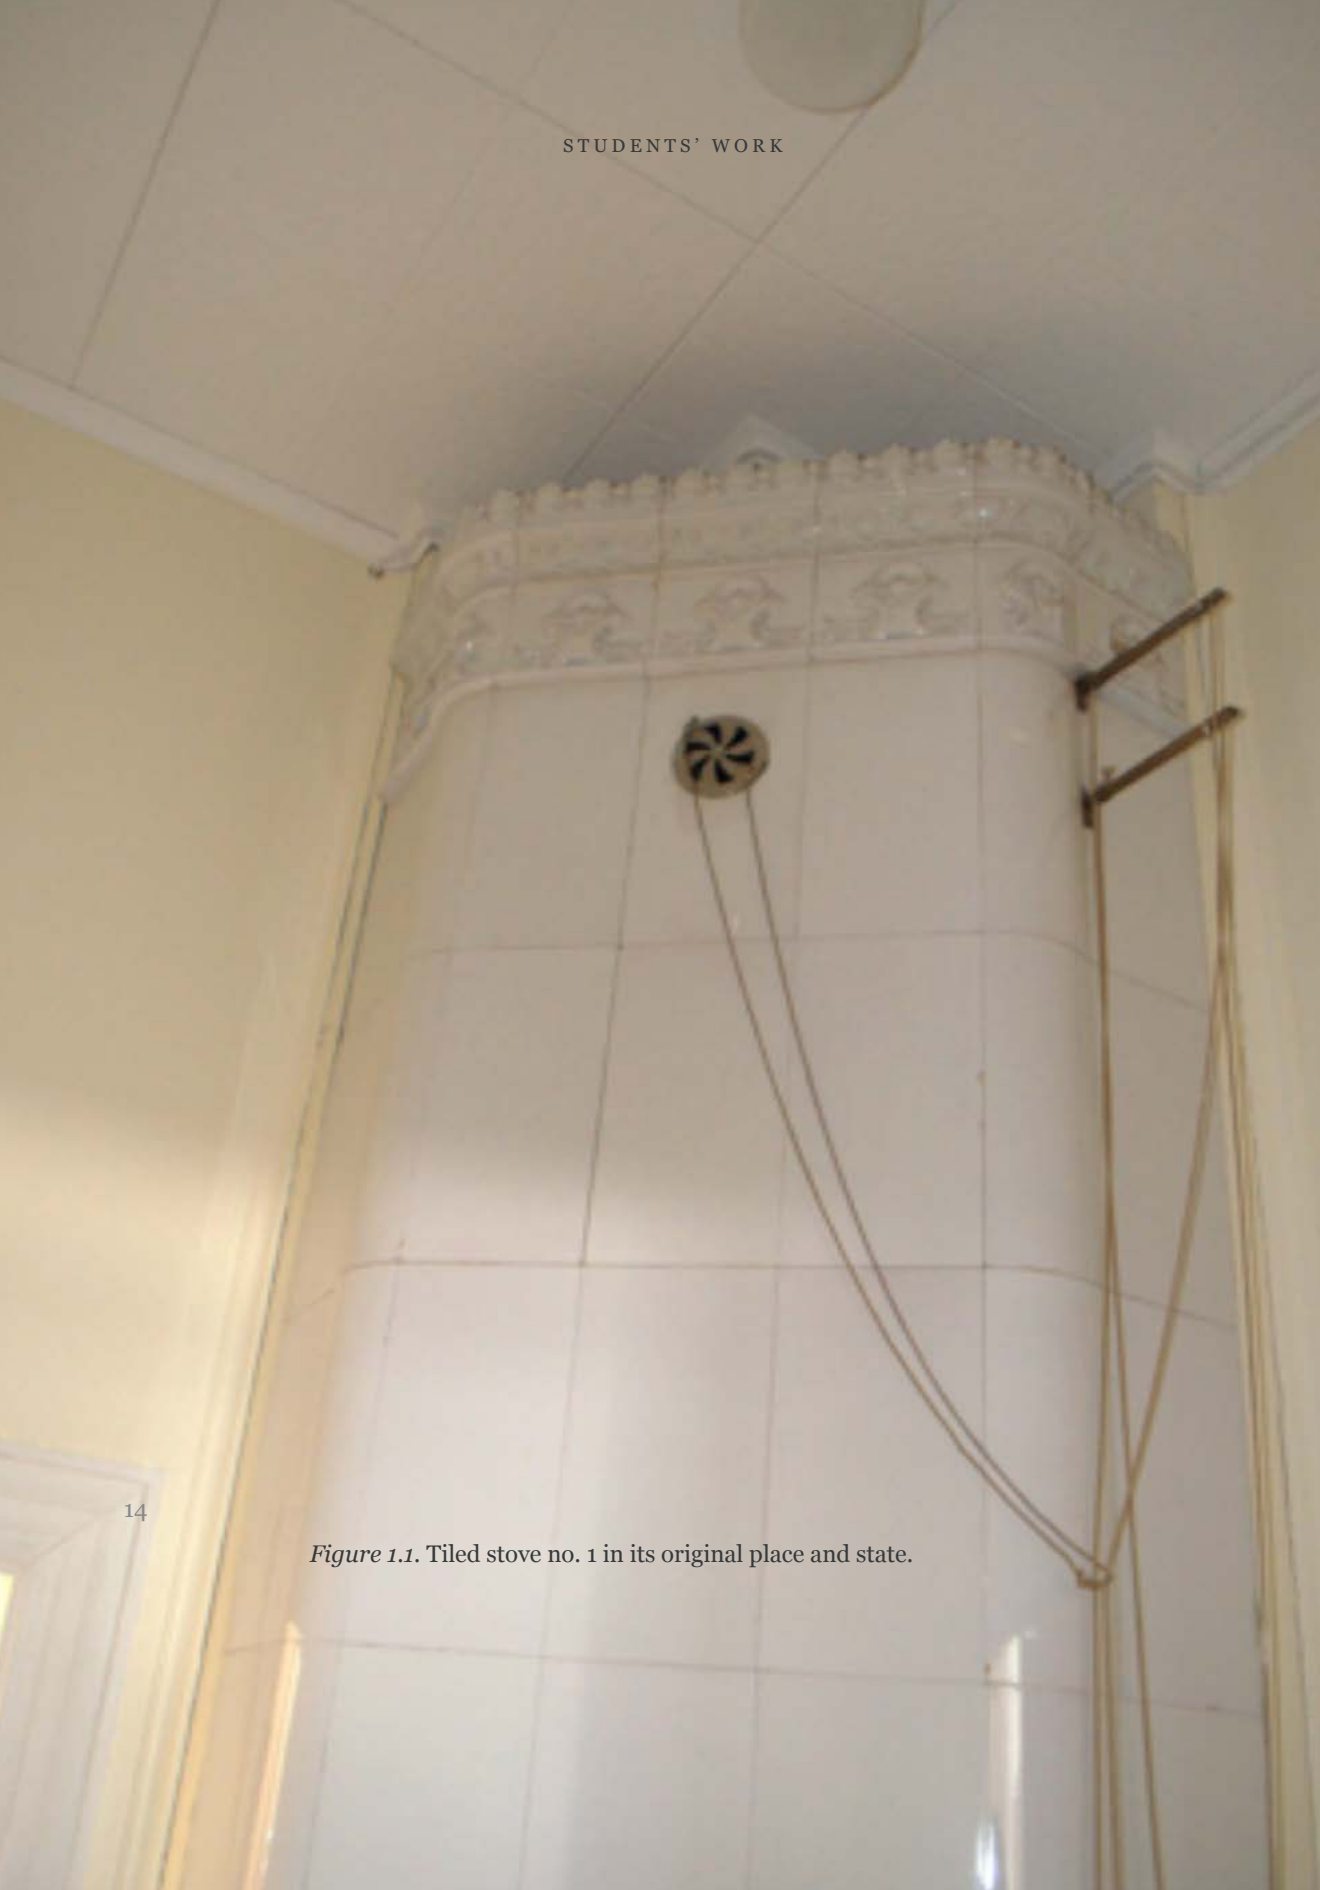
Figure 1.1. Tiled stove no. 1 in its original place and state.

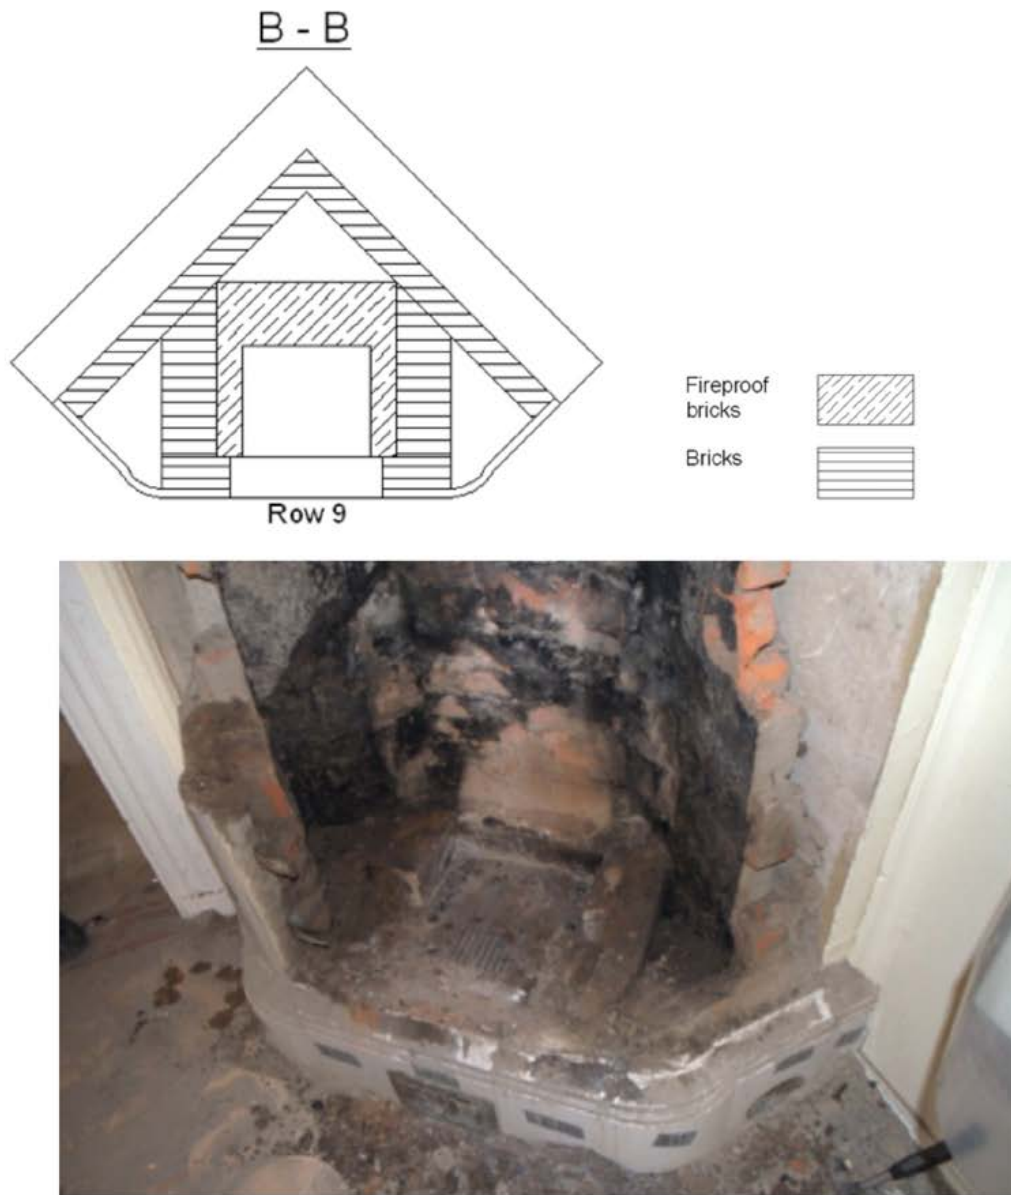
Figures 1.5 a, b. Section B–B and photo of the same.

Here we see tile row 9 where the furnace and its doors were. The bricks closest to the furnace were all fireproof bricks.

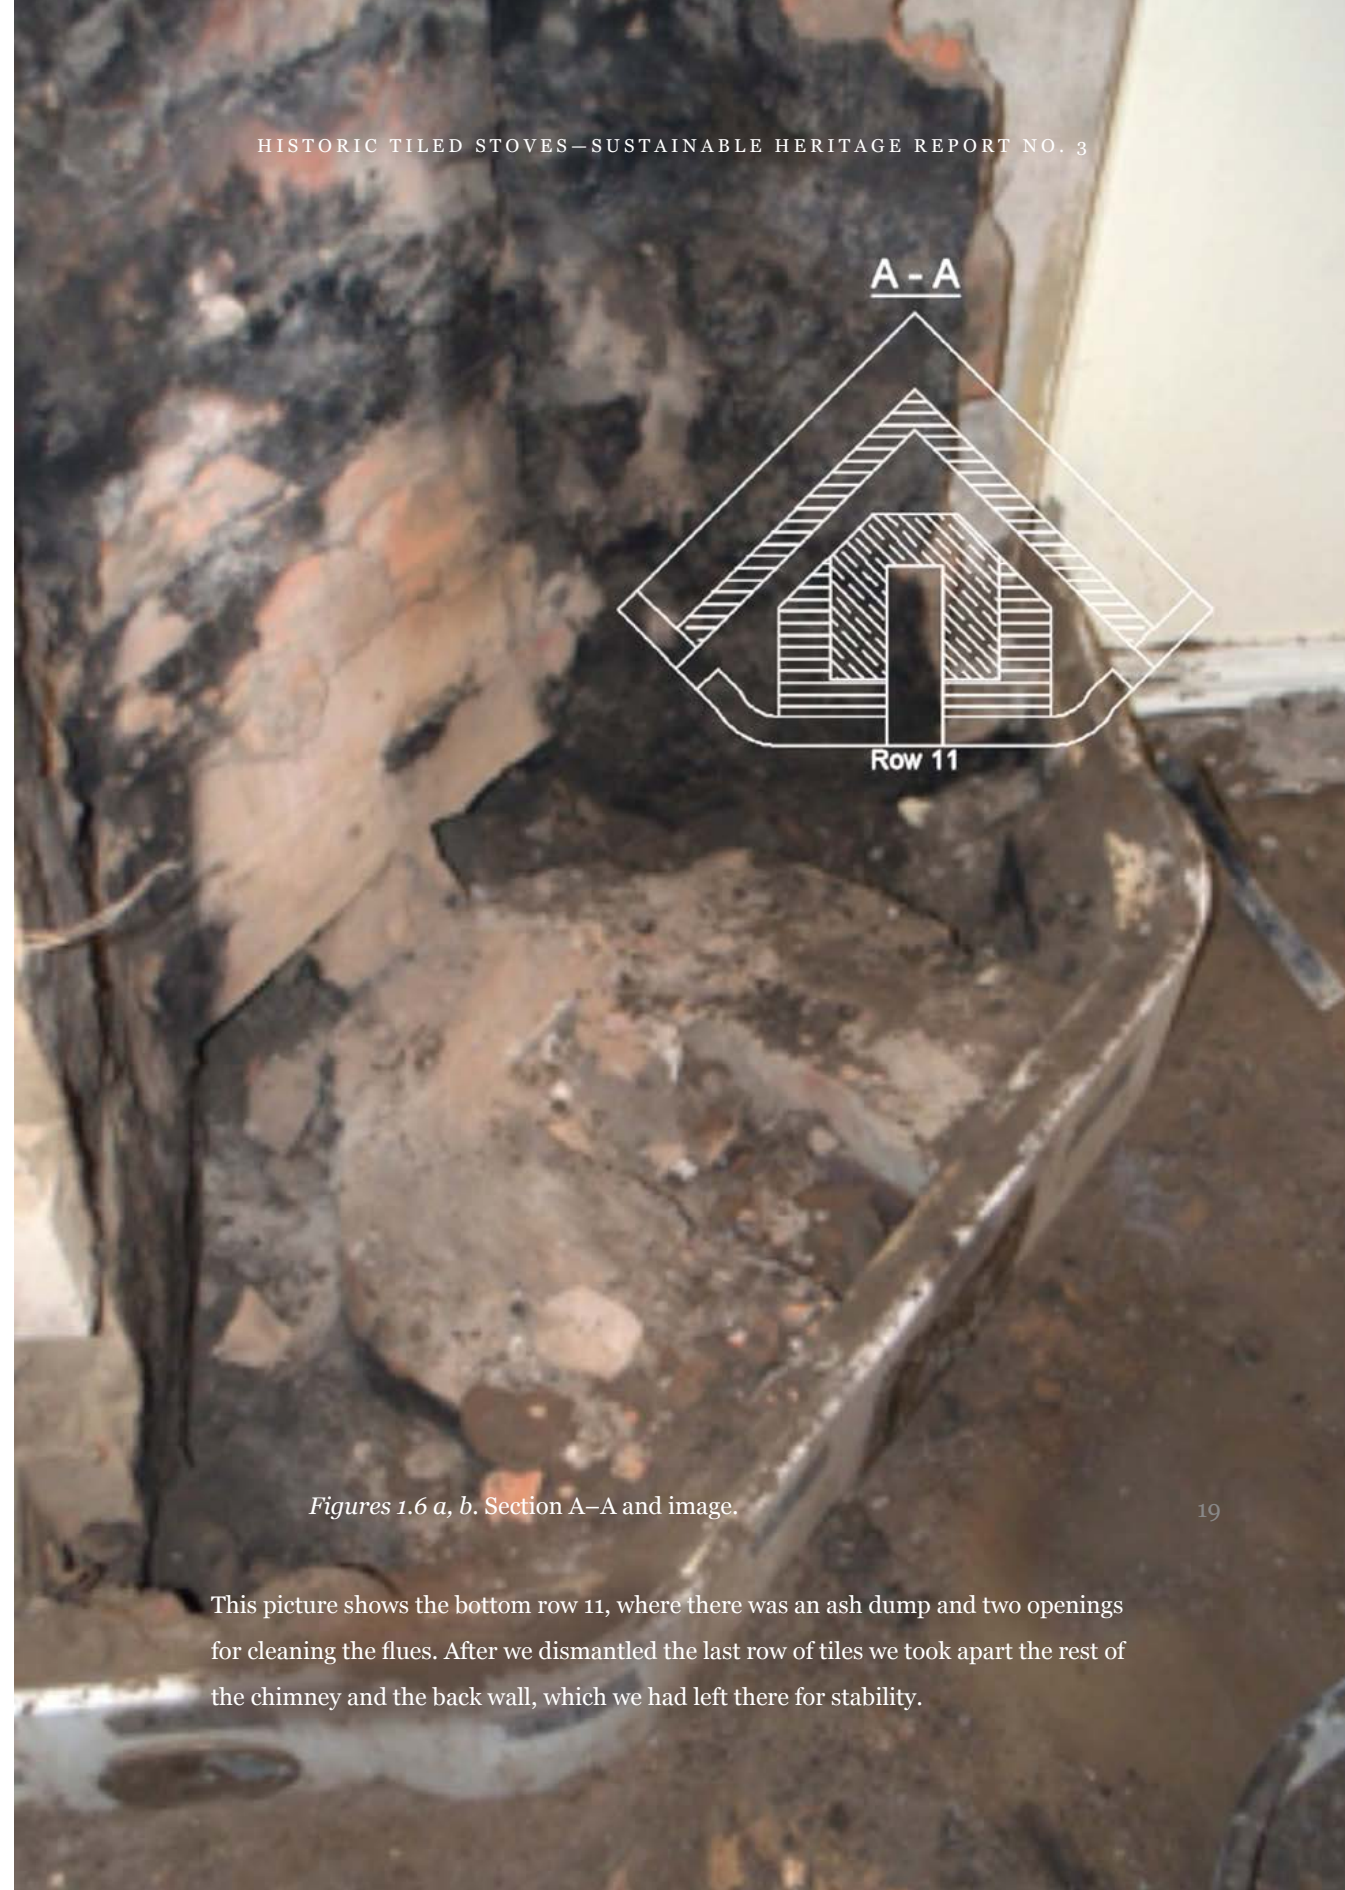
Figures 1.6 a, b. Section A–A and image.

This picture shows the bottom row 11, where there was an ash dump and two openings for cleaning the flues. After we dismantled the last row of tiles we took apart the rest of the chimney and the back wall, which we had left there for stability.

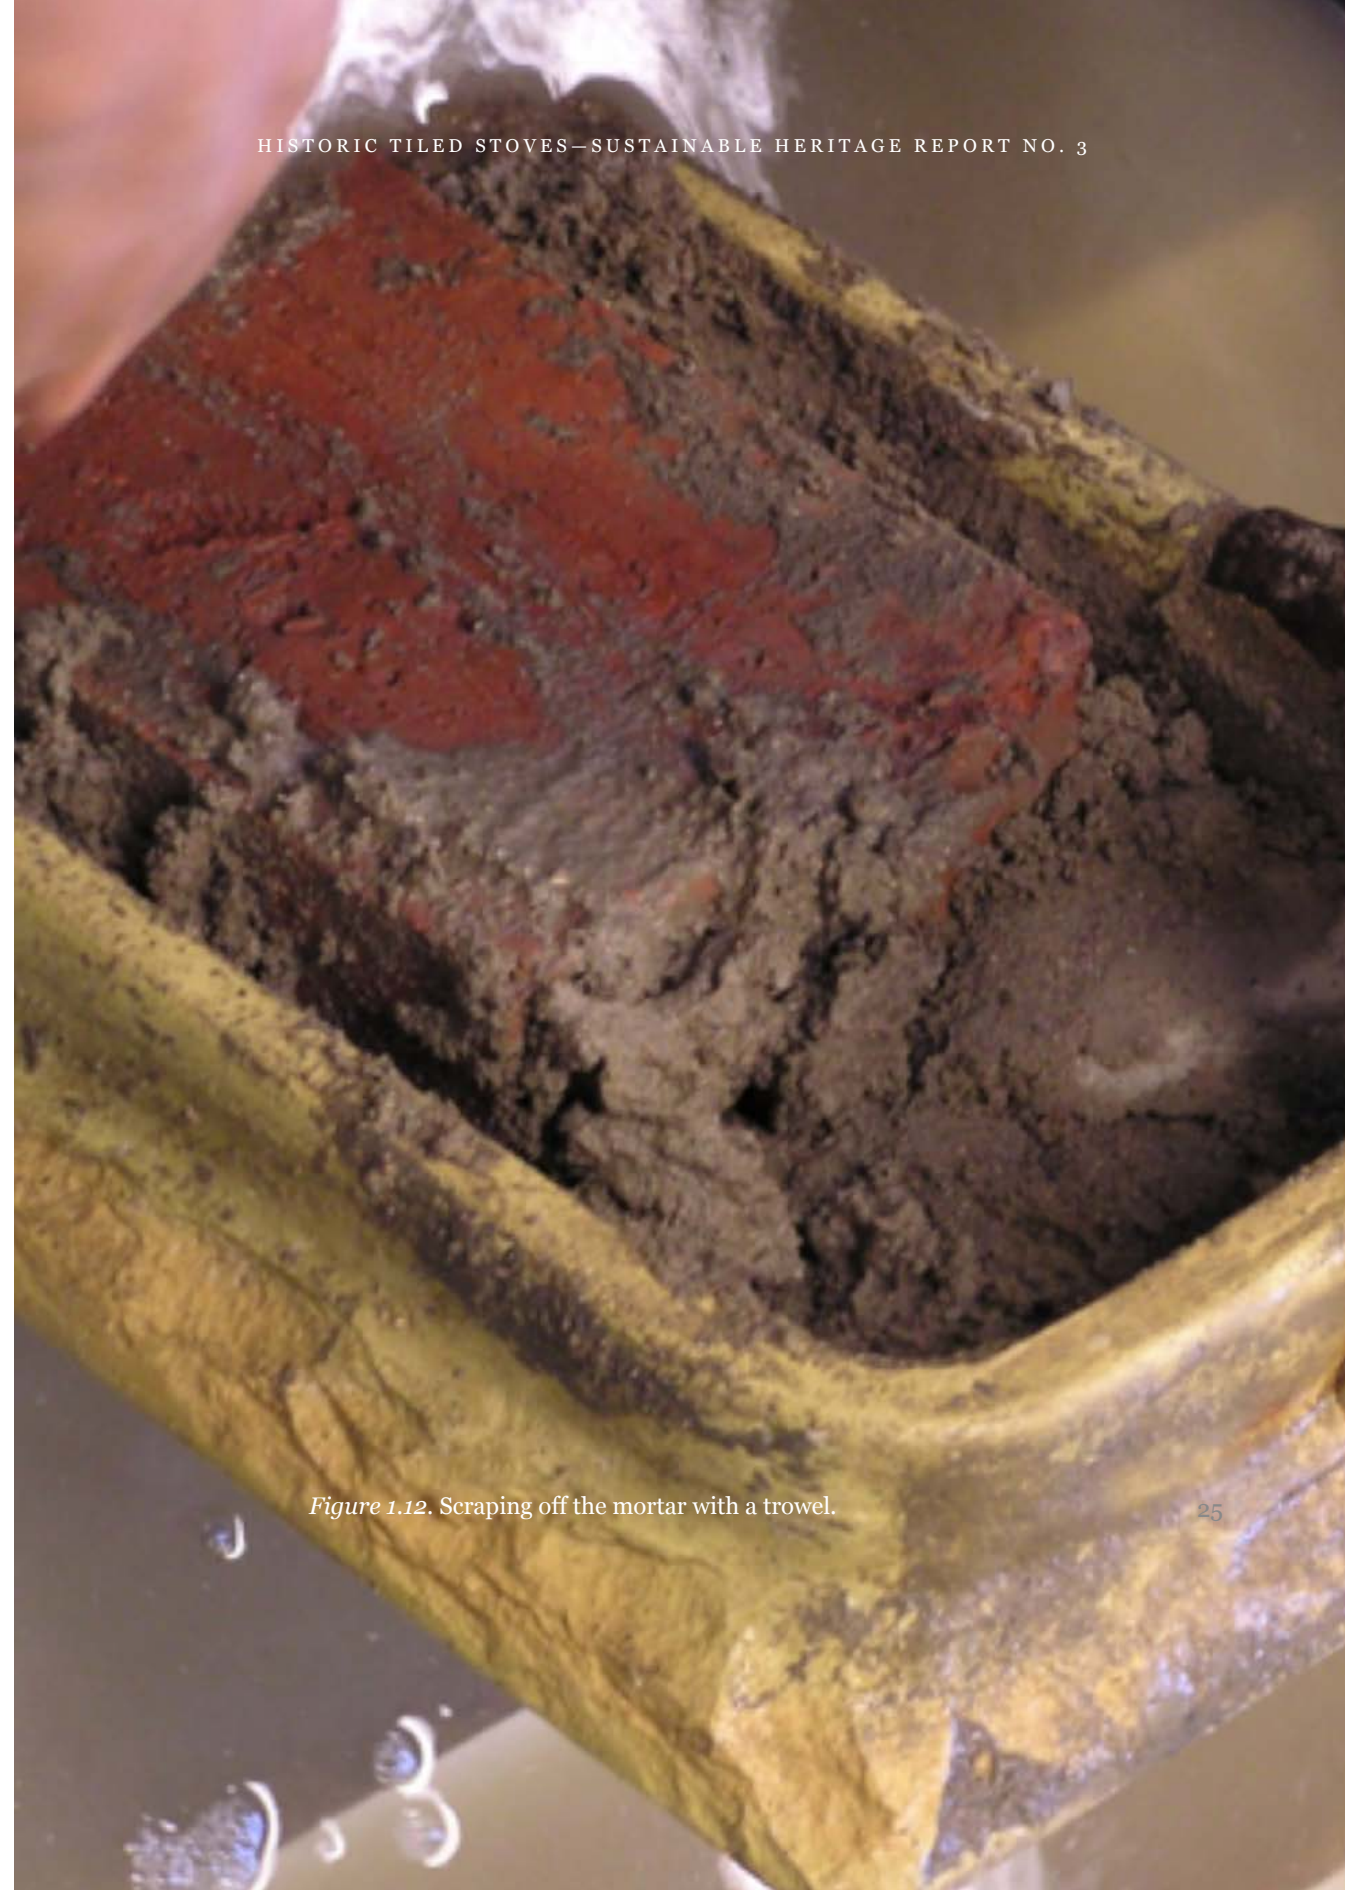
Figure 1.12. Scraping off the mortar with a trowel.

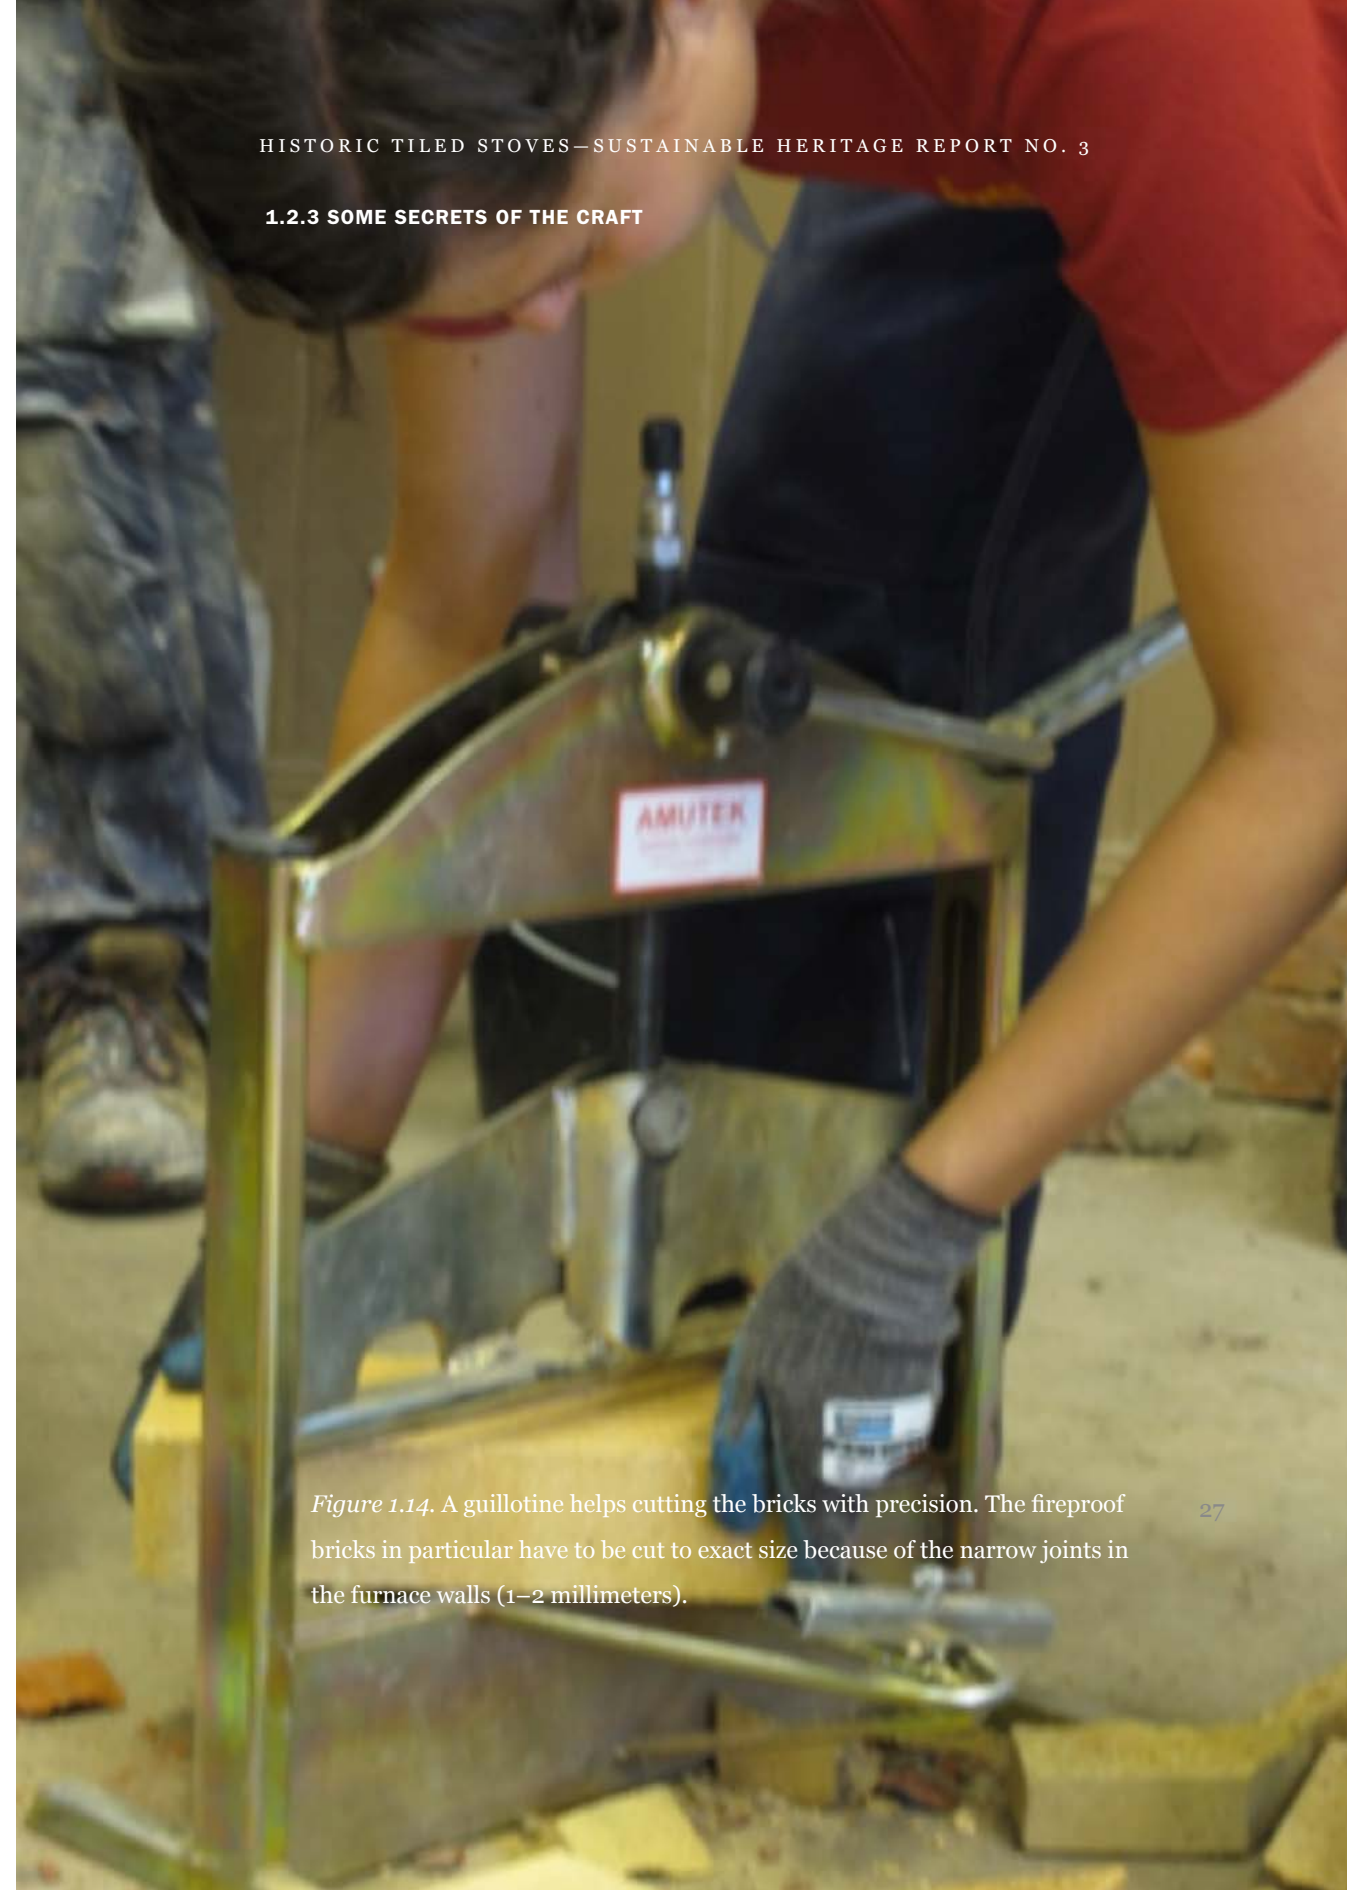
Figure 1.14. A guillotine helps cutting the bricks with precision. The fireproof bricks in particular have to be cut to exact size because of the narrow joints in the furnace walls (1–2 millimeters).

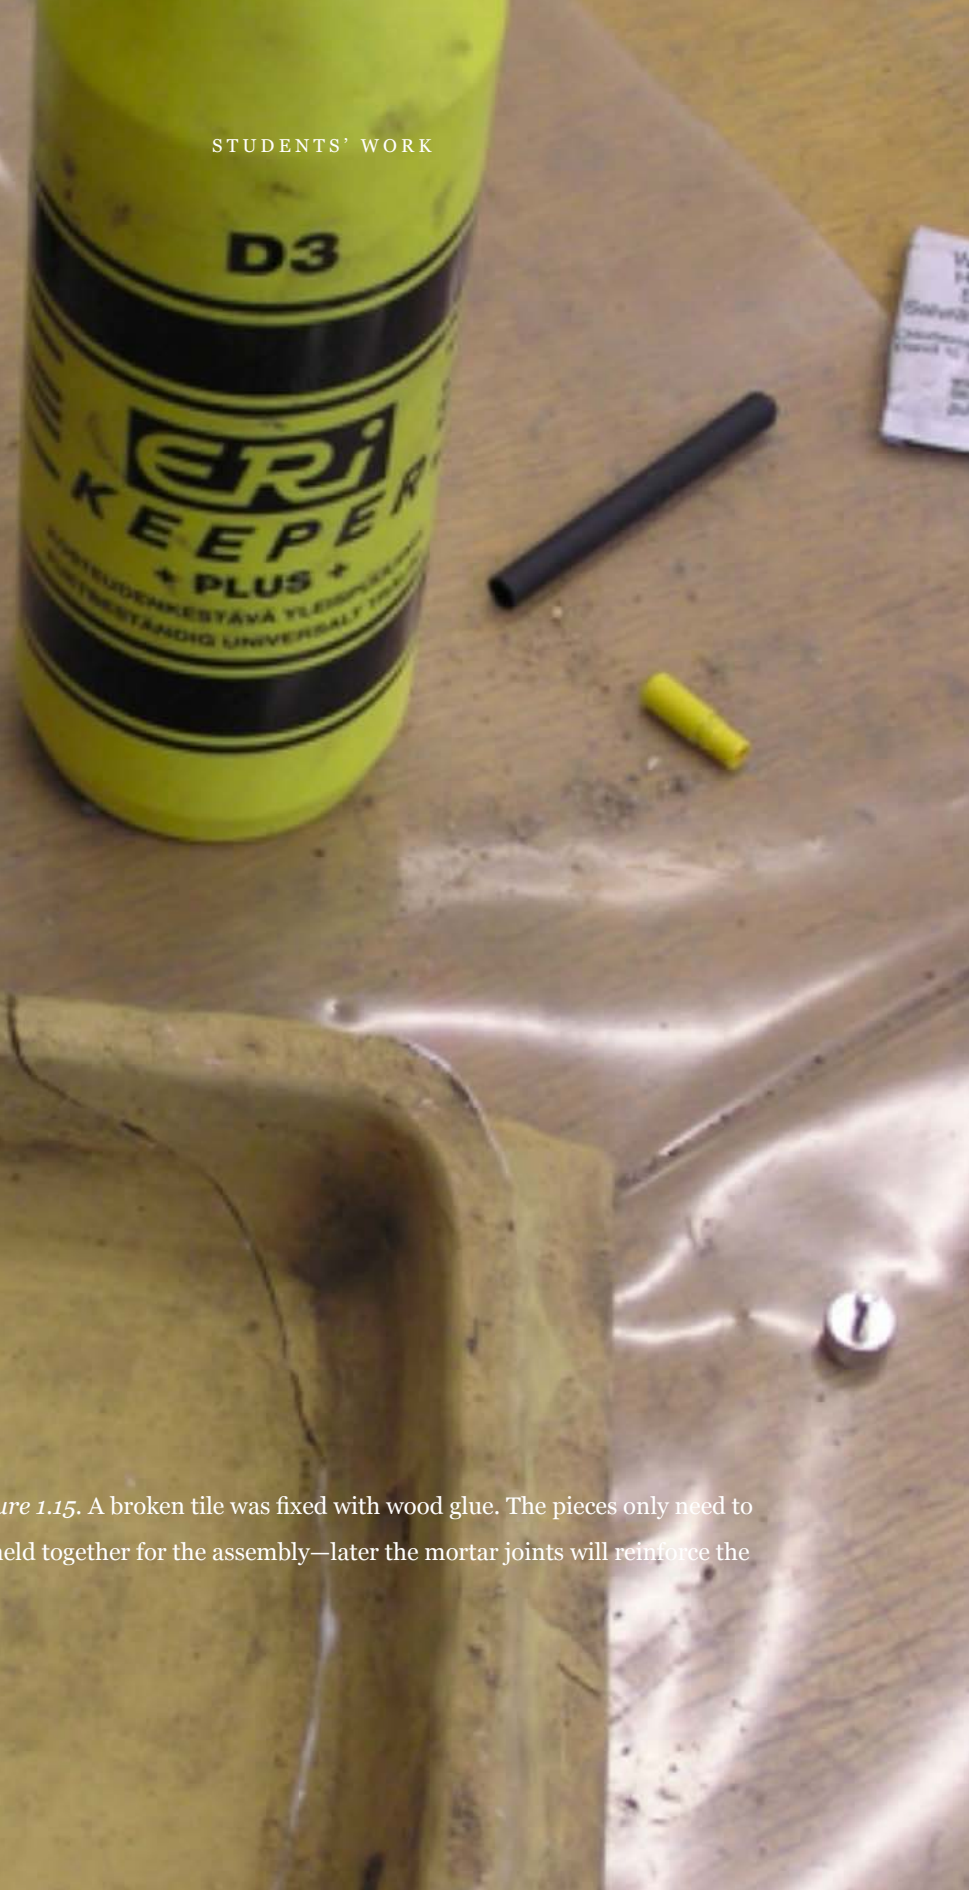
Figure 1.15. A broken tile was fixed with wood glue. The pieces only need to be held together for the assembly—later the mortar joints will reinforce the tile.

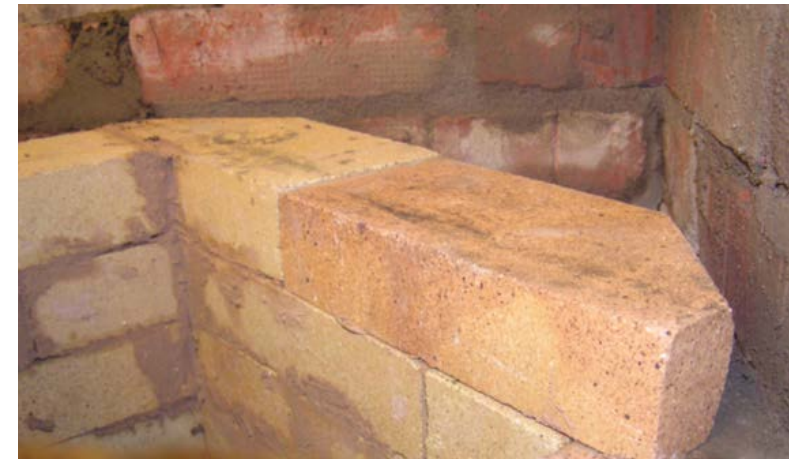
Figure 1.16. Fireproof bricks and mortar are used for the furnace. The bricks have to cover each cross-joint of the previous course.

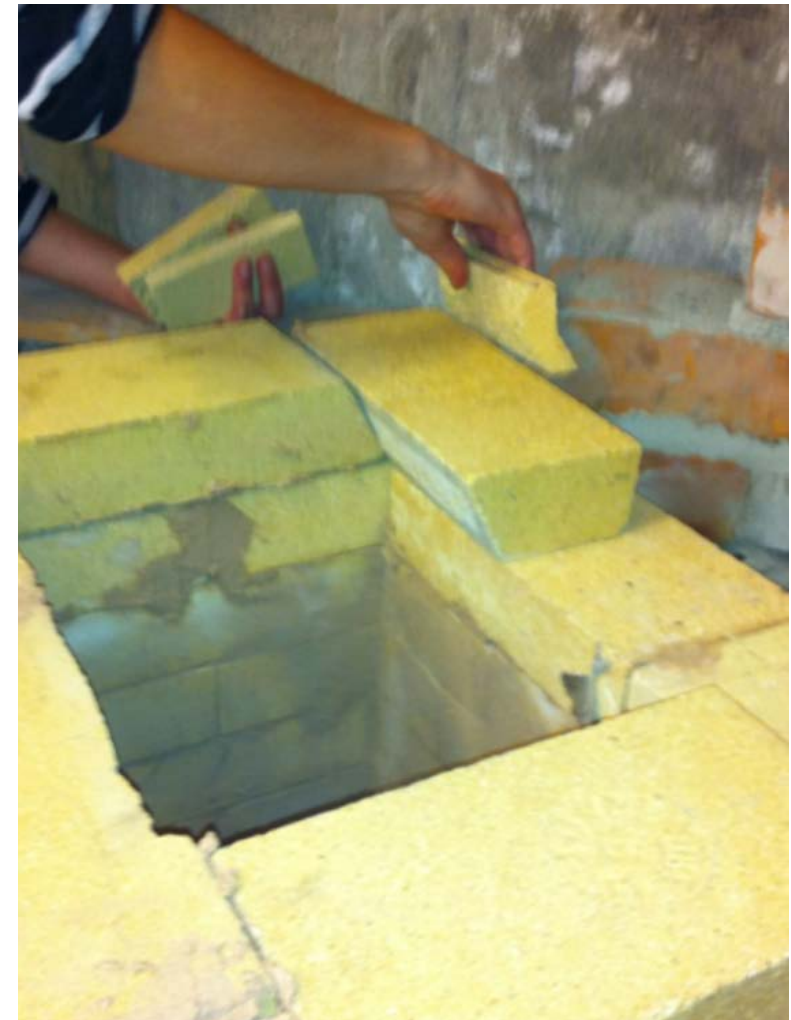
Figure 1.23. The rear masonry was laid to the height of half of the next tiles to be used as a support for the tiles.

The next step was to build the smoke flue upwards from the furnace. It was made narrower than the furnace. The bricks were sawn sidelong to narrow the canal from 420 x 355mm to 350 x 160mm. This is always done to create draught through the stove. Further up the flue is made wider again.

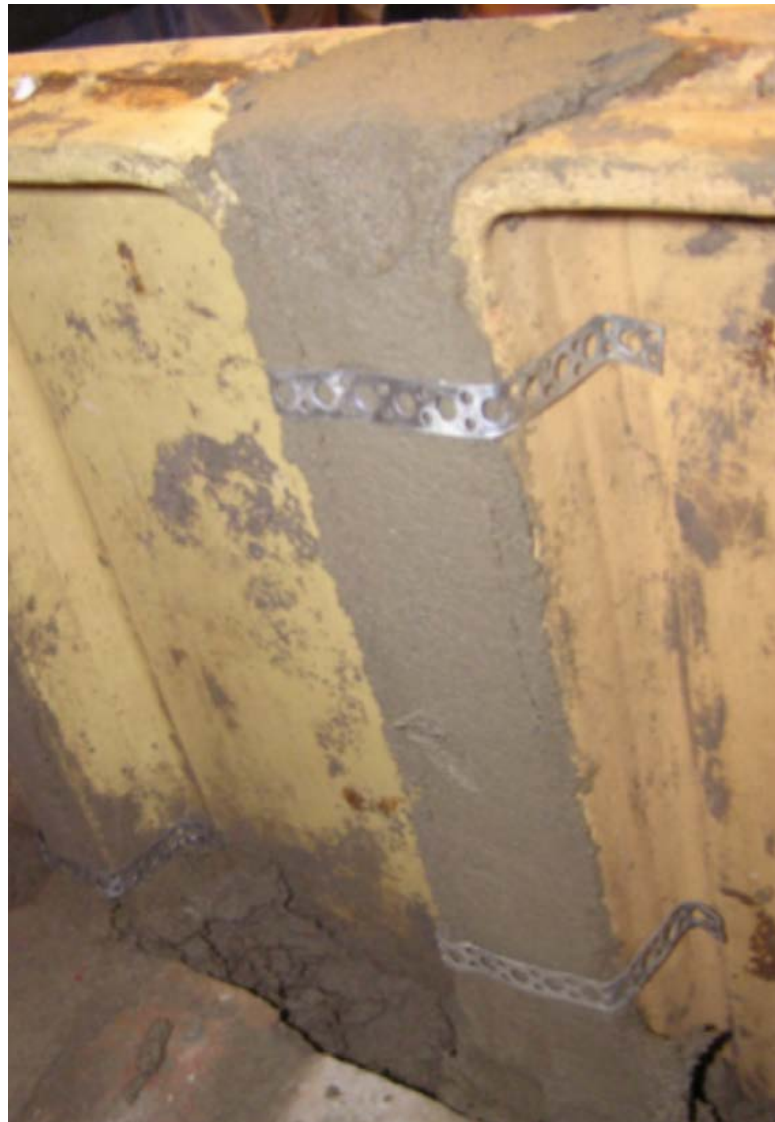
Figure 1.32–33. When the tiles are in place, the gap between them is filled with clay–mortar. Then two clamps made of perforated metal strap are bent to hold them together. The cavity on the backside of the tiles is then filled with mortar and thin bricks. Inside this a wall of bricks is built to finally stabilize the front.

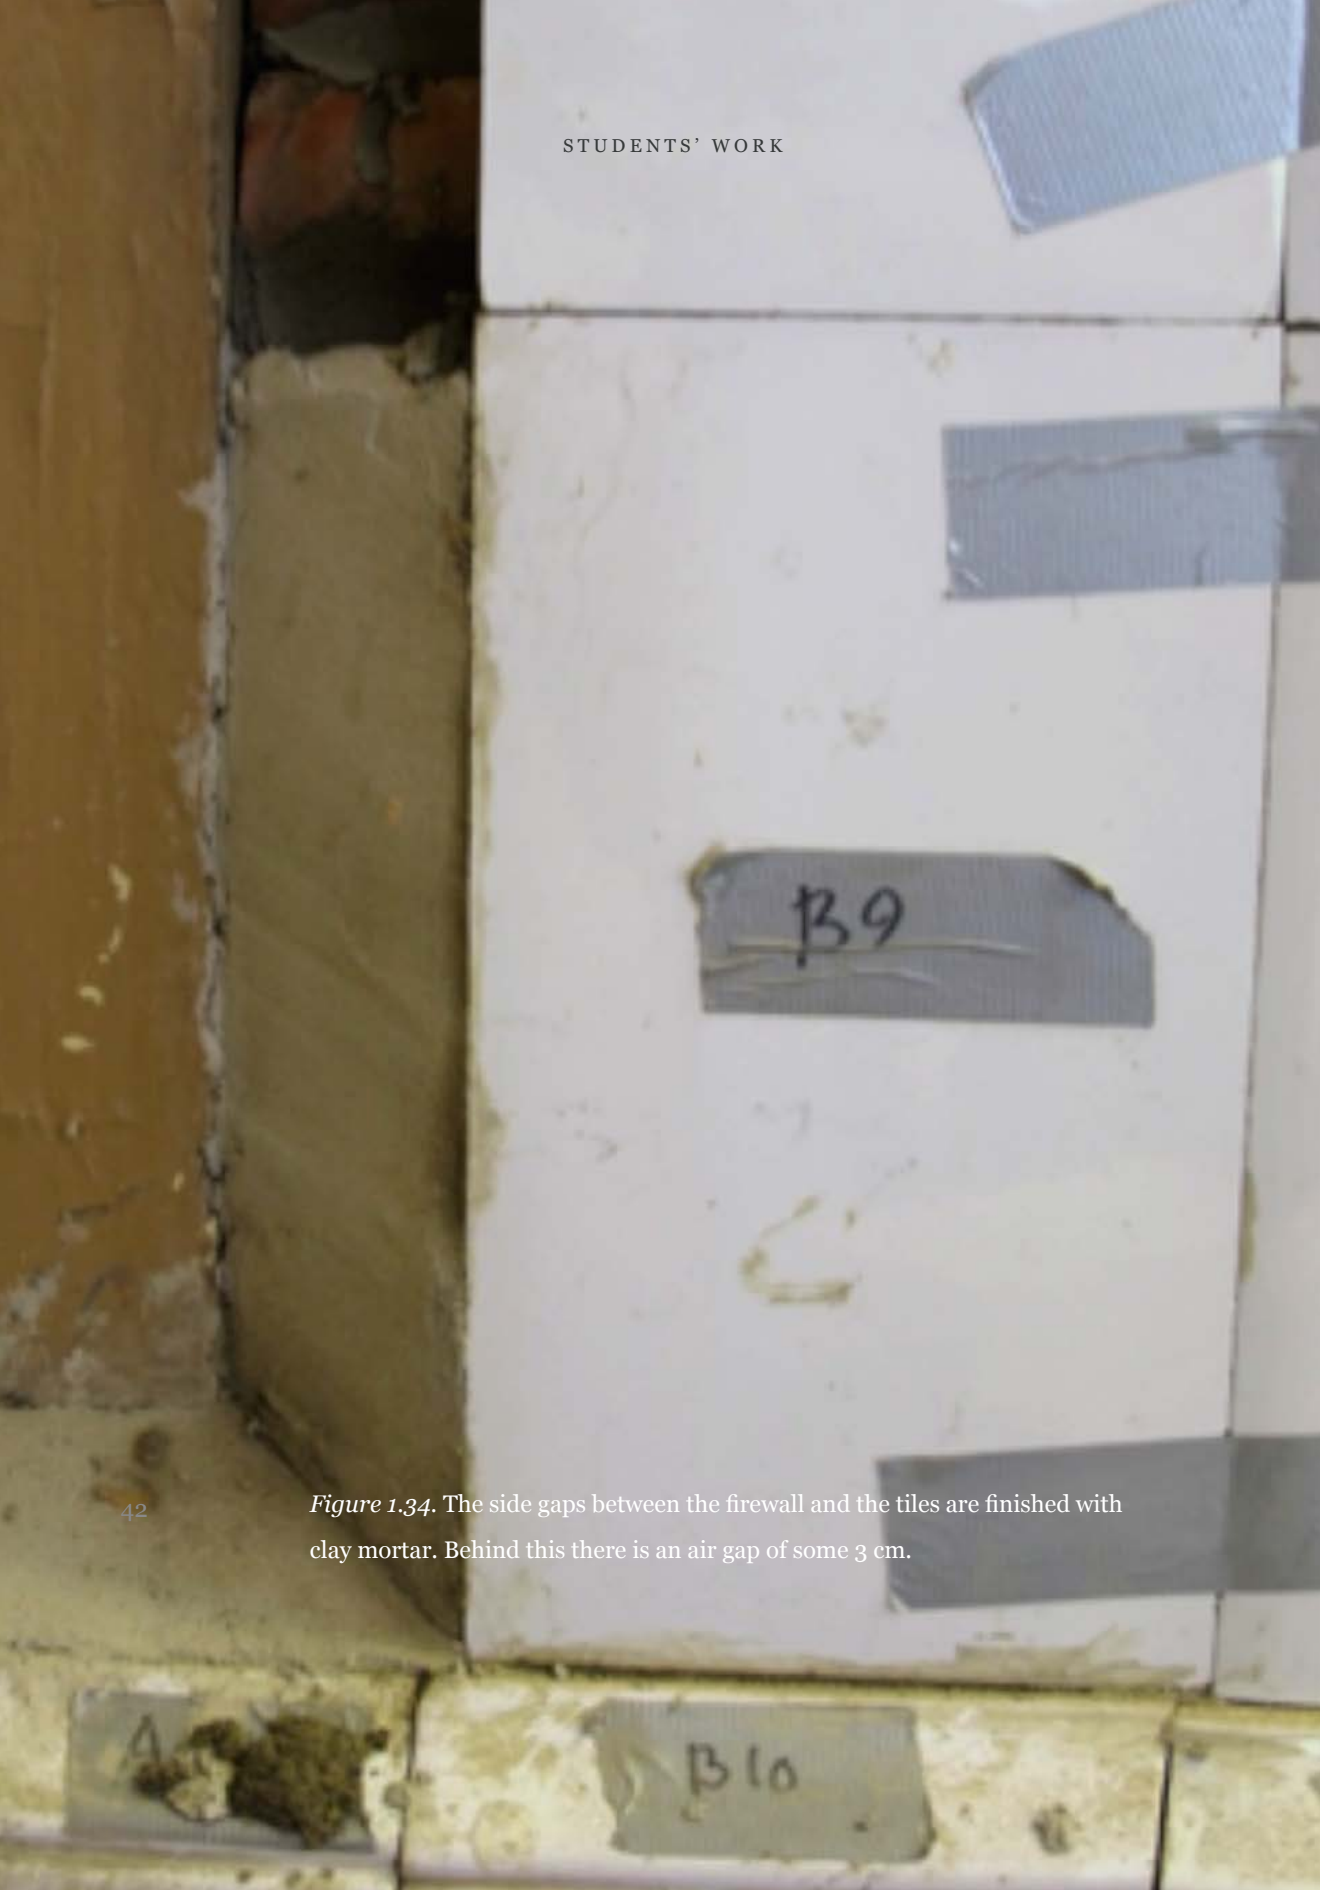
Figure 1.34. The side gaps between the firewall and the tiles are finished with clay mortar. Behind this there is an air gap of some 3 cm.

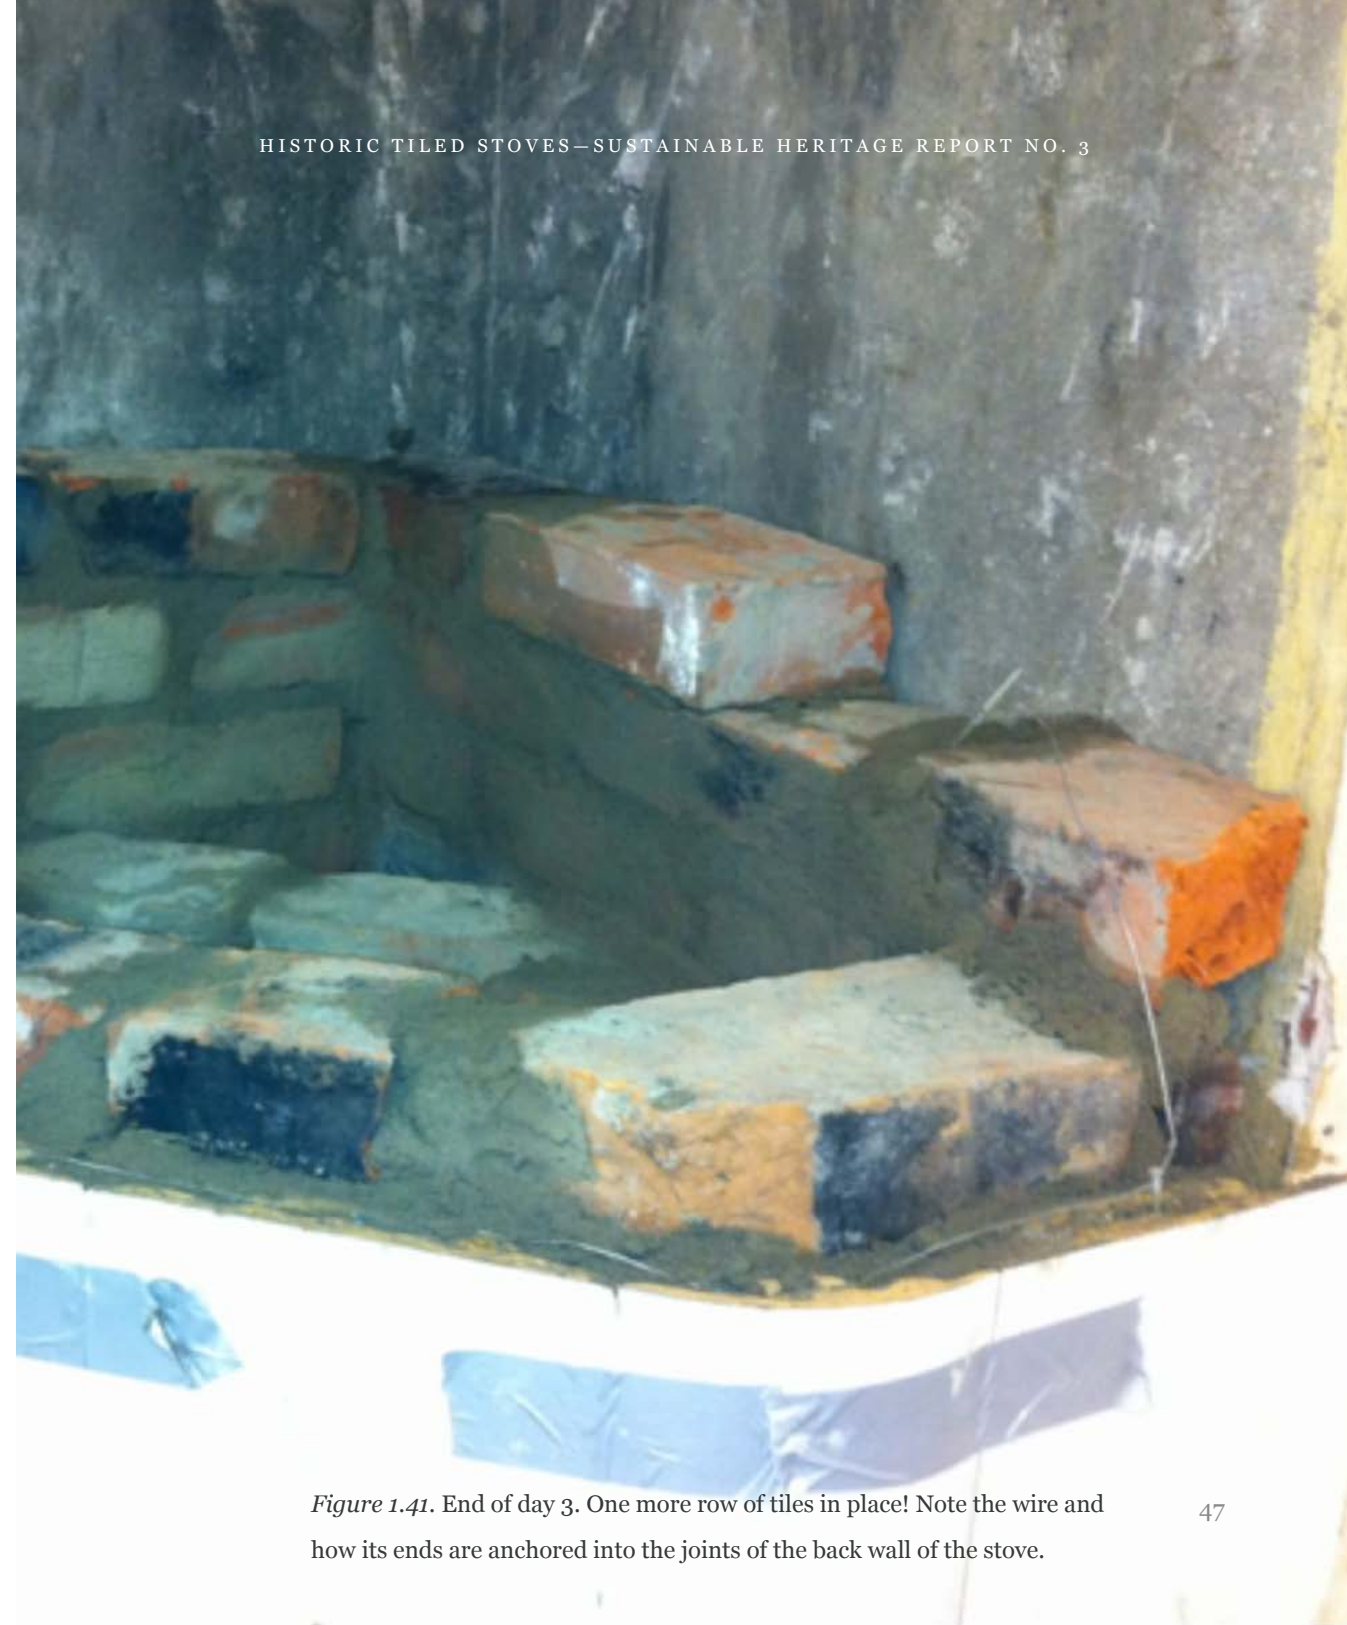
Figure 1.41. End of day 3. One more row of tiles in place! Note the wire and how its ends are anchored into the joints of the back wall of the stove.
