Manual for Dismantling, Documenting and Rebuilding Historic Tiled Stoves

—Sustainable Heritage Report No. 3

A joint project between Gotland University, Estonian Academy of Arts and Novia University of Applied Sciences.

This report is a step by step description of the dismantling and rebuilding of two very tall tiled stoves in an historic school building in Ekenäs, Finland. It is meant to serve as a guide to anybody who is interested in building or rebuilding a classical stove.

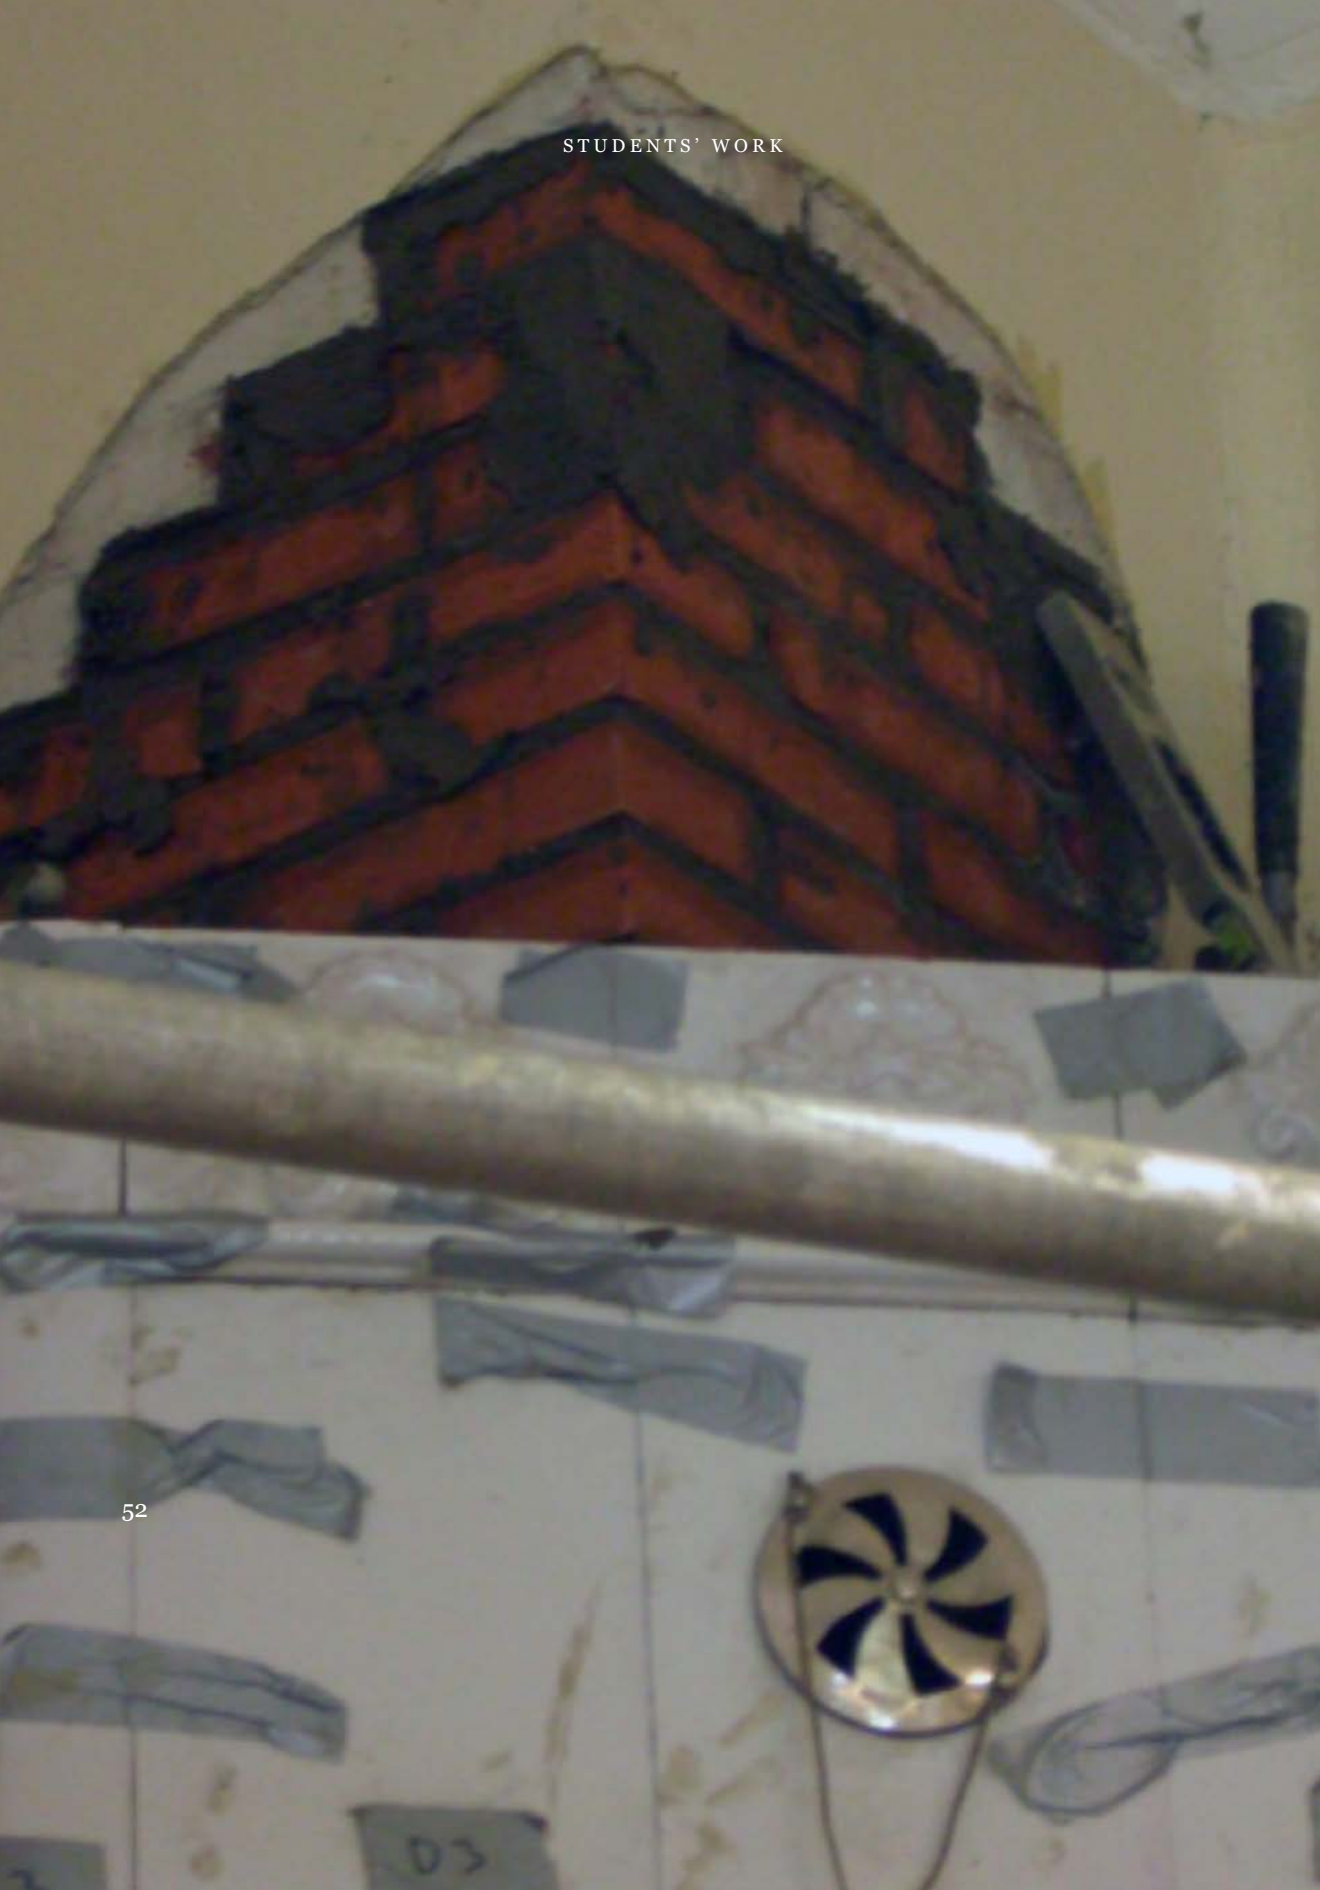
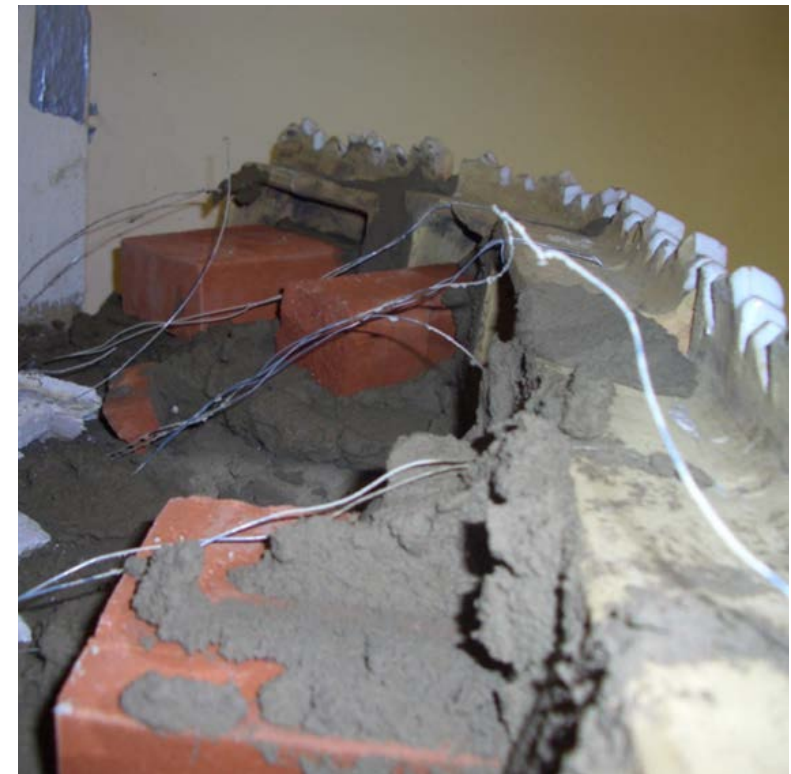
Figures 1.47–48. The chimney was repaired (*left*), before the crown tiles were finally inserted.

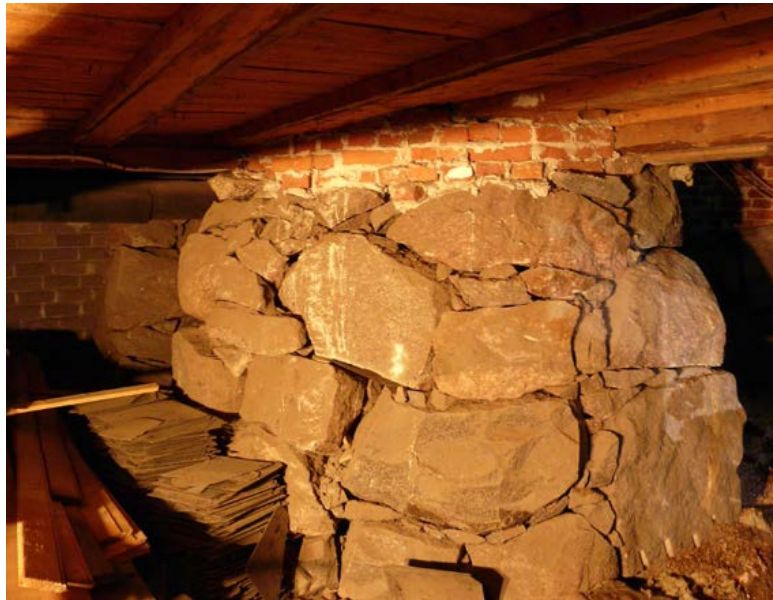
Figure 2.1. Every kind of stove or fireplace has to stand secure and immobile since movements in the masonry would lead to cracks and obvious fire hazard. This enormous dry laid foundation supports the stove whose dismantling and consequent rebuilding is described in the following. The stove itself weighs several tons.

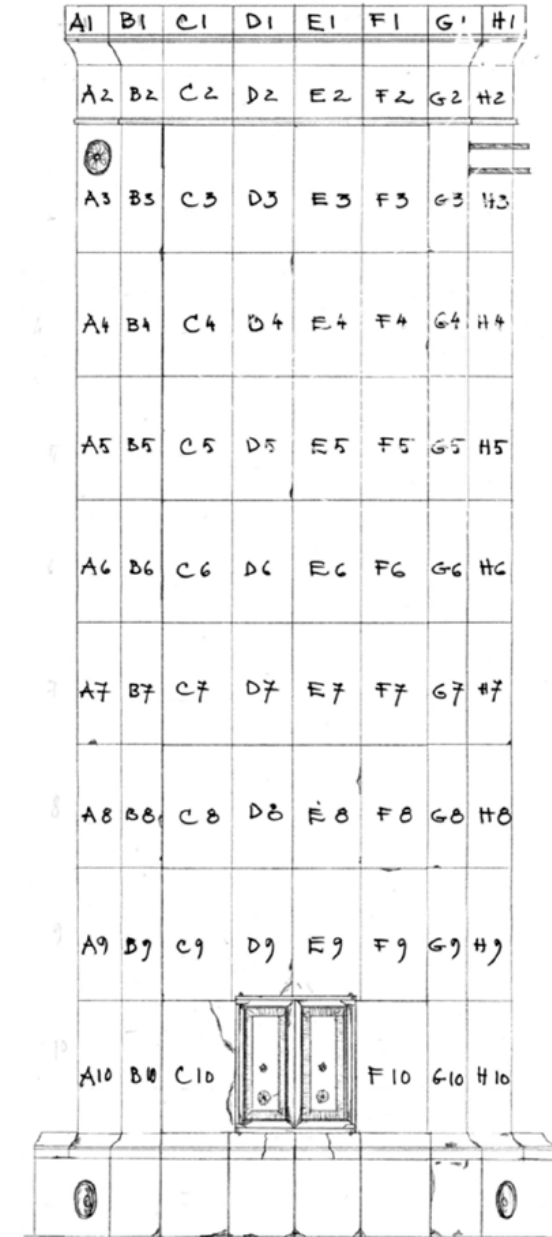
Figure 2.2. Measured drawing of the stove with a symbol for each tile. There are always slight variations in the measurements of tiles and therefore it is important to keep them in the same position when you rebuild the stove.

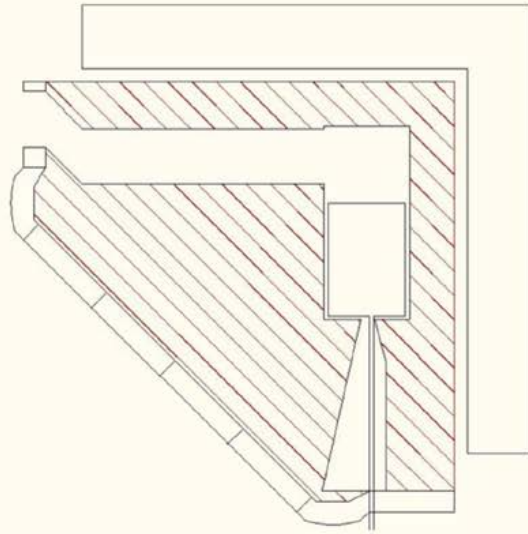
Figures 2.5 a, b. Top air duct was then revealed on the left hand side. Tiled stoves often have an air duct for ventilation in the summer months when the natural air conditioning through the furnace is not in use. This is why there are two dampers: in summer the bottom damper is closed so as to enhance the air flow through the vent into the chimney. When the stove is heated both dampers must be open and when the fire is down the top damper is closed in order to keep the heat from escaping. Also if you want to ventilate after heating you can close the bottom damper and open the top one. The warm chimney will accelerate the flow of air. Ingenious!

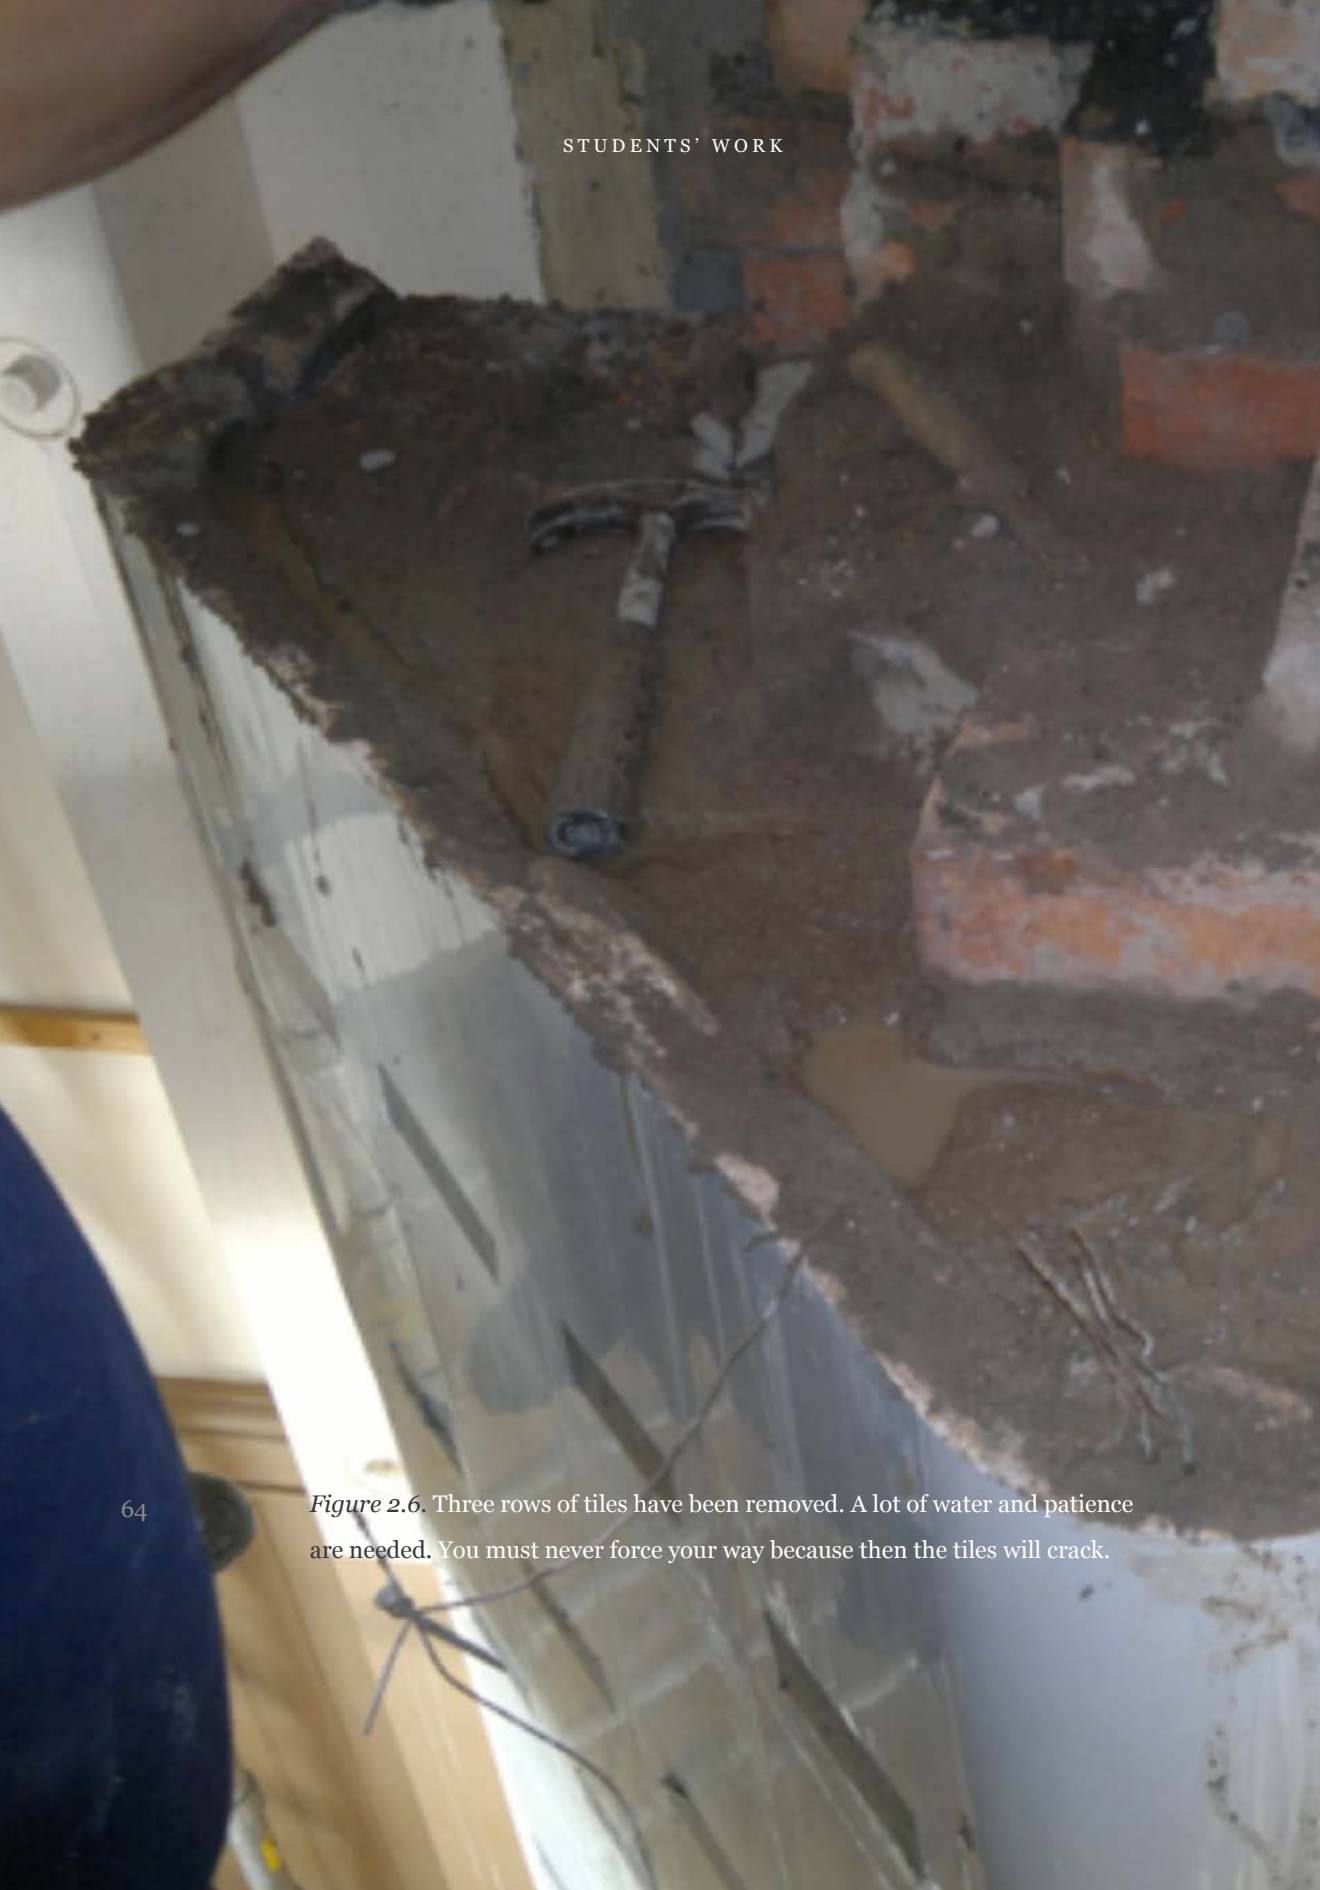
Figure 2.6. Three rows of tiles have been removed. A lot of water and patience are needed. You must never force your way because then the tiles will crack.

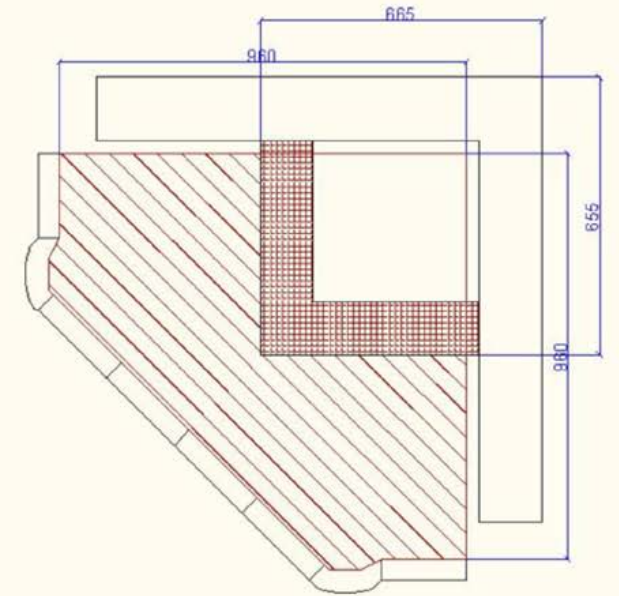
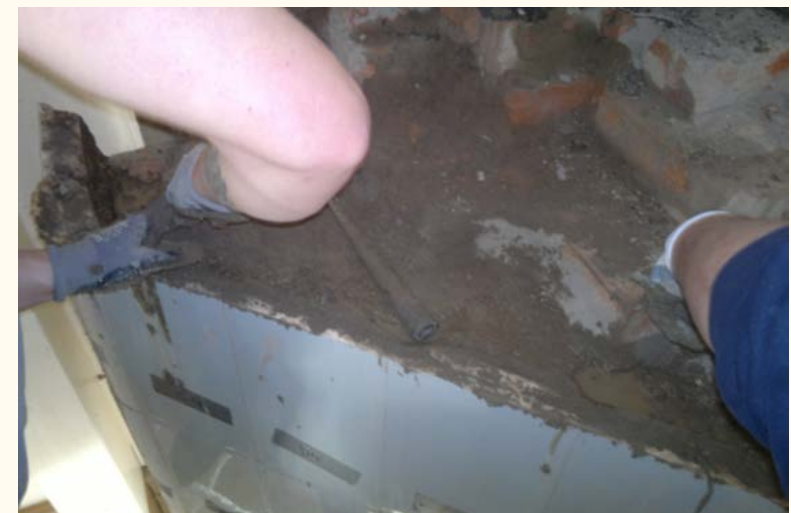
Figures 2.7 a, b. Top view of the fourth row of tiles. The brick work is still solid, i.e. none of the smoke flues that we were looking for are visible yet. Above: measured drawing of the same.

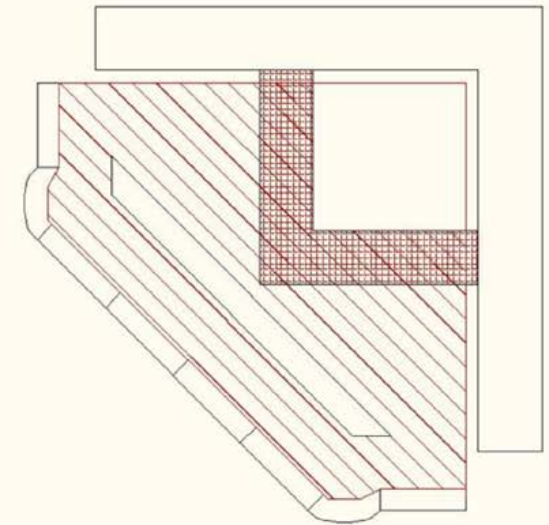
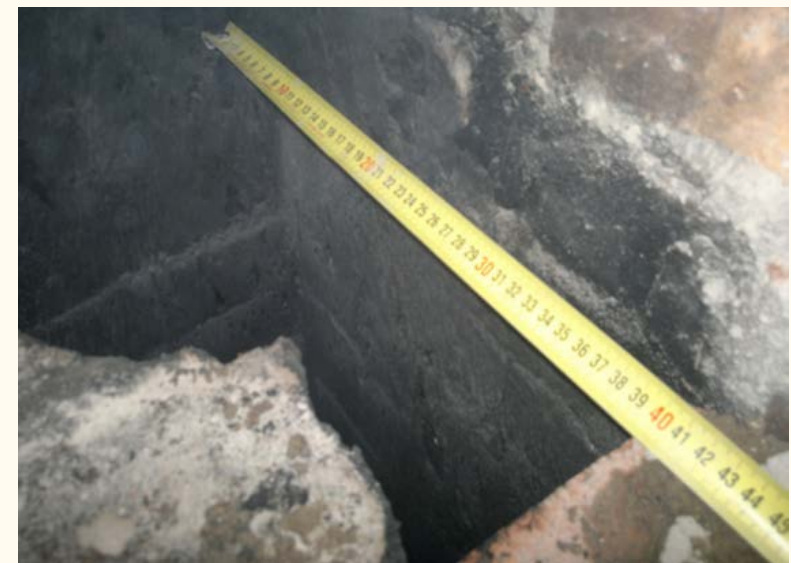
Figures 2.9 a, b. The rear smoke flue which leads to the chimney is found at the top of the fifth tile row. Above: drawing of the same.

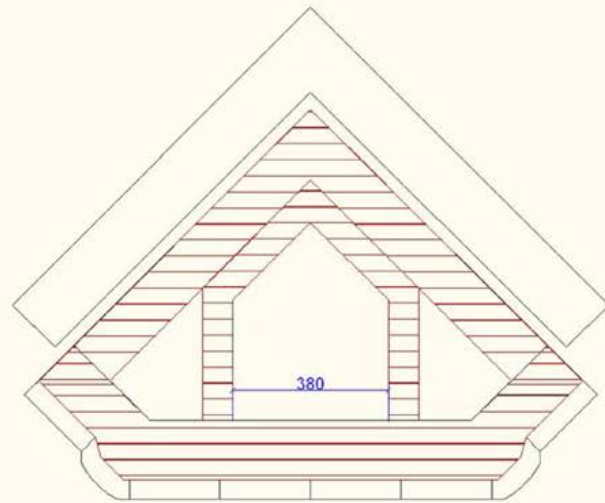
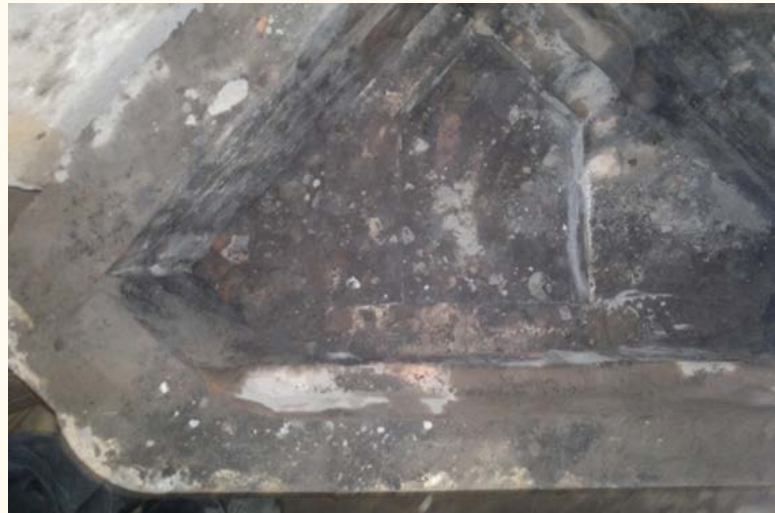
Figures 2.14 a, b. The ninth tile row is still in place but several rows of brick have been taken out from behind it. Here the floor of the furnace can be seen. This is where the dismantling was stopped because the bottom of the stove was intact and it was of course easier to start the rebuilding from a foundation that was of the correct size and shape. *Above:* measured drawing of the same.

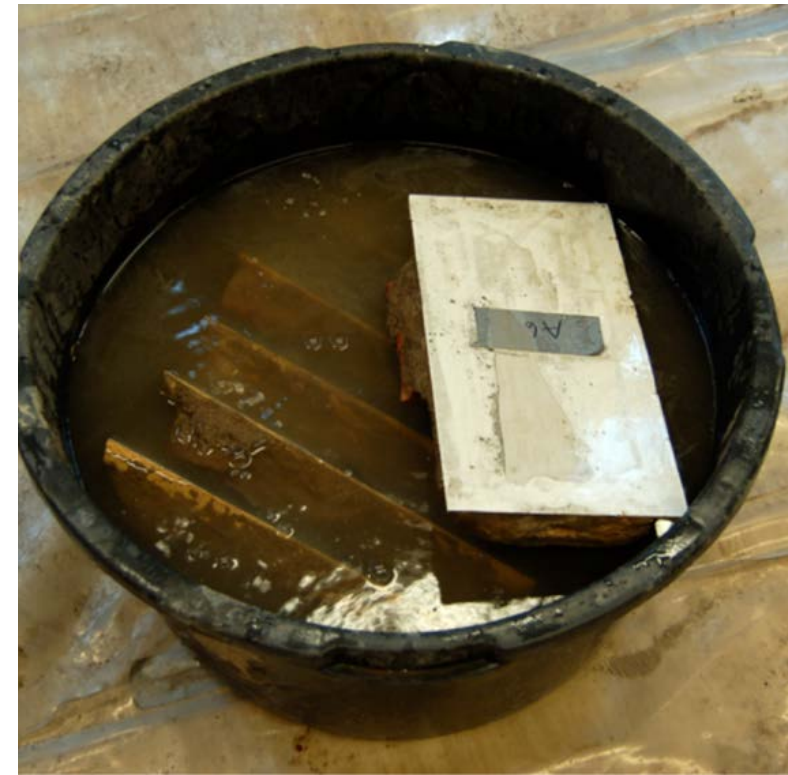
Figure 2.17. The rebuilding of the stove started with removing the mortar from the tiles and the thin bricks in the cavity on the back of each tile. The tiles are sunken in water for about half an hour in order to soften the old mortar before they are washed and cleaned. This is why it is important to use clay mortar: cement would not dissolve in water and the tiles would crack if they were cleaned with force.

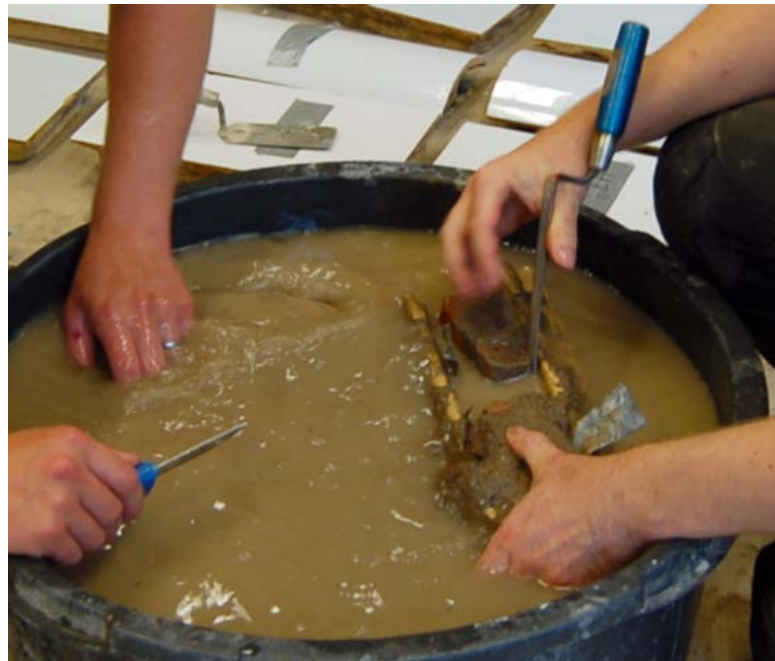
Figure 2.18. The bricks, the metal clamps and mortar on the backside of the tiles are being removed. This takes time and you have to be patient because the edges and corners chip easily. Traditionally also the metal parts were reused but we ran out of time for that.

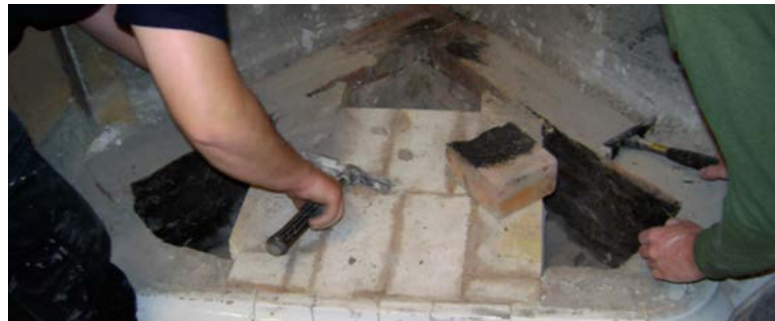
Figure 2.21. This is where we started the rebuilding of the stove. The bottom two rows of tiles were already in place (they were intact and therefore not dismantled). Before laying new bricks the base had to be cleaned and the old mortar removed.

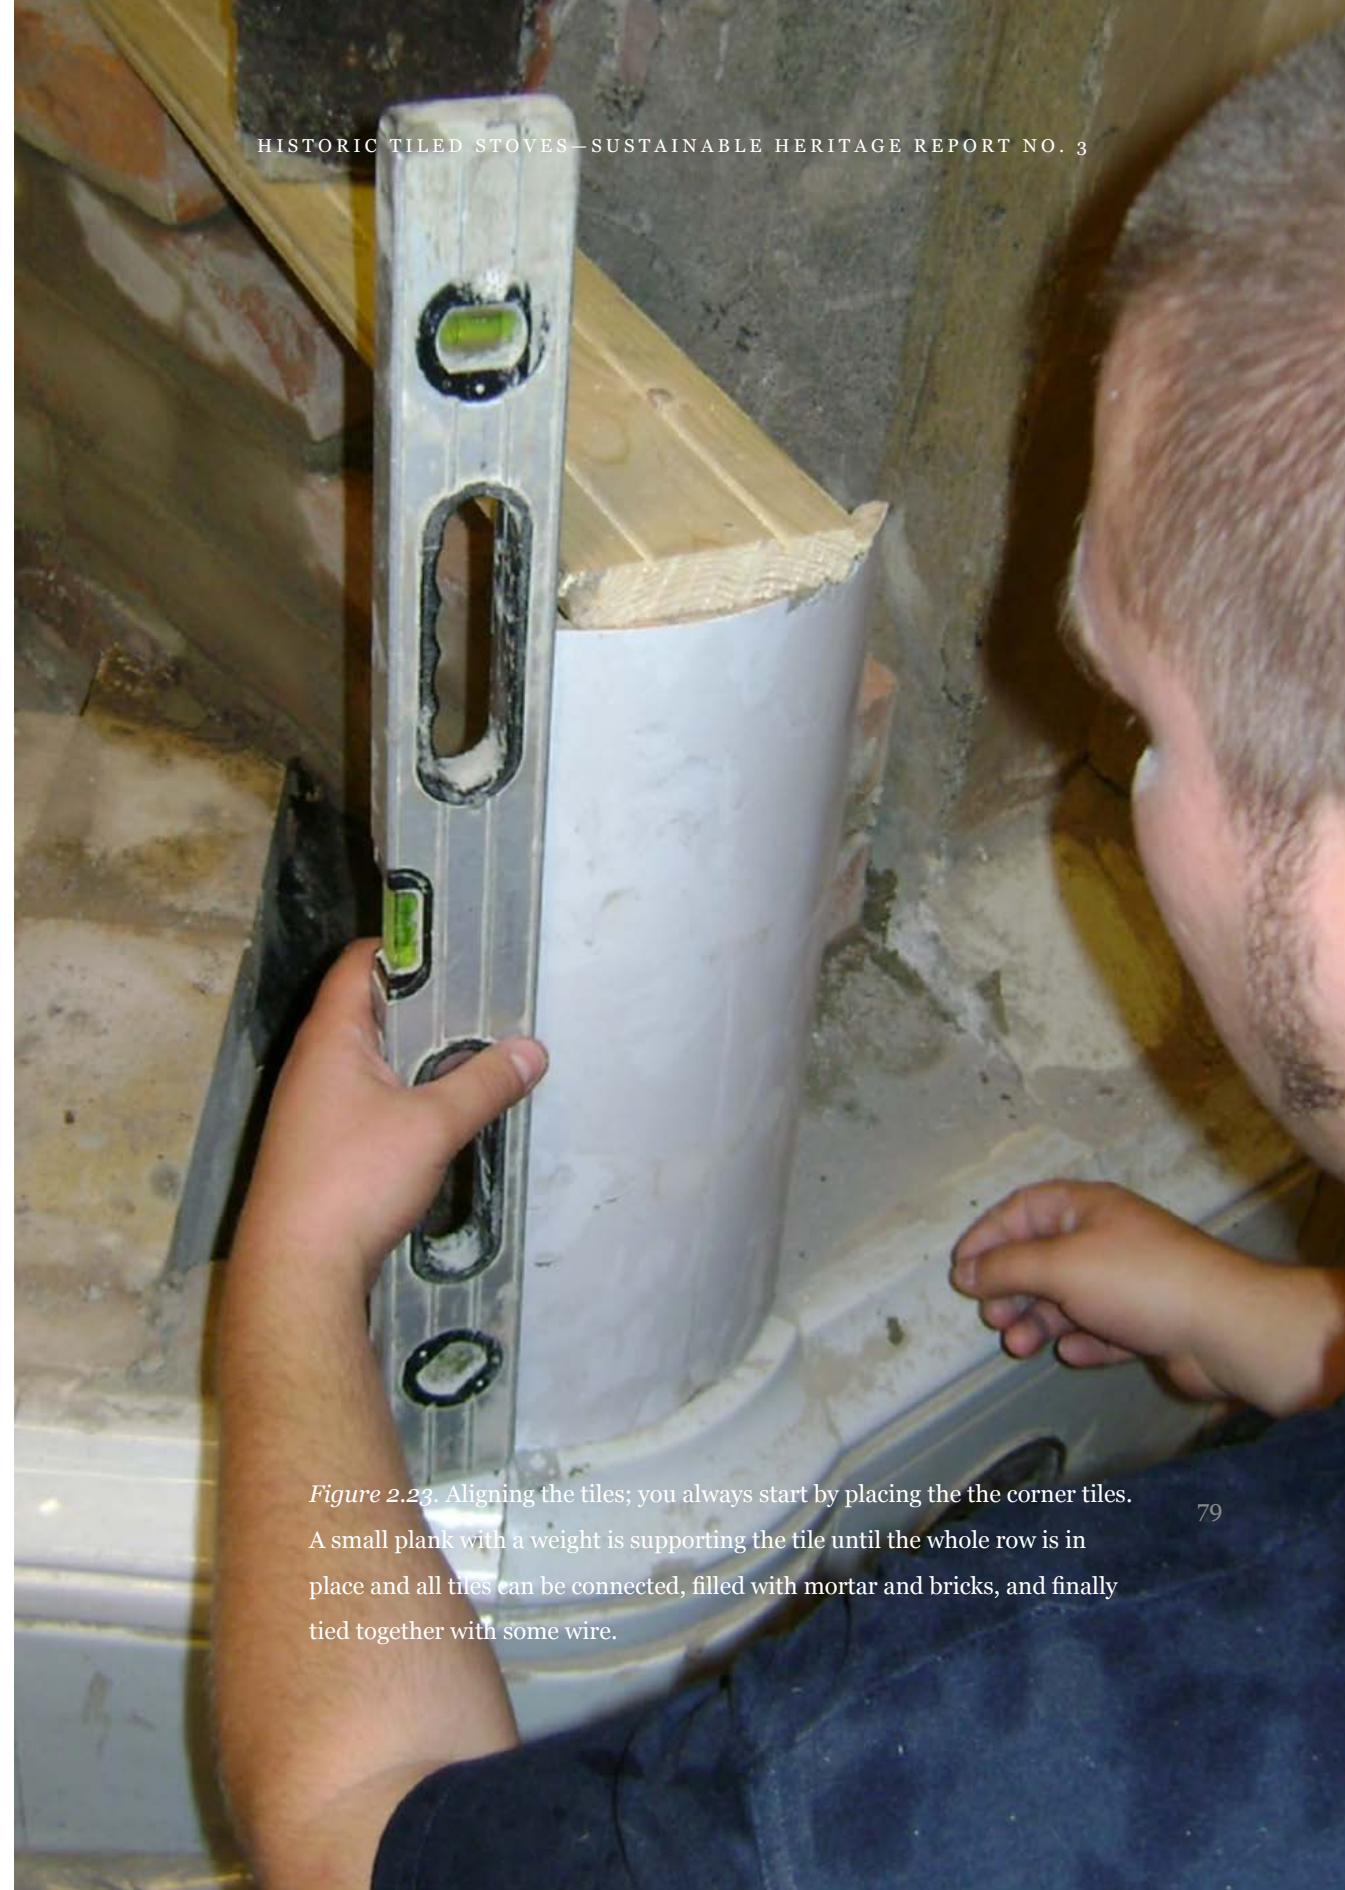
Figure 2.23. Aligning the tiles; you always start by placing the the corner tiles. A small plank with a weight is supporting the tile until the whole row is in place and all tiles can be connected, filled with mortar and bricks, and finally tied together with some wire.

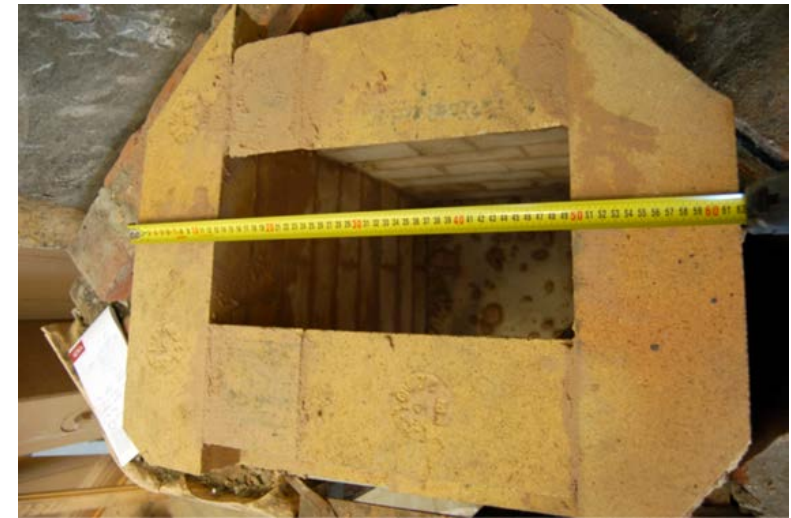
Figure 2.34. The middle flue is narrowed at the back and front of the furnace with a row of bricks that have been shaped with an angle grinder. This bottle neck will improve the draught in the flue.

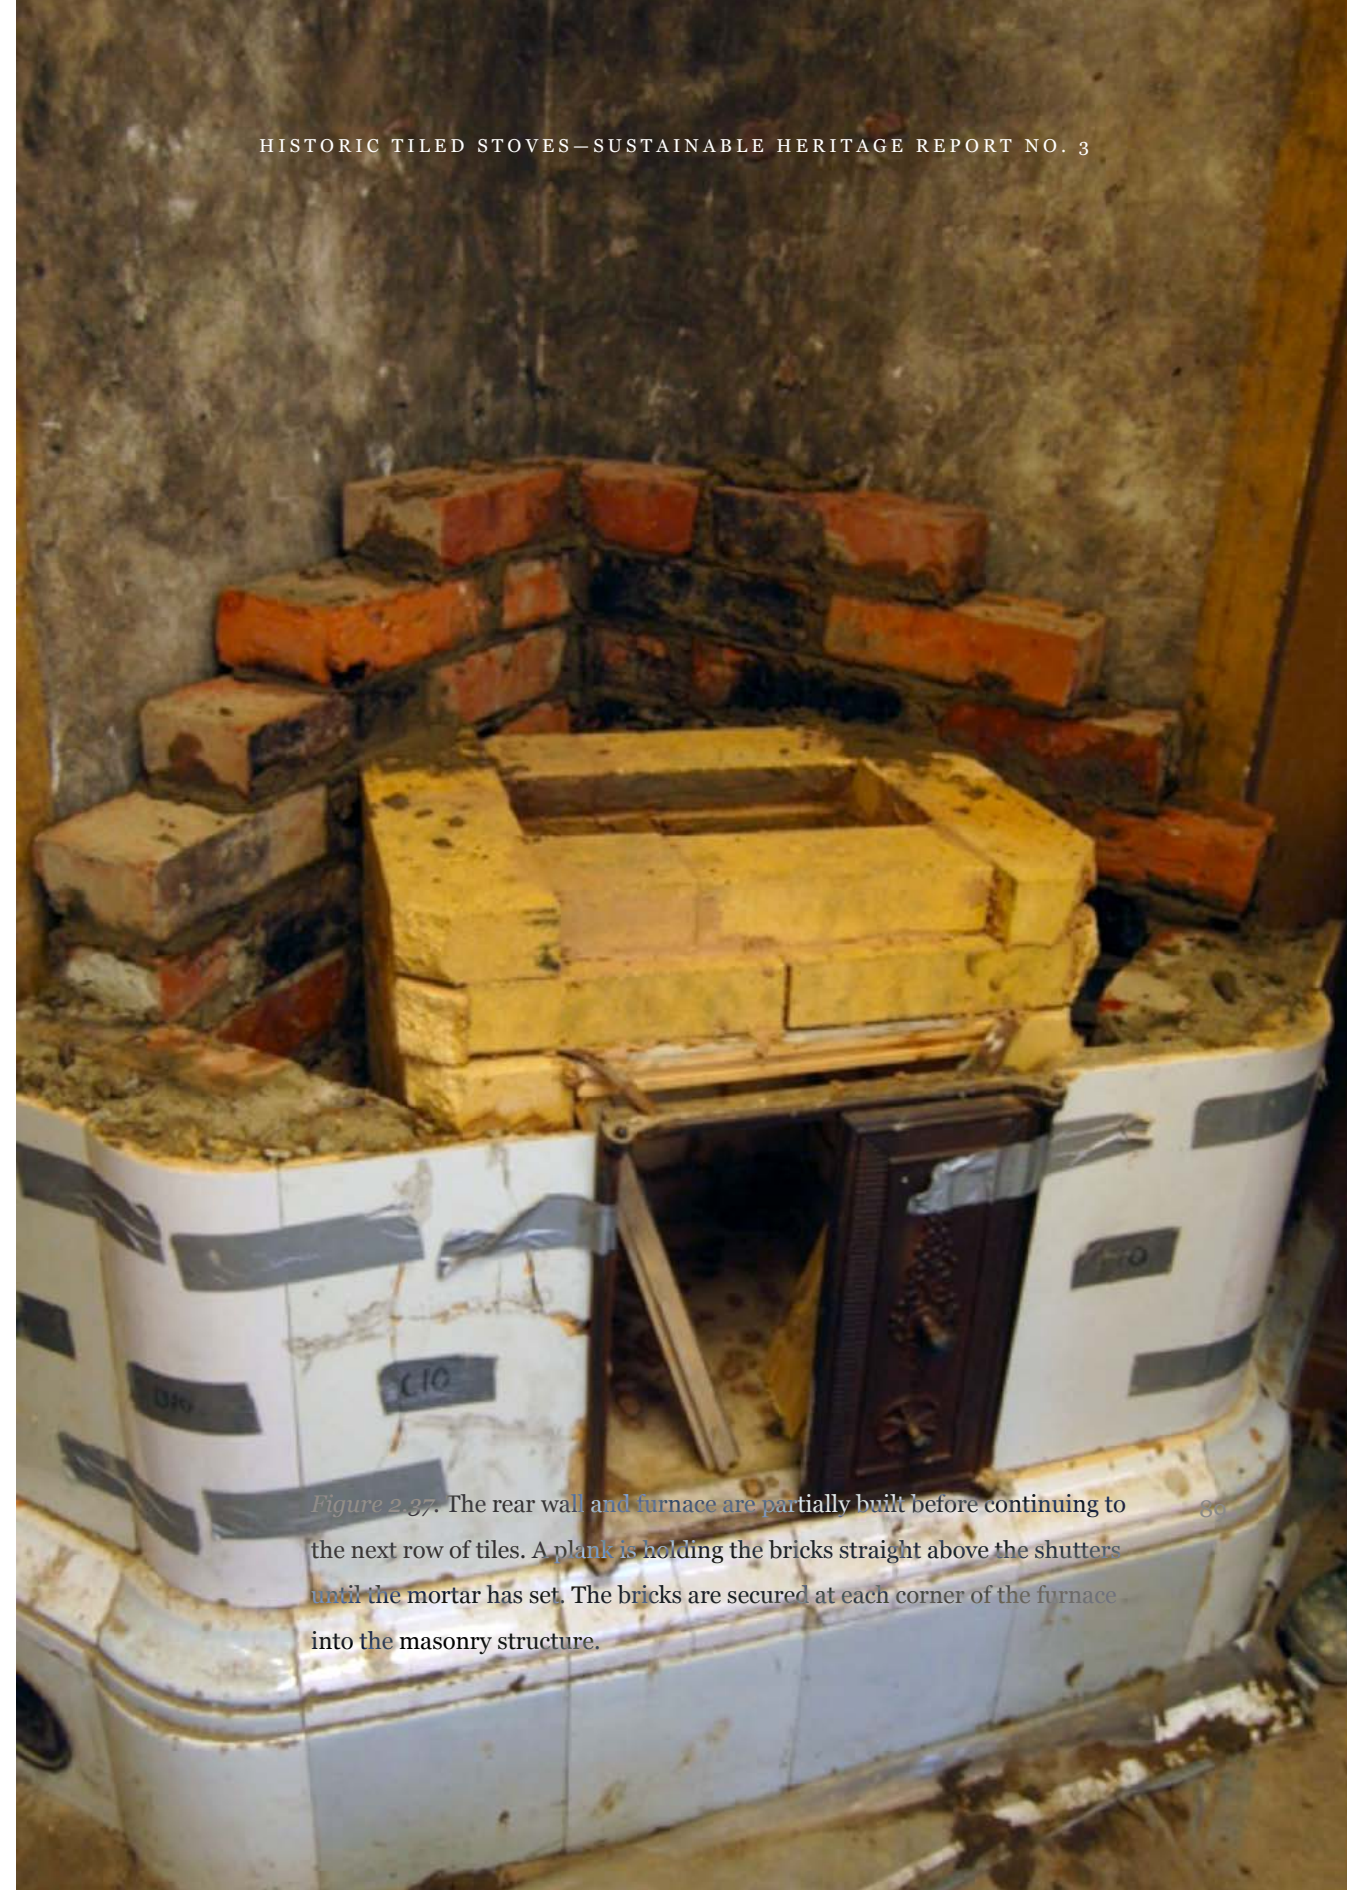
Figure 2.37. The rear wall and furnace are partially built before continuing to the next row of tiles. A plank is holding the bricks straight above the shutters until the mortar has set. The bricks are secured at each corner of the furnace into the masonry structure.

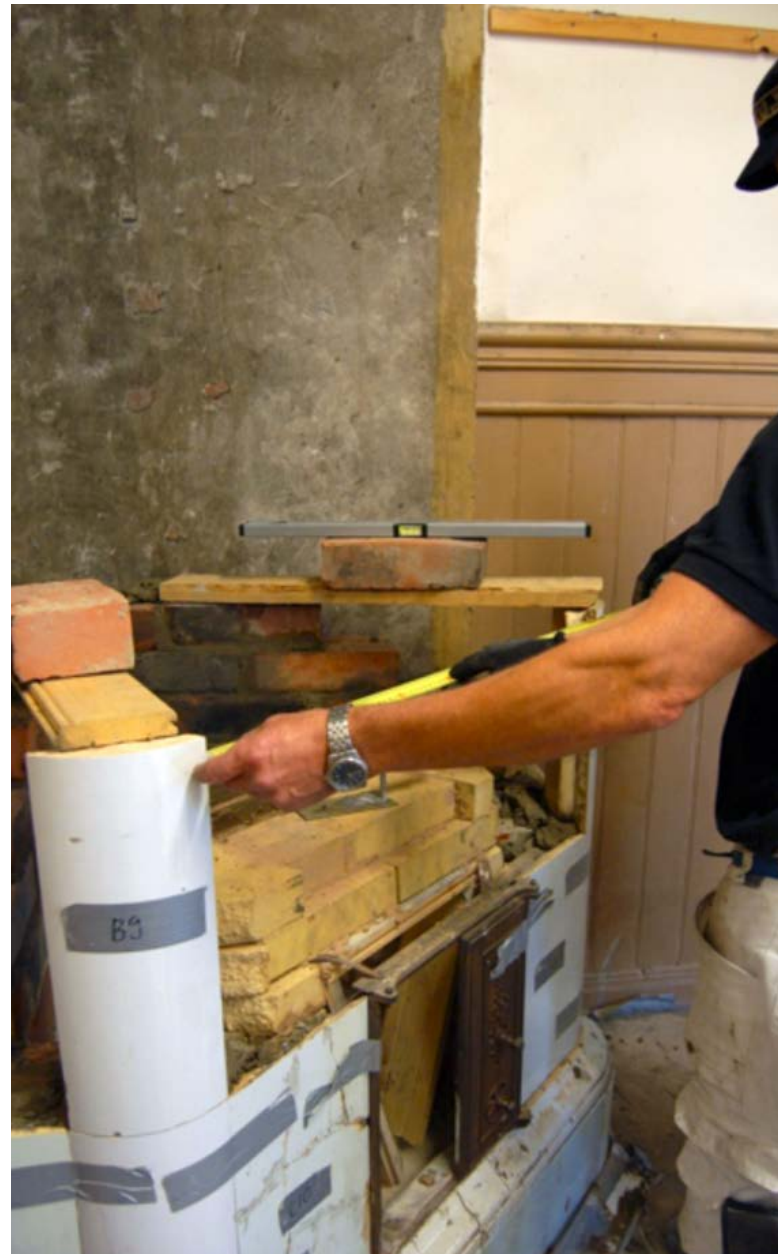
Figure 2.41. When both corner-tiles are in place the distance is double-checked to insure that the centre tiles will fit.

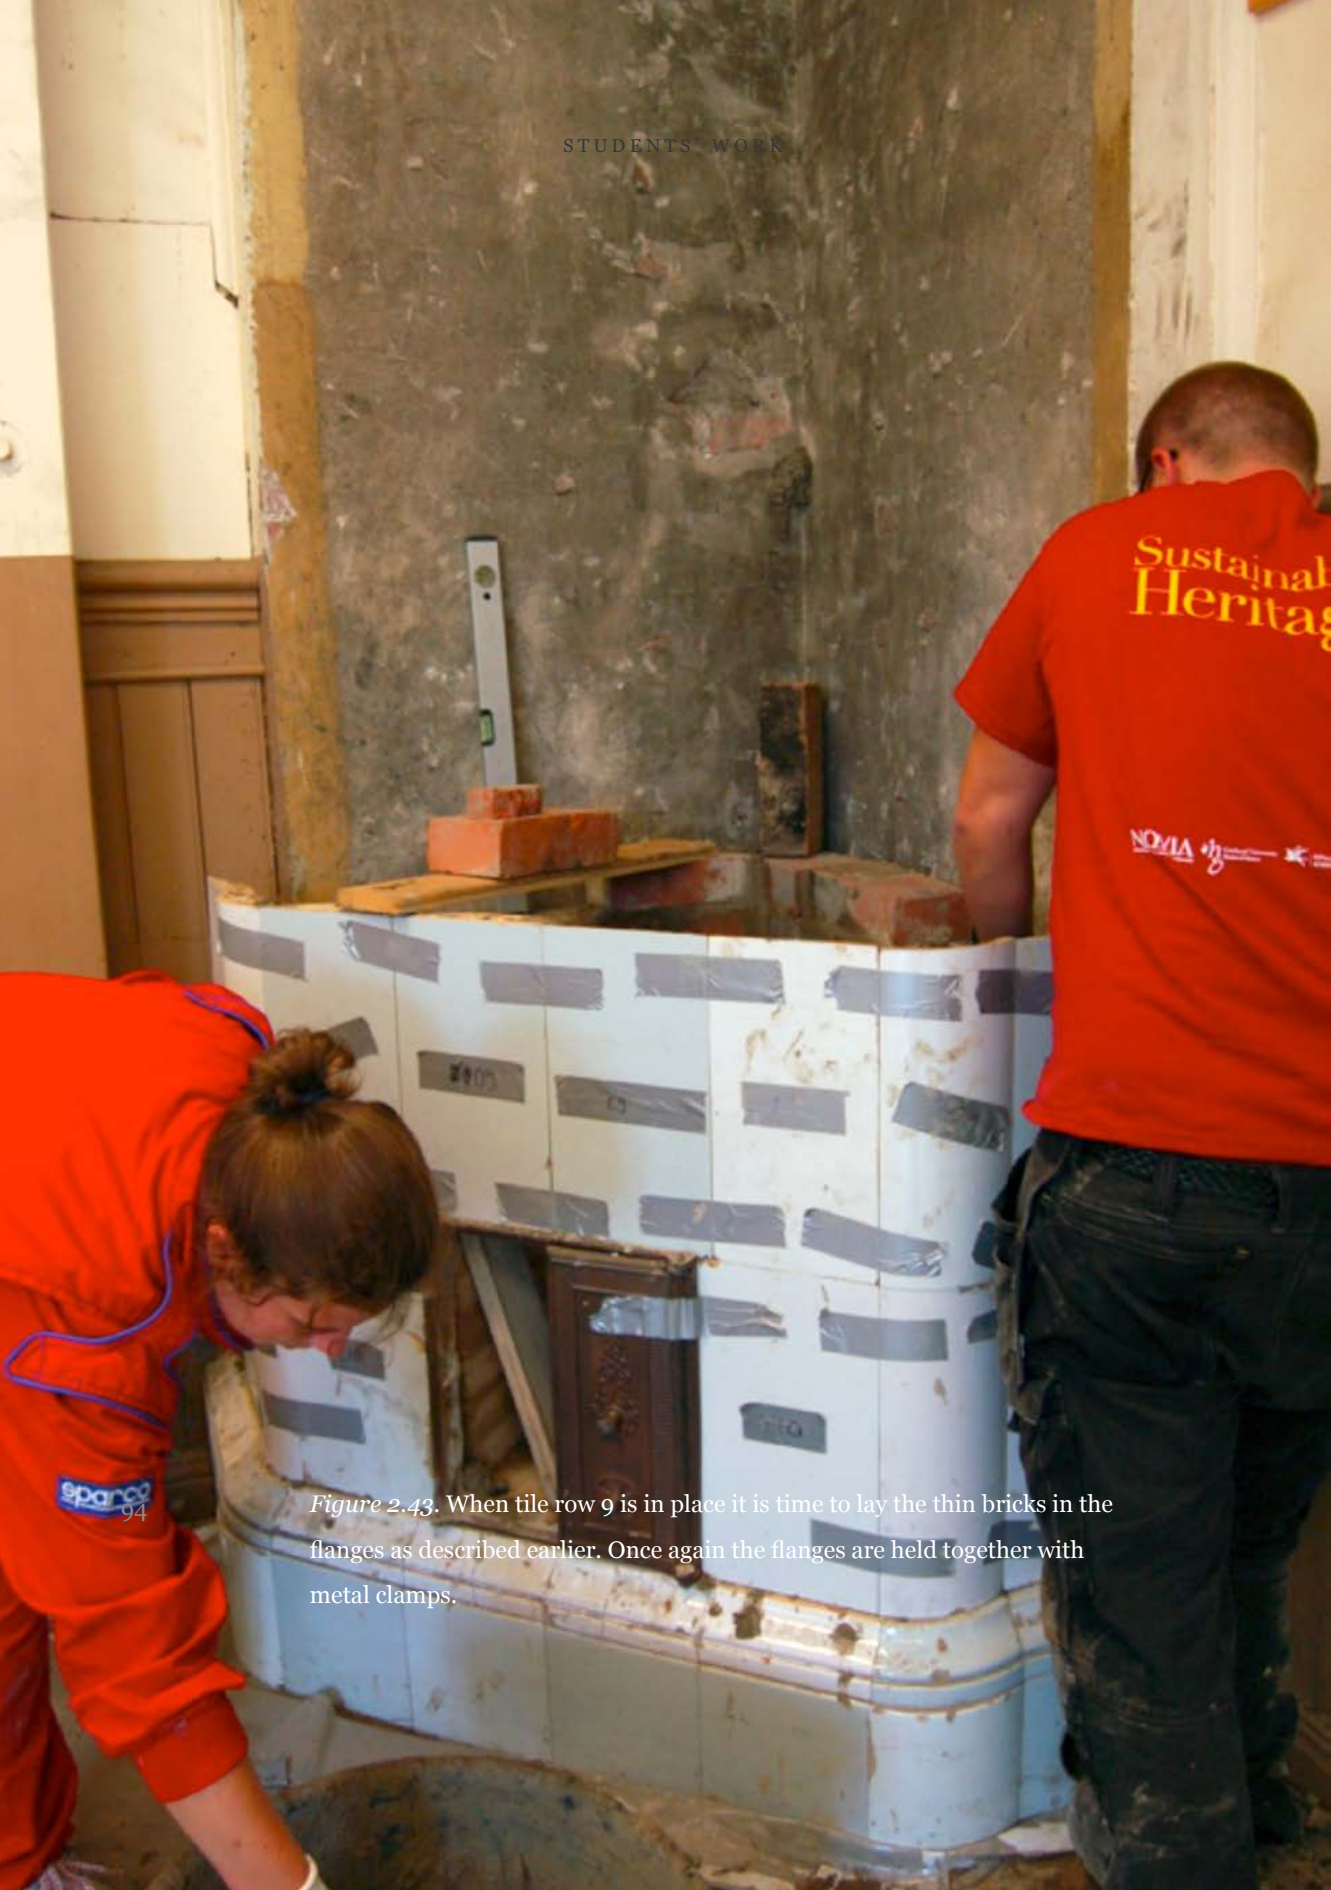
Figure 2.43. When tile row 9 is in place it is time to lay the thin bricks in the flanges as described earlier. Once again the flanges are held together with metal clamps.

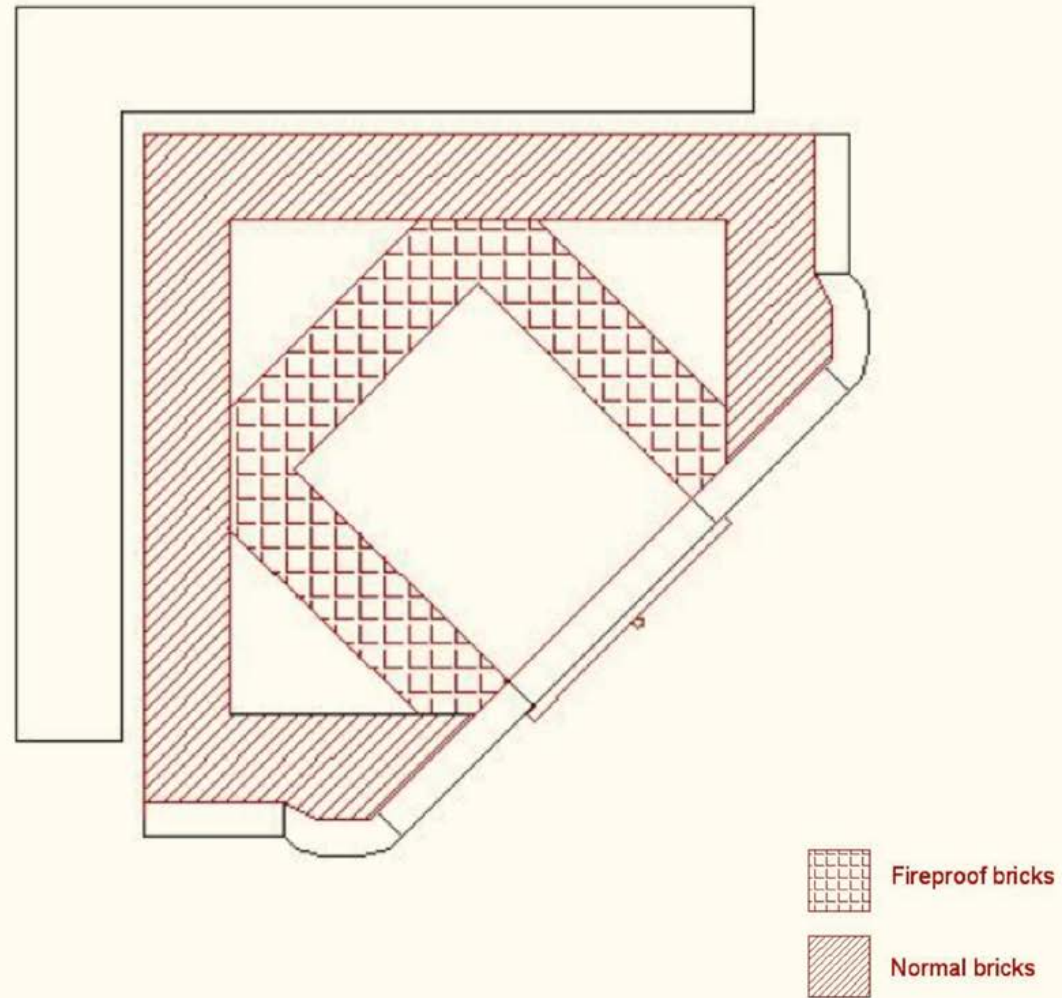
Figure 2.61. Tile row 10: square furnace in the middle; side flues meet underneath the furnace and lead to the flue in the back which leads to the chimney at the top.
