CONSERVATION OF WALL PAINTINGS AT SUUREMÕISA MANOR

Sustainable Report No. 9

HIIMUMAA, ESTONIA // INTENSIVE COURSE AUTUMN 2015

A joint project between Uppsala University, Estonian Academy of Arts, Novia University of Applied Sciences and supported by the Nordic Council of Ministers through Nordplus funds.

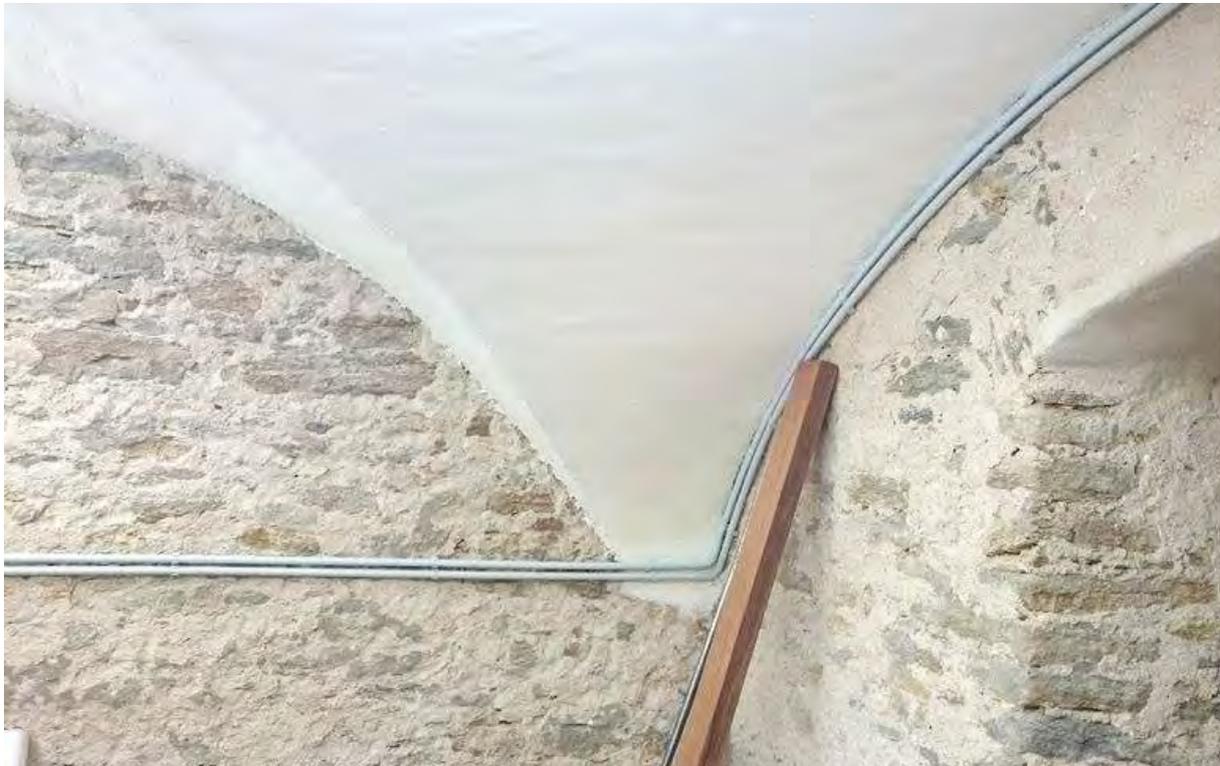
The basement featured vaults of limestone. The higher ranked paid servants lived in the basement which was also used as a working space and storage area.

Basement. Photo: Robin Lindqvist.

The basement was renovated in 2015 when the new ventilation system and electrical wiring were also installed. The ceilings and walls were painted white. Some of the floors were also retiled.

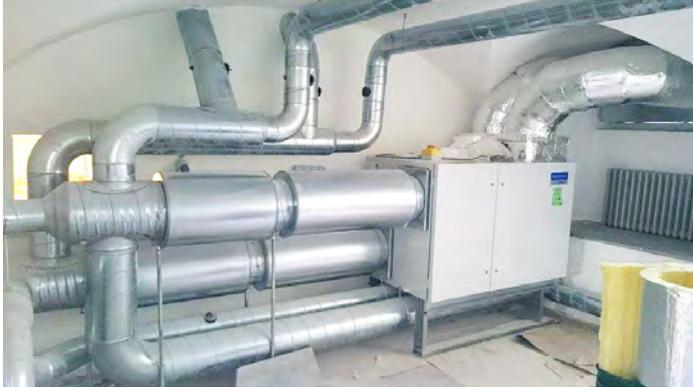
Ventilation machine. Photo: Robin Lindqvist.

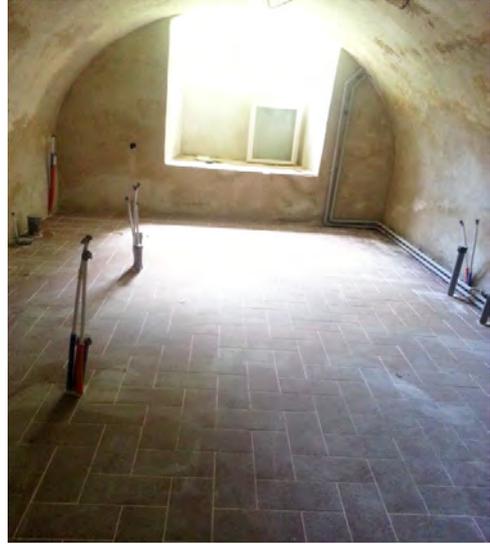
New flooring in the basement. Photo: Andreas Selenius.

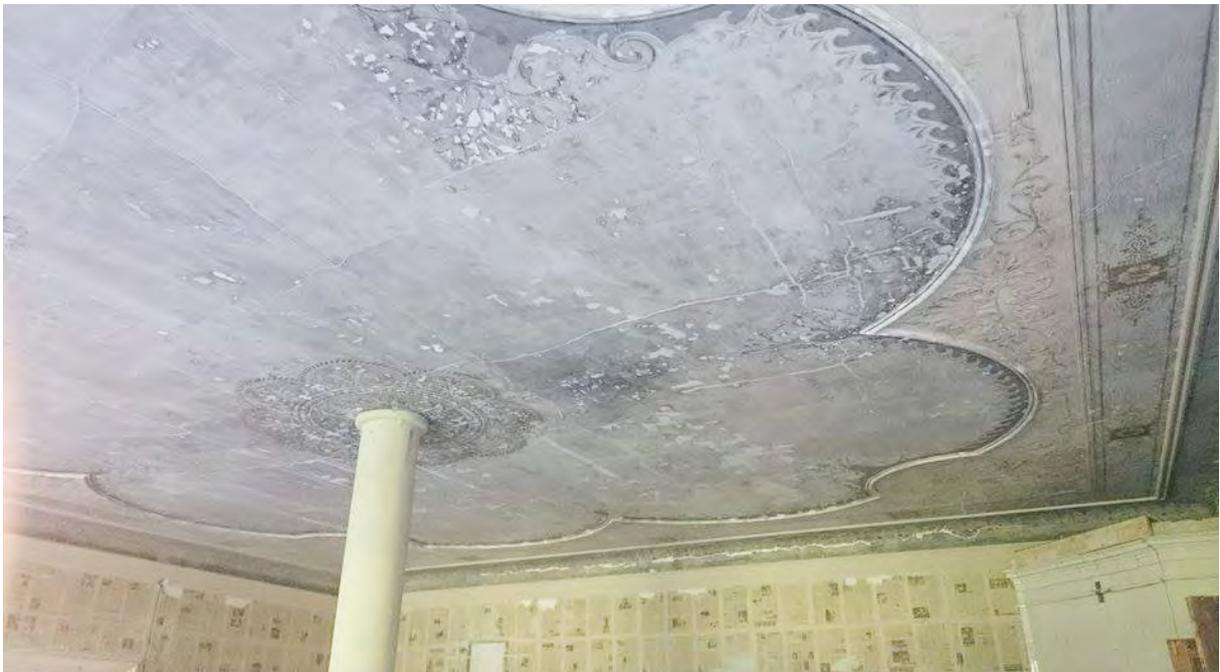
On the first floor the ceiling is reinforced with a pillar to prevent it from collapsing due to large loads on the 2nd floor.

The pillar. Photo: Robin Lindqvist.

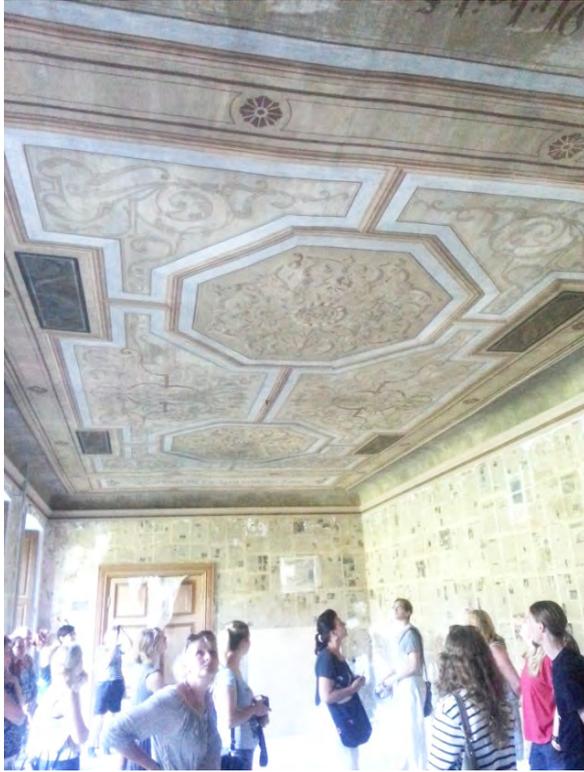
Recreated painting. Photo: Andreas Selenius.

The original ceiling paintings in some of the rooms have been recreated. In some of the rooms the floors were replaced and the panels and walls painted over. Due to heavy water damage one of the ceilings had to be reinforced using a metal plate which is hanging from the roof truss.

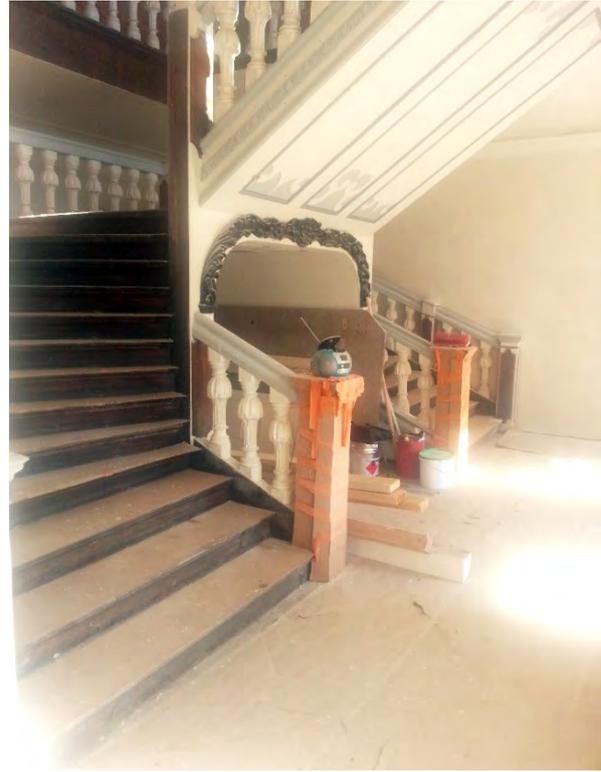
The carved oak staircase leading up to the 2nd floor right from the entrance. Photo: Andreas Selenius

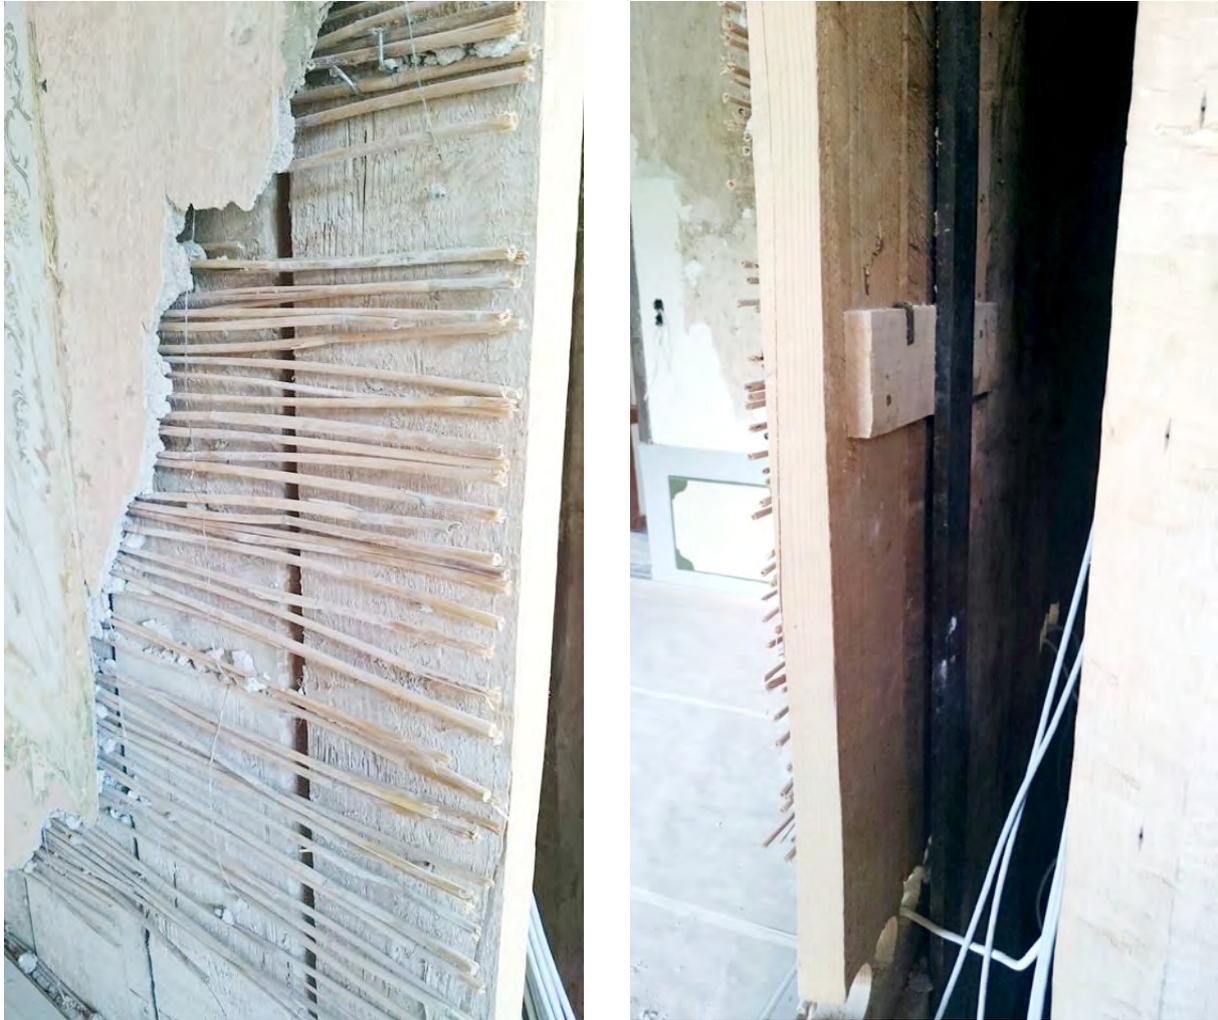
On the second storey there is a wall which is made of wood which was constructed later. The rest of the walls are made of stone. The metal beams leading from the roof truss to the metal plate reinforcing the floor can be found inside the wooden wall.

The wooden wall. Photos: Robin Lindqvist.

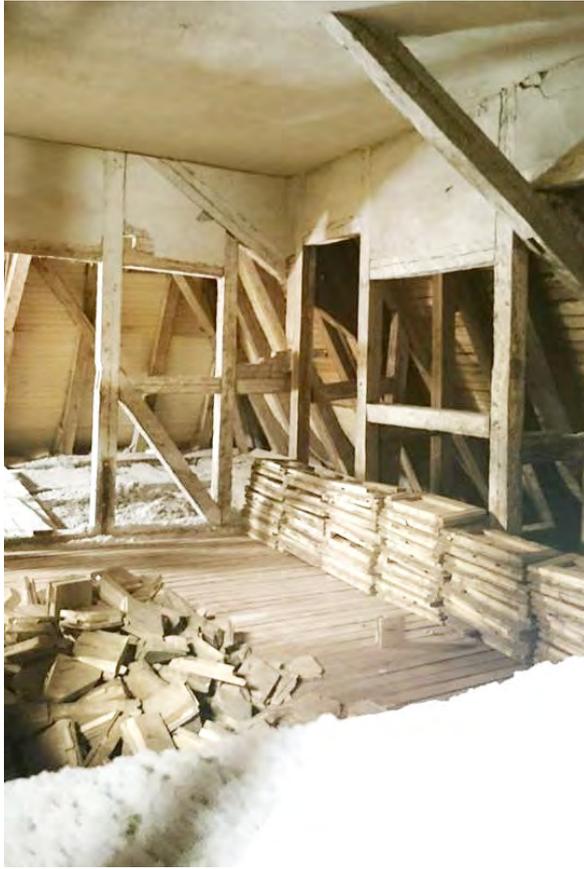
The attic was used as the living area for servants. The small rooms are made of wood and bricks. The filling material in the roof has been renewed. The roof truss is made of massive wood. The huge chimneys also worked as a ventilation system and are connected to most rooms in the manor. Some of the ceiling constructions had to be renewed and reconstructed due to damage caused by fire and old age. There were 4-6 windows but they were removed due to leakage. The three roof-windows are original and were made locally in Hiiumaa.

Servants living area. Photo: Robin Lindqvist

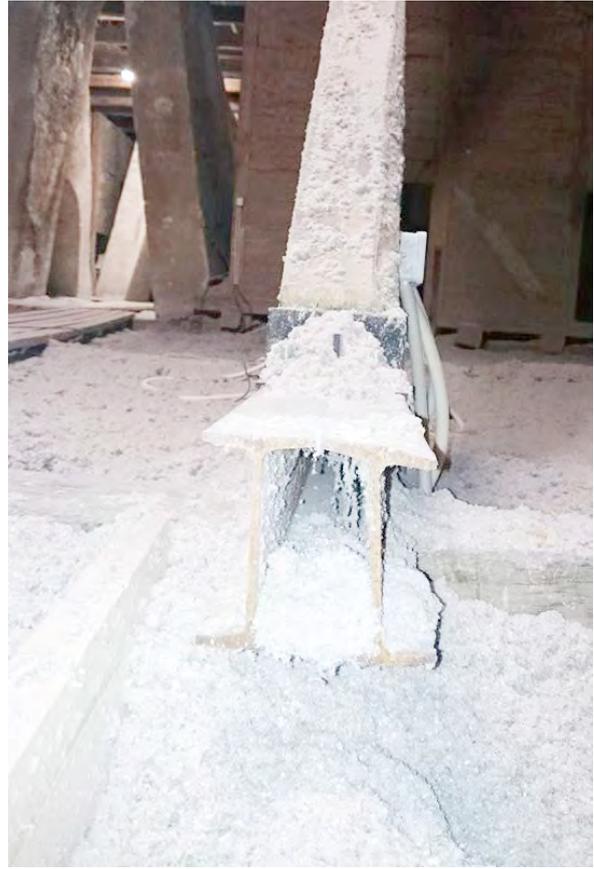
Metal beam, Russian-time engineering. Photo: Robin Lindqvist

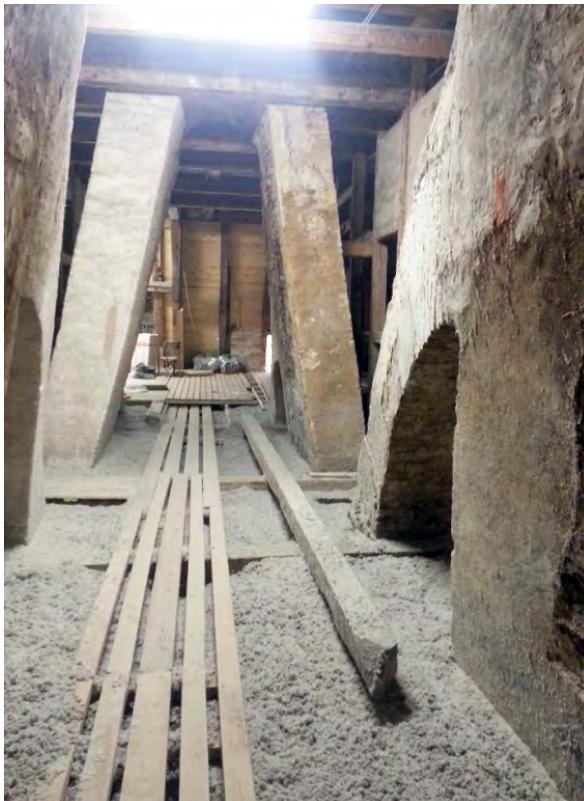
The huge chimneys. Photo: Andreas Selenius

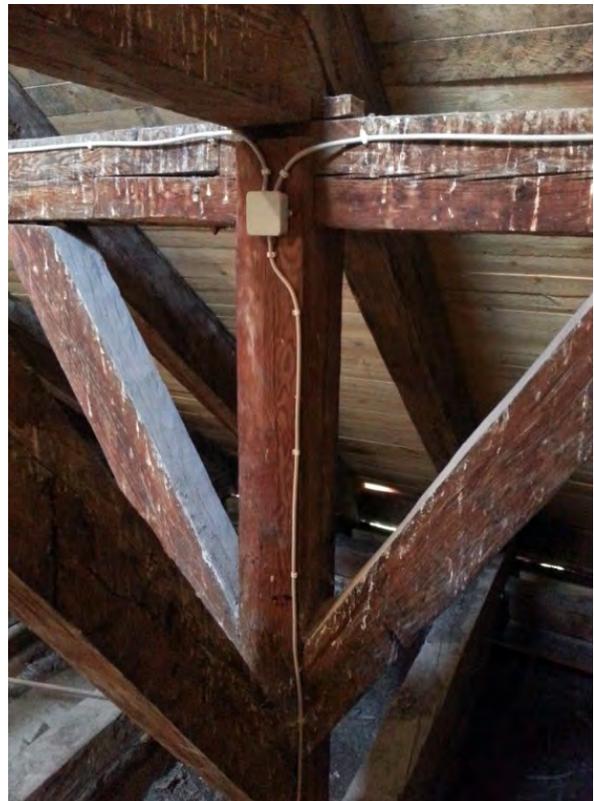
The roof truss of massive wood. Photo: Andreas Selenius

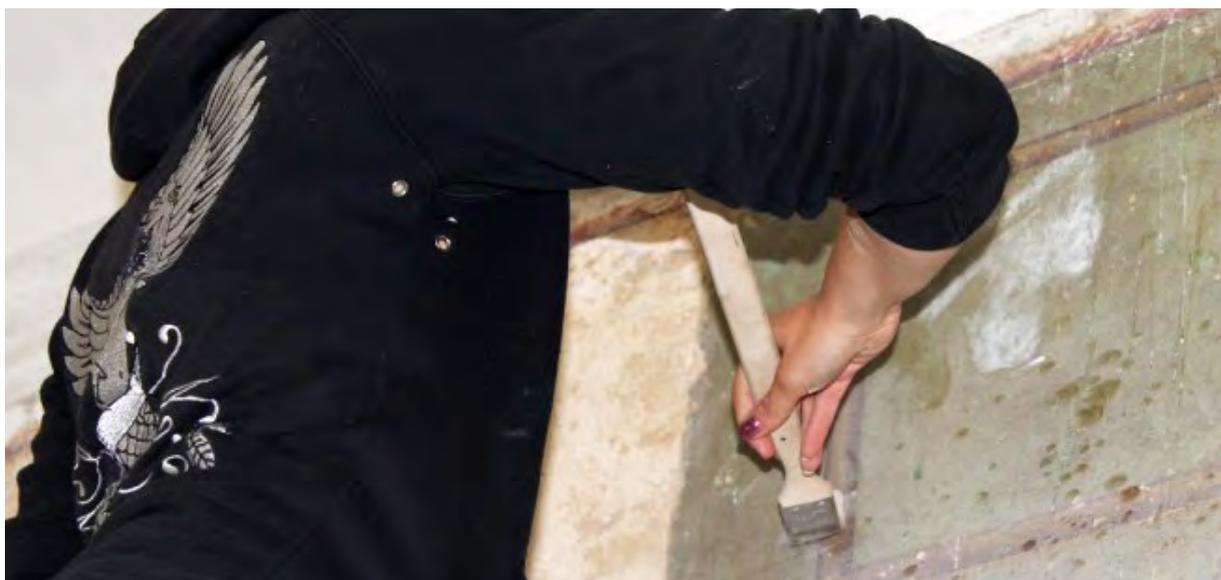
In room N16 the cleaning process took part on the single fragment of wall N1. The fragment represented a green wall painting covered with wallpaper glue.

Dusting the wall surface. Photo: Anna Holmberg

The first task was to clean the walls with brushes to get all the loose dust away. The painting was also measured and drawn at the beginning of the day.

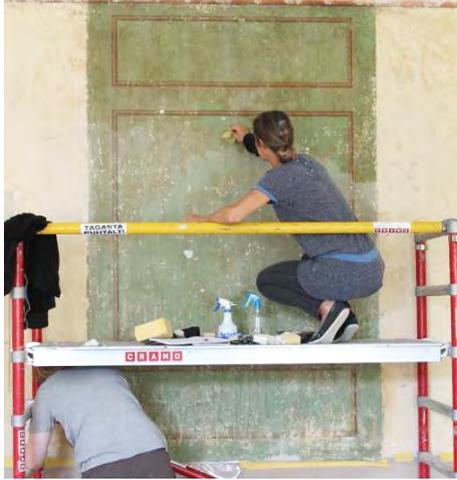
Kautchuck sponge cleaning. Photo: Anna Holmberg

After dusting, the next step was sponge cleaning. The particular sponge used is made of natural rubber. The rubber sponge used is widely used in the conservation field due to its neutral pH and ability to effectively pull the dirt from the surface due to the high porousness of the sponge.

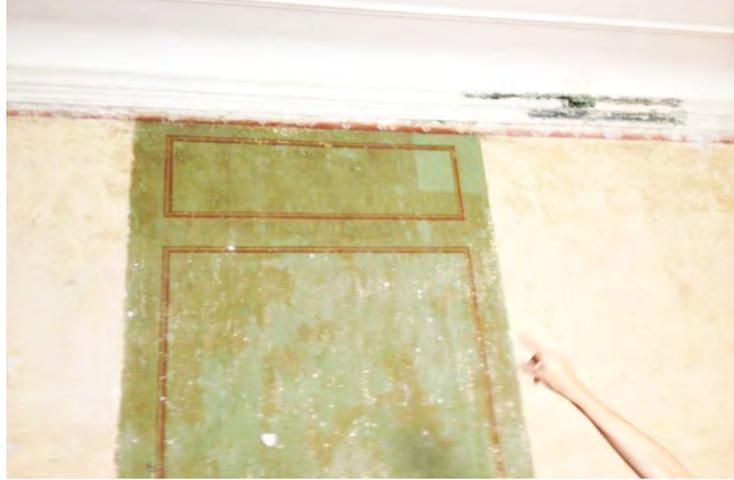
Wallpaper glue residues test cleaning. Photo: Anna Holmberg

The next task was to remove the glue using wet mechanical method. The glue was firstly moistened using water and then carefully removed using scalpel blades.

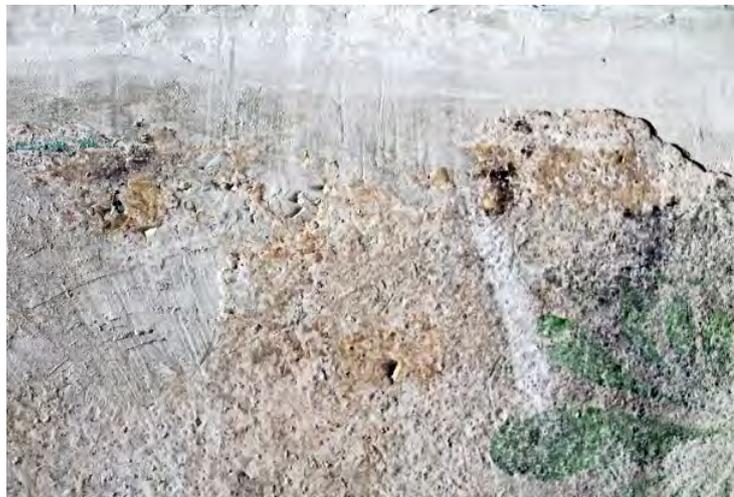
In Room N2 the cleaning took place on wall 1, wall 2 and wall 3. In the upper section of wall 1, more layers were discovered.

1. Base
2. Plaster /Lime wash
3. Brownish red paint layer
4. Plaster /lime wash
5. Light green colour
6. Plaster/ lime wash
7. Brown paint layer
8. Plaster / Lime wash
9. Red paint layer
10. Plaster/ Lime wash
11. Wallpaper fragments

Wall 1 fragment. Photo: Anna Holmberg

As one of the oldest and best preserved colour layers, the green paint layer emphasized. The lost parts of the green paint layer on the wall 1 were reconstructed in order to obtain the visual integrity of the room. The walls 2 and 3 were left unreconstructed, as the conservation work was based on on the principle of minimal interpretation and intervention.

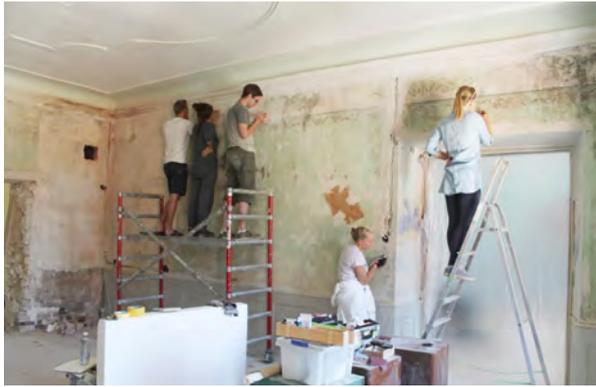
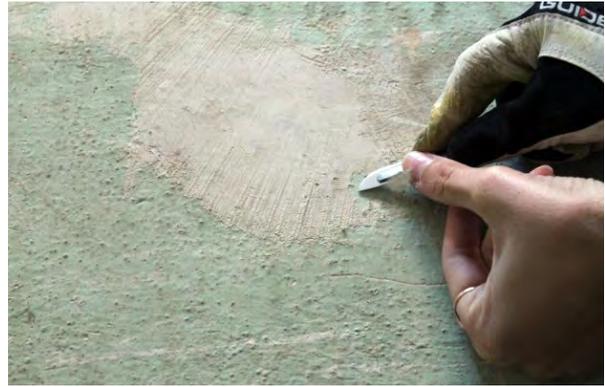
Photos depicting the process of revealing the green paint layer. Photos: Anna Holmberg

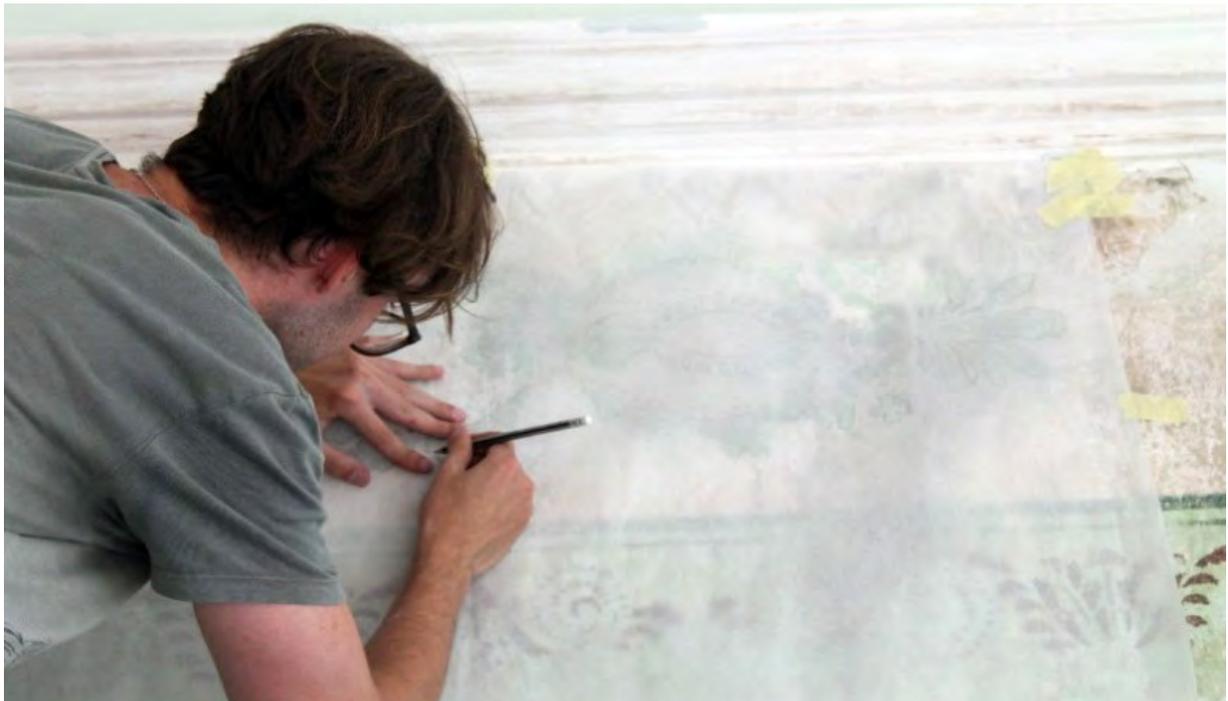
Reproduction of the ornament outlines through transparent paper. Photo: Anna Holmberg

In the green room, there were ornaments at the top of the walls that were going to be reconstructed and in some places, renewed. To perform the reconstruction, the reproduction of the green ornament was needed. The first task was to duplicate the ornament on transparent piece of paper using plain graphite pencil.

The next task was to make a stencil. The preparation phase consisted of sizing a thick piece of paper with linseed oil. After the sizing of the paper, it was left to dry for a day. The linseed oil sizing was done to prevent the stencil from changing during the process of paint application.

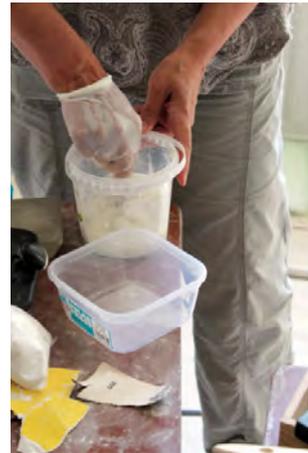
Preparation of the casein medium.
Photo: Anna Holmberg

The next step was to make a casein medium to be used as a paint binder. The casein paint medium consisted of dry casein powder, water and borax. Casein is normally a protein extracted from cottage cheese. Borax is a mineral based material. Its use allows the casein medium to obtain a neutral pH and be used with all kinds of pigments.¹

- 2 1/2 oz. (80g) Casein Powder
- 9 fl. oz. (ca 250ml) cold water
- 1 oz. (32g) Crystalline Borax
- 9 fl. oz. (ca 250ml) hot water

1. The dry casein powder is soaked in cold water for approximately one night
2. Borax powder dissolved in warm water
3. Borax solution is added to casein solution and stirred
4. The mixture is left to cool down

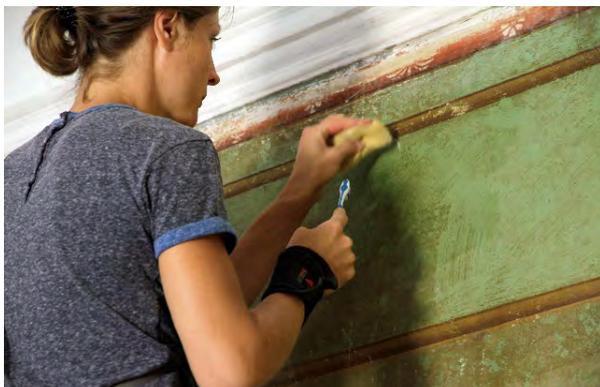
Today we continued cleaning the W-wall painting. We finished scraping out a part of the flower ornament above the green wall painting.

Karin cleaning the W-wall painting. Photo: Josefine Israelsson

For the green surface we used clean water and toothbrushes to remove the wallpaper glue residues.

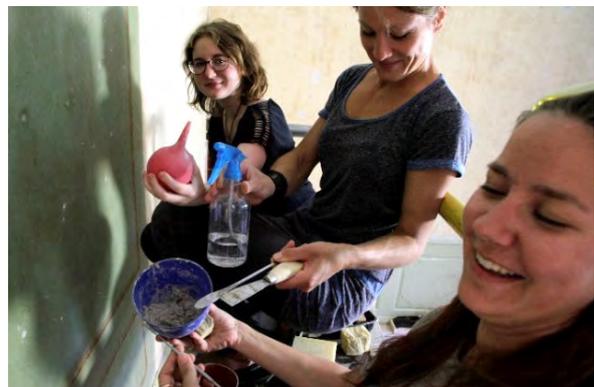
Picture of all the tools to clean and plaster the holes. Photo: Liina Talts

When we were satisfied with the result of the cleaning, we started filling the holes. We used an air pump to get the loose particles out of the cavity so the plaster could stick better. The plaster consisted of $\frac{3}{4}$ sand and of $\frac{1}{4}$ lime, the filler was cattail fluff (kaveldun).

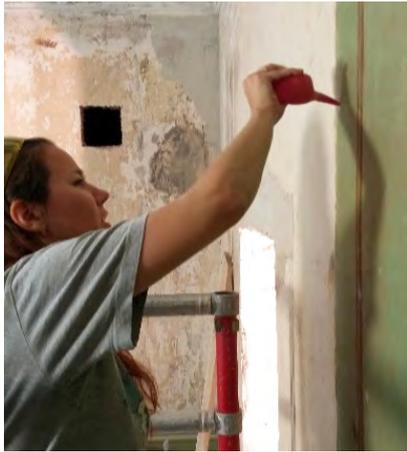
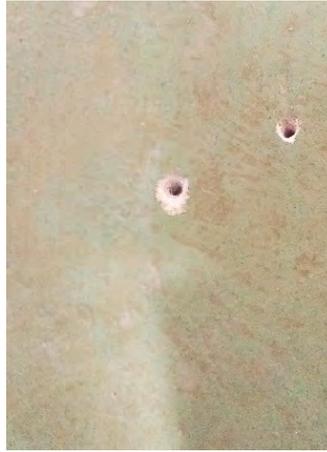
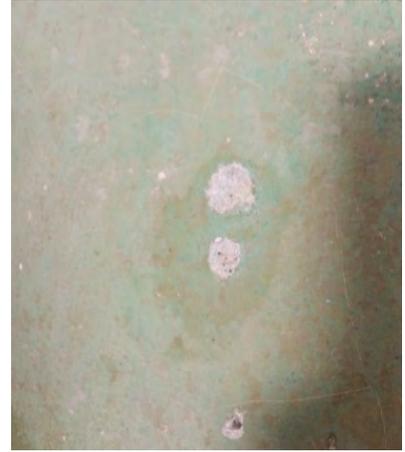
Air pumping the dirt away from the holes. Pictures of holes on the W-wall painting and holes filled up with plaster. Photos: Josefine Israelsson

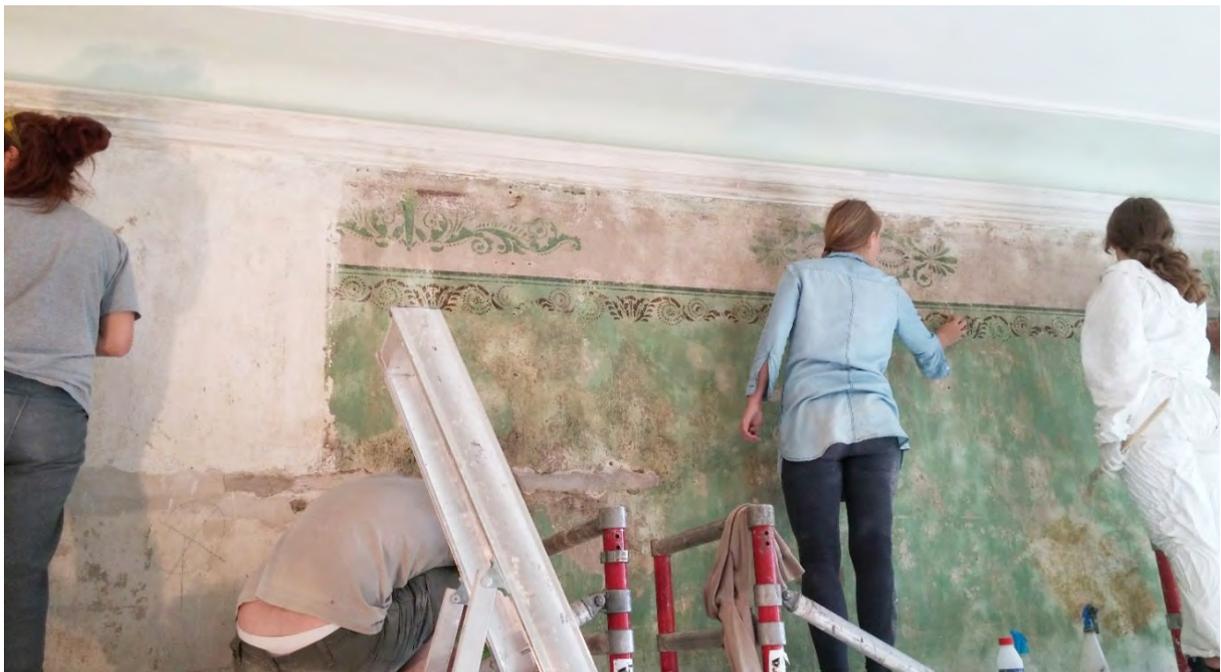
Cleaning the example wall. Photo: Josefine Israelsson

Also in room N2 we continued cleaning the wall painting (mint-green walls and two different stencil ornaments on the upper part of the wall). We worked on every wall but we focused on the S-wall since it was supposed to serve as an example in the end. The residues of plaster and putty were removed mechanically with scalpels and for soot deposits we used water and sponges or sand paper. Ugly yellowish brushstrokes were removed with acetone. When we considered the wall to be clean enough, we consolidated the wall painting of the S-wall with a transparent layer of casein using spray bottles.

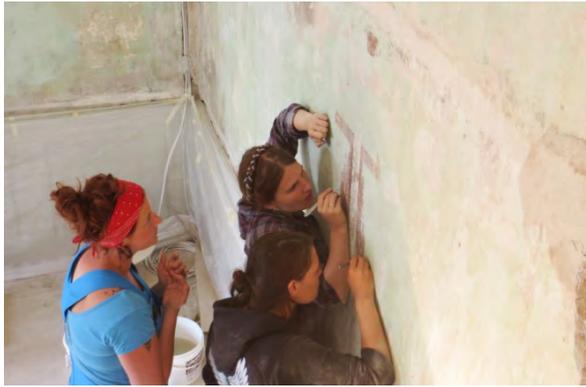
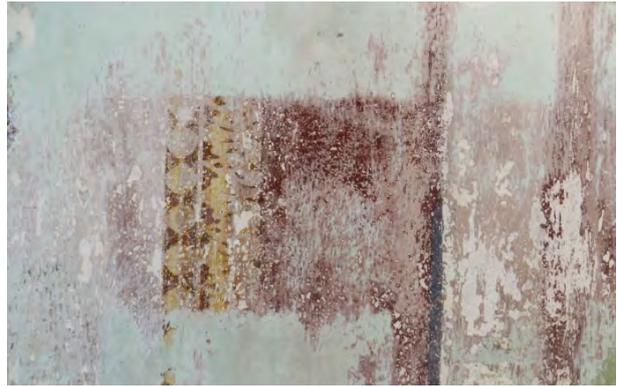
Whilst cleaning the visible paint layer, we continued exposing small sample areas of the wall painting underneath it. We discovered that in the first paint layer, there was probably some kind of vessel on a tripod painted on the upper part of the wall and large panels with ornamented borders in the lower parts of the wall.

Exposing sample areas of the first wall painting. Photos: Taavi Tiidor

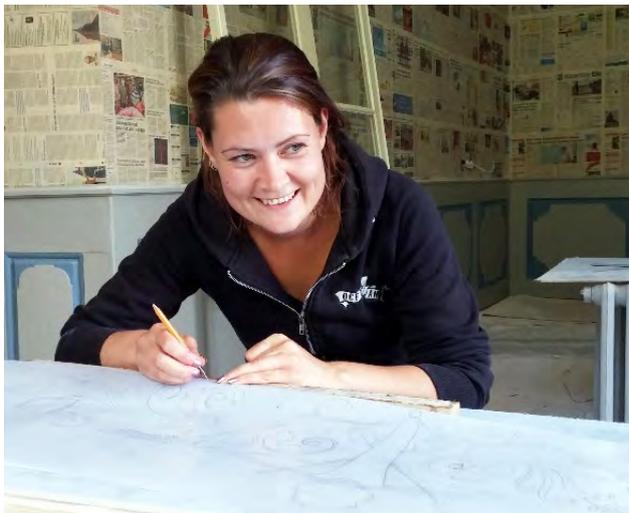
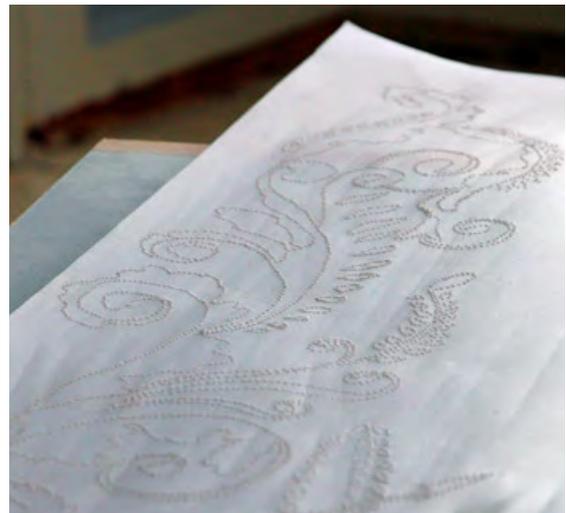
Magdalena using the needle to punctuate the outlines of the ornament and a close-up of the ornament. Photos: Josefine Israelsson

We used two techniques to transfer the image on the wall to paper. The first technique was to punctuate with a needle the outlines of the ornament. The second one was to cut out the ornament, thus creating a stencil.

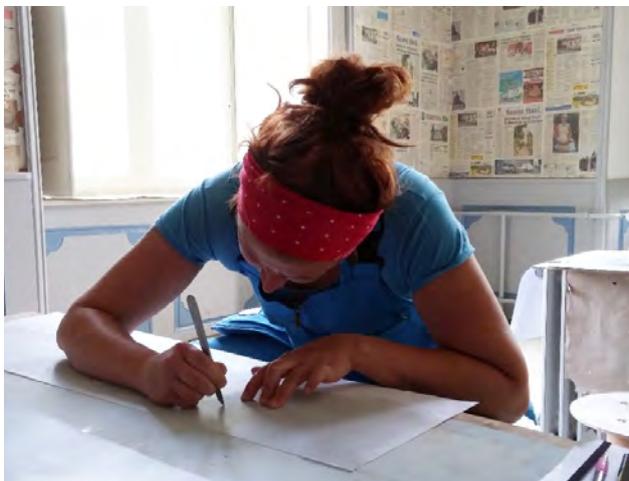
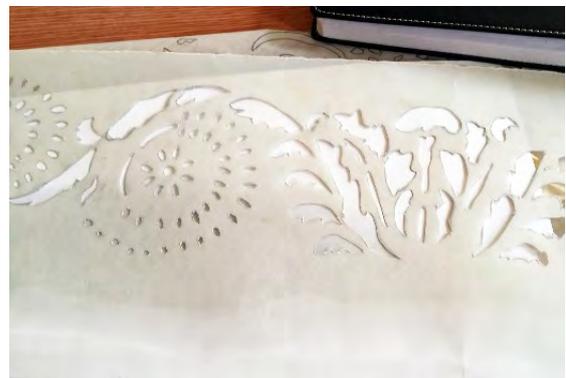
Rebecca cutting out the ornament and a close-up of the stencil. Photos: Josefine Israelsson

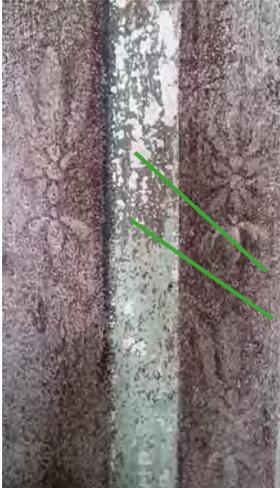
Room N2. Schematic reconstruction of the 1. wall painting layer on the East and South walls by Johanna Lamp (EAA)

Close-up of the flower ornament on the brownish-red frame.

Little fragments of bluish-green paint inbetween two painted panels.

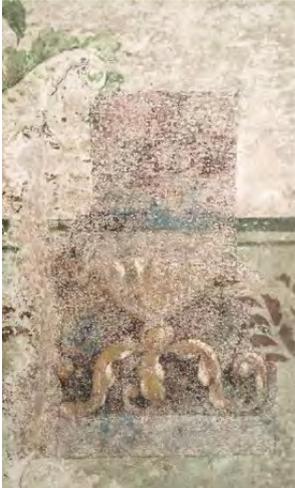
Sondage on the upper part of the wall. Supposedly some kind of a vessel on tripod.

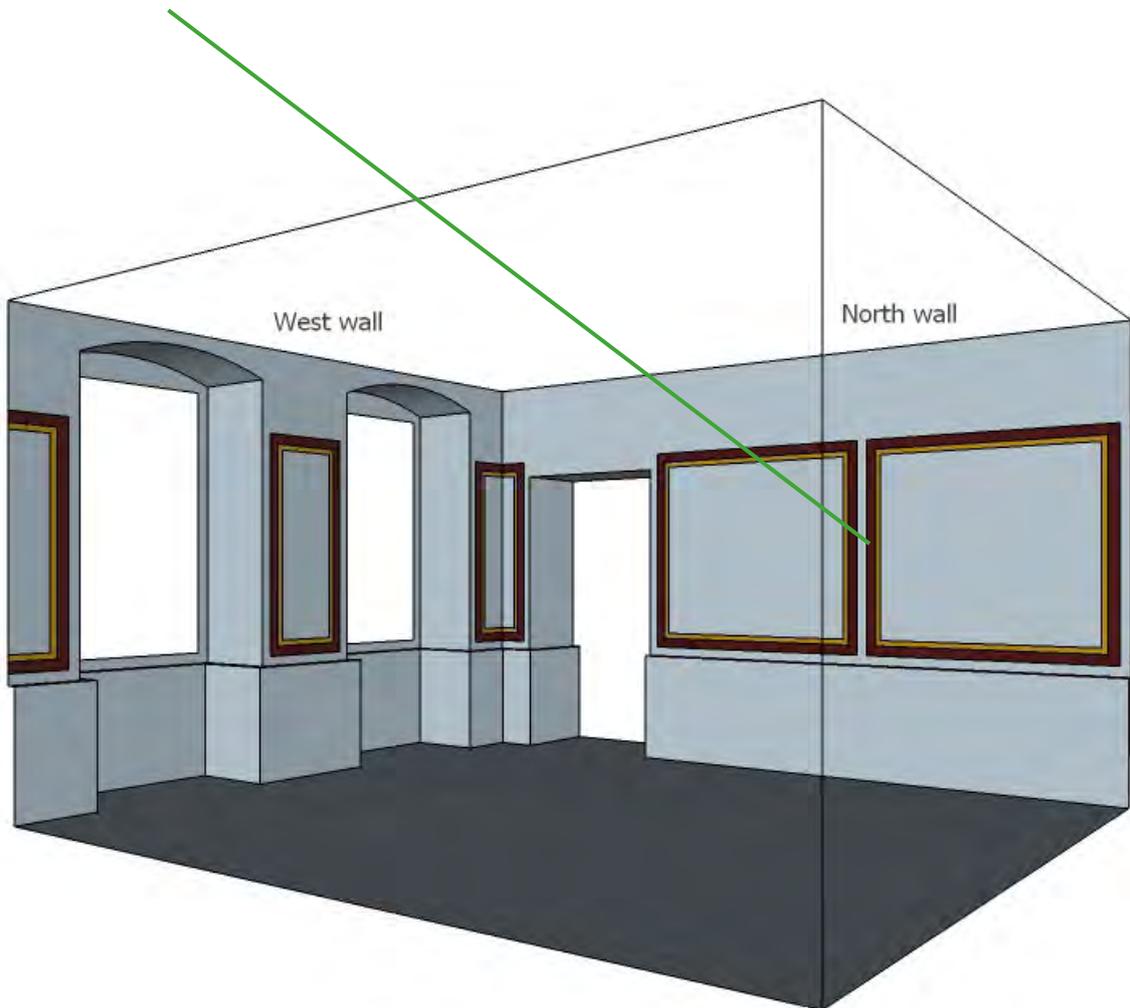
Room N2. Schematic reconstruction of the 1. wall painting layer on the West and North wall by Johanna Lamp (EAA)

Close-up of the ornament on the ocher yellow frame

A thin blue line on the border of the brownish-red frame

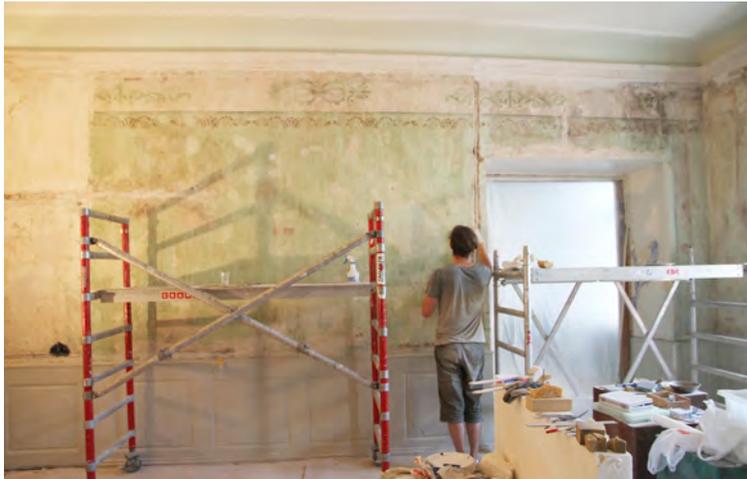
Work with filling holes with plaster continued. Photo: Rebecca Vemdal

During the morning gathering we decided that the work in room N2, the green room, should concentrate on the south wall to give it a finished look. This decision was partly due to the reconstruction which was to take place in the southeast corner of the room. Some students continued the work filling holes with the coarse plaster that had been made the previous day.

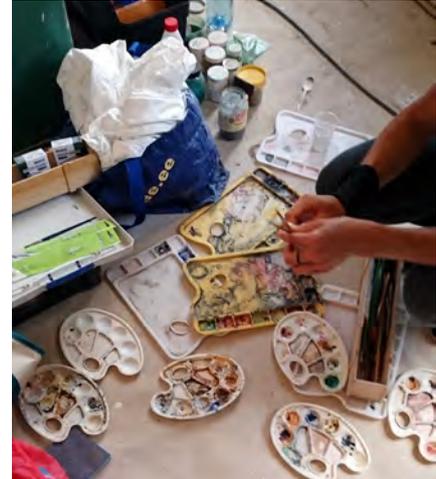
Mixing of pallets to get right hue of colour.
Photo: Rebecca Vemdal

Palettes were mixed to match the existing historical colour on the walls. The pigments used together with the kasein mixture included chrome oxide, yellow ochre, iron oxide black and chalk white, all of these together came as close as possible to the original colour. Aquarelle colours were also used during the process of painting, to give the finished result a more transparent hue, and not to interfere with the historic feel. Another reason for the use of watercolours is because the result will be more reversible than would be the case with a pure casein based colour.

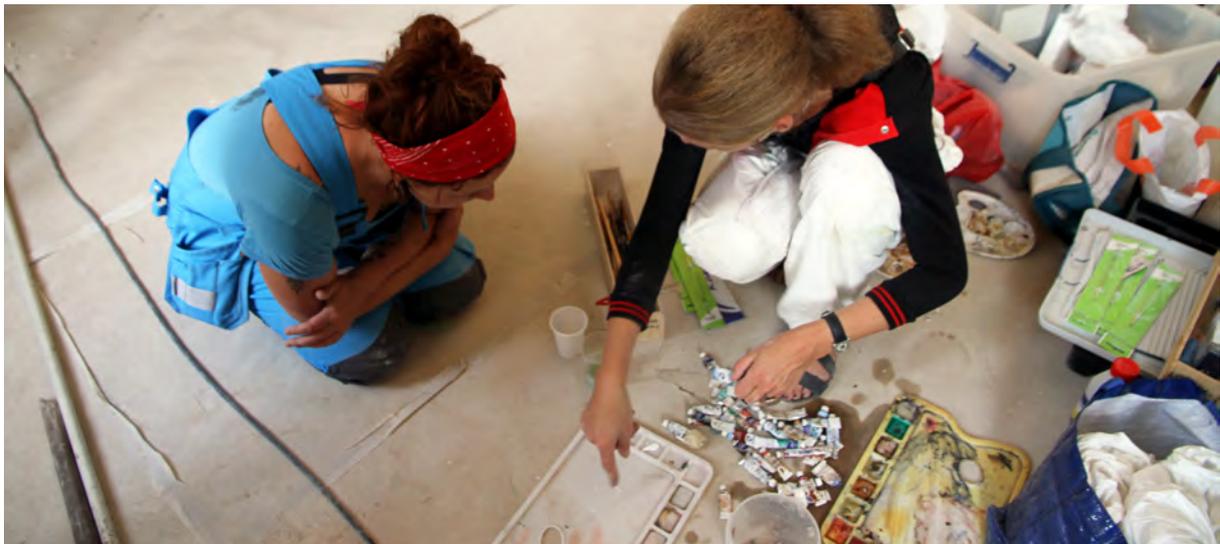
Student being shown how to mix the watercolour with the kasein. Photo: Viktoria Arvidsson

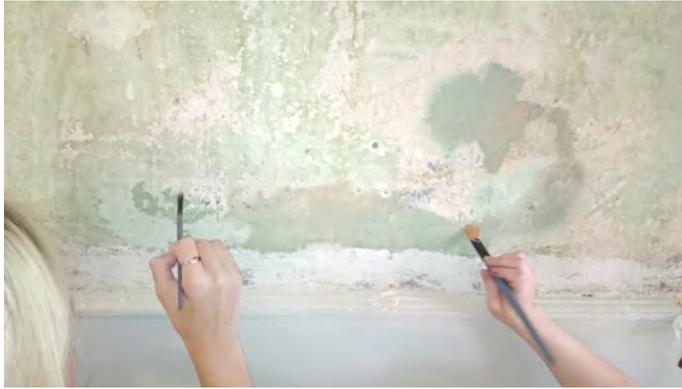
Retouching of stains and blemishes on the south wall. Photo: Rebecca Vemdal

We retouched the red/brown ornaments along the walls and also started work on the homogenous green by retouching stains and blemishes on the south wall.

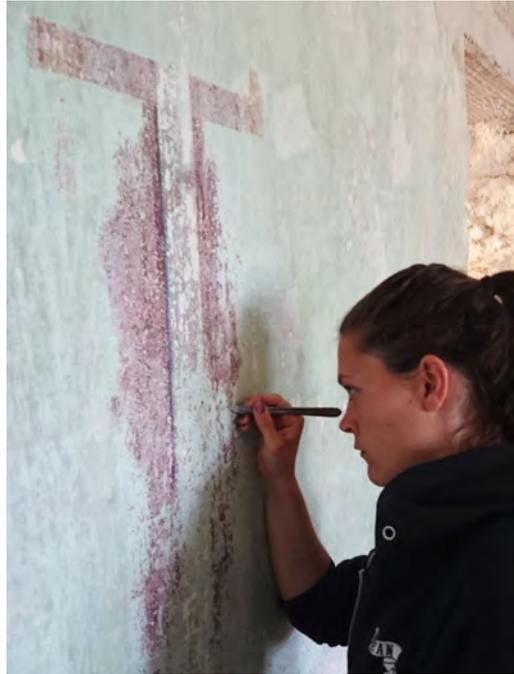
Right: Student scraping paint to reveal flower ornaments on the east wall.

The cleaning and revealing of the flower ornament continued on the east wall and we found traces of the same ornament on the north wall as well. Also the pattern of the ornament became clear. A test stencil was made of that very same ornament.

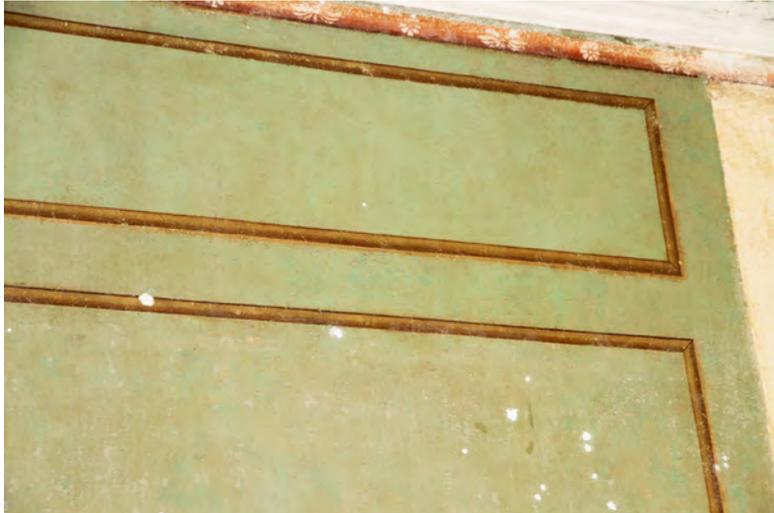
Dried plastered holes ready for retouching with paint. Photo: Rebecca Vemdal

We continued to fill holes with fine plaster. Excess plaster was removed carefully with sponges and water. Tests were made to find the right palette to fit with the historical color of the wall. In this room casein based paint was also used and we applied the same process of mixing the pigment base with aquarelle colours for reversibility.

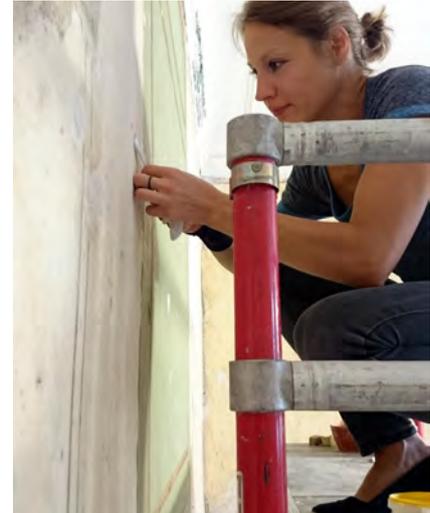
*Filling of small holes in room N16.
Photo: Vikoria Arvidsson*

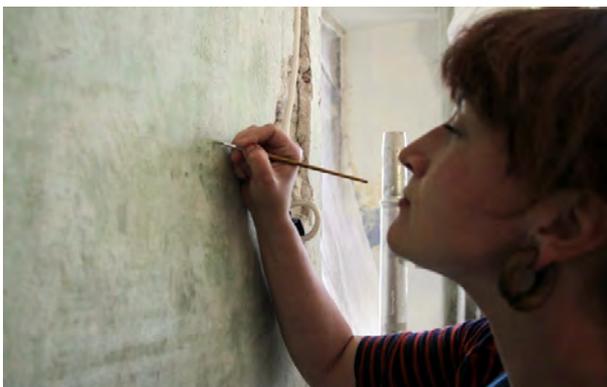
Rebecca filling in blank spots. Photo: Viktor Källgren

On Friday the group concentrated on finishing work in room N2 of the manor house. The main aim of the workshop was to conserve the south wall of this room since it hosted the best preserved stencil paintings. Therefore, most of the participants focused on filling in the uncoloured, and discoloured spots on the south wall. In order to give the south wall a more homogeneous appearance, casein colour mixed with several pigments or various watercolours were used.

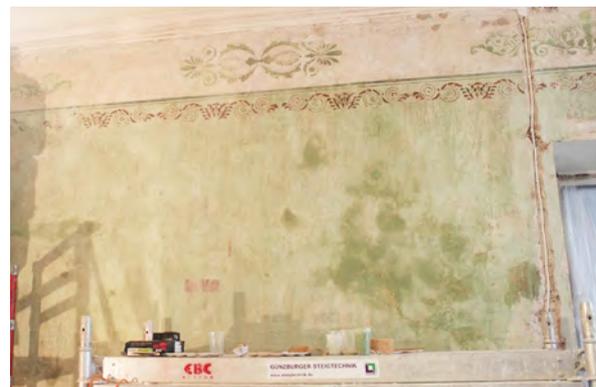
The green casein colour drying. Photo: Diana Haapsal

It was a time-consuming process to mix a perfect-toned green casein colour to match the green finishing of the walls. First, a trial batch of green casein colour was made to try out on the western side of the south wall which was later to be replastered. The green colour was mixed using a variety of pigments: Chalk White, Chrome Green, Pine Needle Green, Turquoise, Deer Brown, Iron Oxide Black, Zinc White and Yellow Ocre.

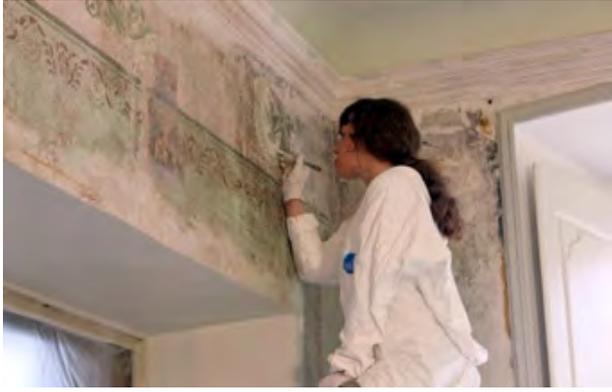
Claudia cleaning out the amphora with a scalpel. Photo: Diana Haapsal

The finished product was then applied with either a brush or a sponge to all the noticeably discoloured patches on the walls. In some discoloured areas we needed to remove dark paint layers or soot prior to the recolouring. Some of us continued previous day's work by cleaning out the stencil paintings hidden underneath smudgy wallpaper paste or secondary paint layers.

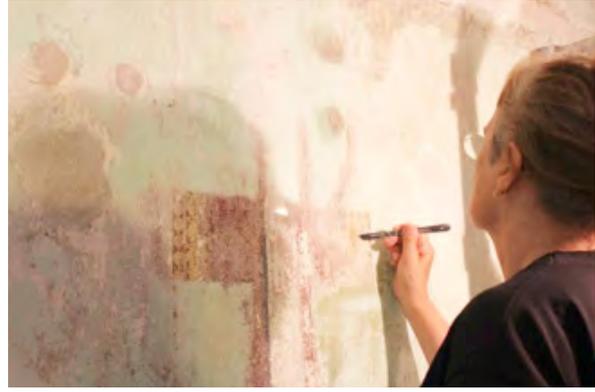
Kirsti cleaning out the earlier wall painting. Photo: Diana Haapsal

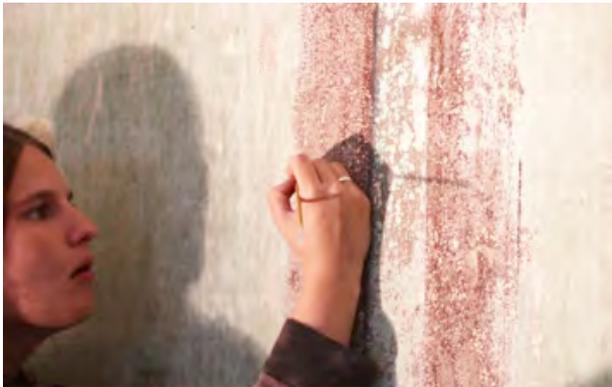
Magdalena doing neutral retouch with a brush. Photo: Diana Haapsal

Due to poorly preserved colours in certain areas, it was also necessary to fill in minor lacunae in the stencil paintings. This was done using the *aqua sporca* technique with much diluted watercolours. The aforementioned method, which is also called the "flat on surface" technique, consists of covering the lacunae with neutral colours similar in hue to the painting, in order to create an aesthetic whole. In doing so the original painting becomes more visible whilst retaining its authentic essence.

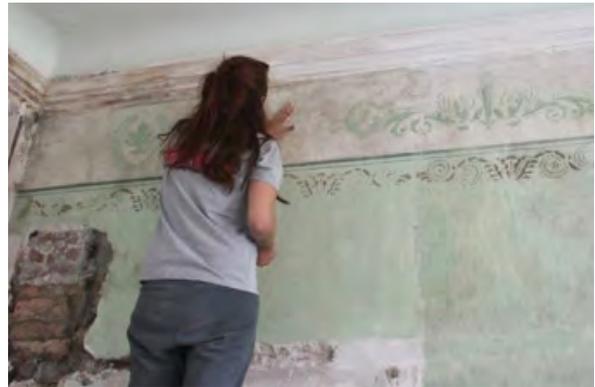
Egle making greyish spot even with white chalk. Photo: Diana Haapsal

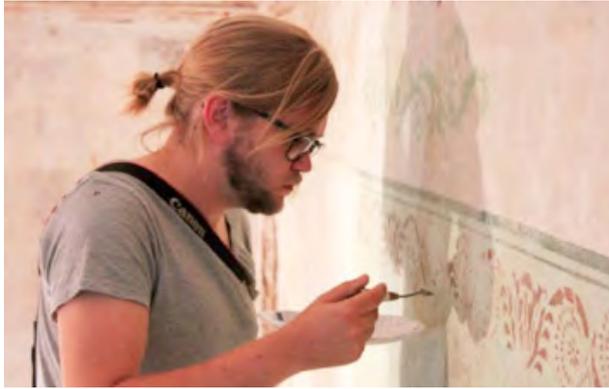
Viktor fixing holes with plaster. Photo: Diana Haapsal

In order to complete the finishing of the south wall, some minor holes from nails and other damage had to be filled with fine plaster. The plaster which consisted of lime, sand, water and typha was applied with a spatula and a wet sponge to blend the surface with the surrounding areas. The plaster corrections were later tinted with the green casein colour to match the colour of the conserved walls.

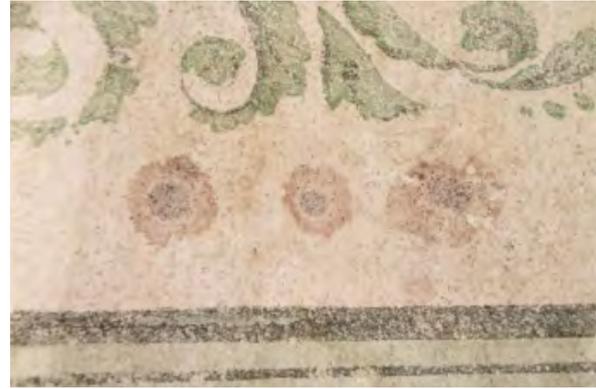
Recently placed plaster in 3 damaged spots on the south wall.
Photo: Viktor Källgren

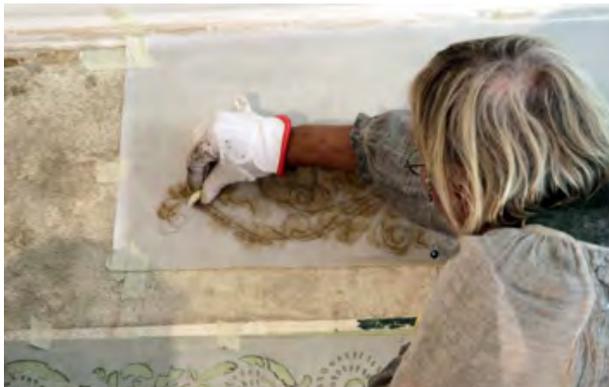
Heli is using a sachet with pigment to attach it to the wall using the pinned through stencil. Photo: Viktor Källgren

In the re-plastered top left corner of the south wall Mihhail and Egle used previously made stencils to reconstruct the painting. Using stencils eased the continuation of the original ornaments on the left side of the wall. The first stencil was made by copying the herbal ornament on the top of the wall to some tracing paper. Then it was applied to a thicker paper by pricking through the lines of the ornament using a pin. This method enabled to copy the pattern on the wall by fixing the stencil to the desired location and sponging the ornament on the wall with a subtle loose pigment. As the guidelines were therefore visible on the wall, it was easy to complete the job by hand.
