CONSERVATION OF WALL PAINTINGS AT SUUREMÕISA MANOR

Sustainable Report No. 9

HIIMUMAA, ESTONIA // INTENSIVE COURSE AUTUMN 2015

A joint project between Uppsala University, Estonian Academy of Arts, Novia University of Applied Sciences and supported by the Nordic Council of Ministers through Nordplus funds.

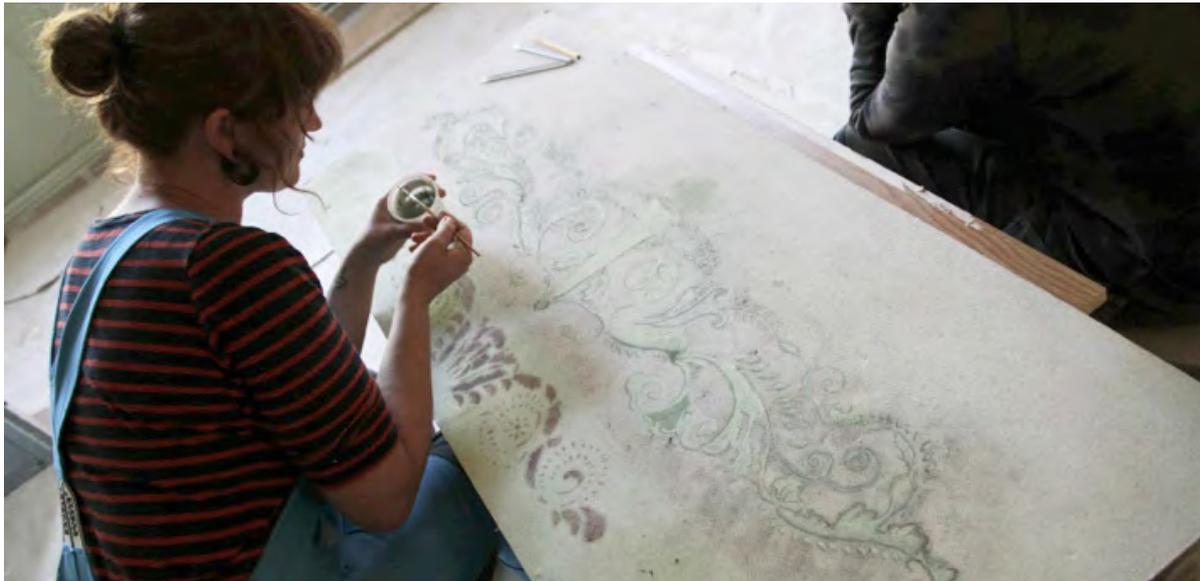
Rebecca is filling in the shadows of one of the ornaments made on masonite. Photo: Viktor Källgren

In order to give every participant a chance to practice creating stencil paintings, the three groups of students from Sweden, Finland and Estonia were each allotted a piece of masonite to make their own attempts at the two different stencils.

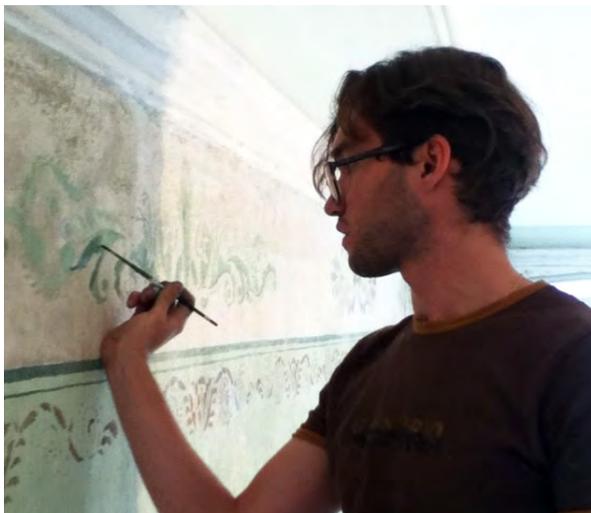
Mihhail adding shadow. Photo: Egle Mikko

On Saturday 28th of August we started to finish work on the south wall in the main room of focus. By that time, work in the second room N16 had been finished to a satisfactory level. Mainly the S-walls reconstruction of a continuous part of the original ornament was touched up by Mihhail to add shadow, light and also lighten the gray color of the background (background color was lightened with pastels). Most of the work, cleaning and retouching to the original ornaments was completed. Some finishing touches with watercolors to the S-walls original ornaments were made by Merike Kallas and Hilka Hiiop. Also on the S-wall, the doors portal, Claudia completed her cleaning of the victory chalice giving it a minimal retouch of color. The outcome of cleaning the victory chalices ended up entirely different from what had first been retraced on paper. In the first retracing (done on Tuesday 24.08.15) was a guess that, what turned out later to be torches, were a crossed feather and sword at the foot of the chalice. This new discovery was also corrected on the reproduction of the chalice (Friday 27.08.15).

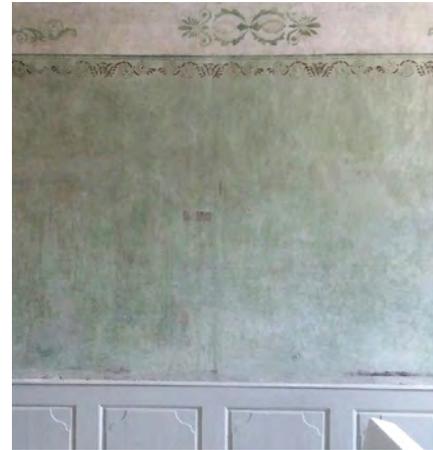
Finished look of the south wall. Photo: Merike Kallas

The rest of the South wall was also done via the aqua-sporca technique, last touches for the green wall were applied and the scaffoldings were removed from the room. Both N2 and N16 were given a thorough Scandinavian style speed cleaning, with Kirsti leading the massed ranks of students in this process.
